Research and Development

Highlights 2002

U.S. Department of Transportation
Federal Aviation Administration

Airport and Aircraft Safety R&D Division

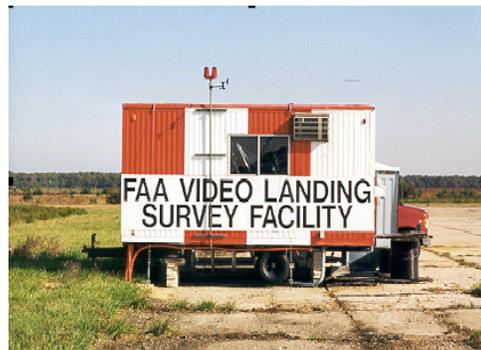
Figure 2. FAA Technical Center's Video Landing Survey Facility

The Federal Aviation Administration has re-established an Operational Loads Monitoring Program, which includes both flight and landing loads data collection on civil transports. The FAA Technical Center's landing data acquisition facility is shown in figure 2.

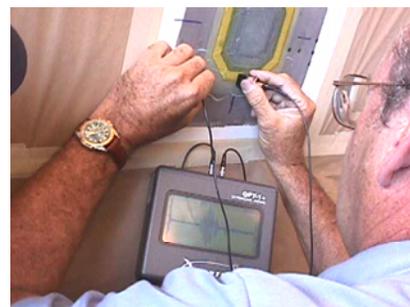
Figure 2. Ultrasonic Inspection of Repair

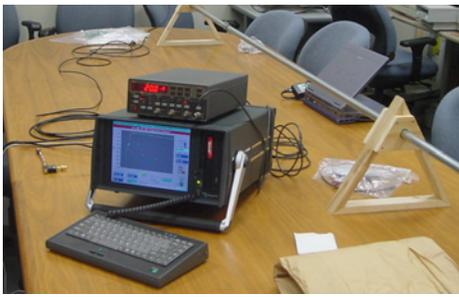
Figure 1. CM Technologies EDT Prototype

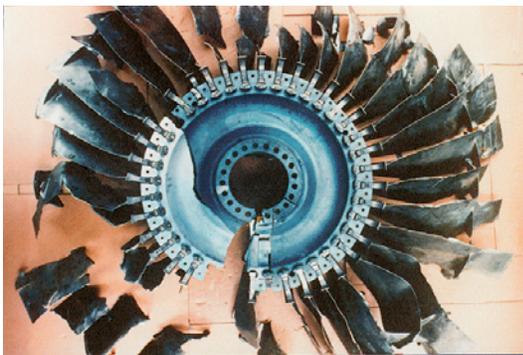
Figure 1. Reconstructed Stage 1 Fan Disk From the No. 2 Engine of a DC-10 That Crashed at Sioux City, Iowa, on July 19, 1989, Caused by a Material Anomaly Produced During Melting

Despite the current rigorous safe-life design approach for failure-critical rotating components, the commercial service experience of turbine-powered aircraft has shown that material and manufacturing anomalies can reduce the structural integrity of critical rotating components and increase the risk of failure (see figure 1).

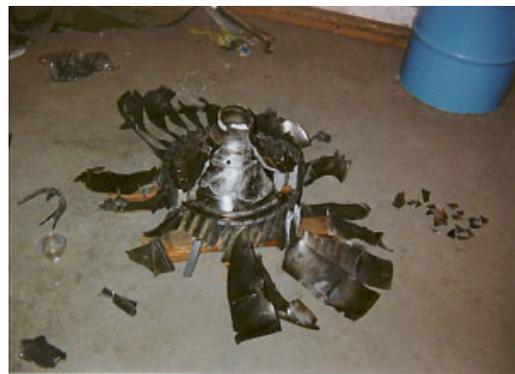
Figure 1. Uncontained Engine Fan Disk Debris

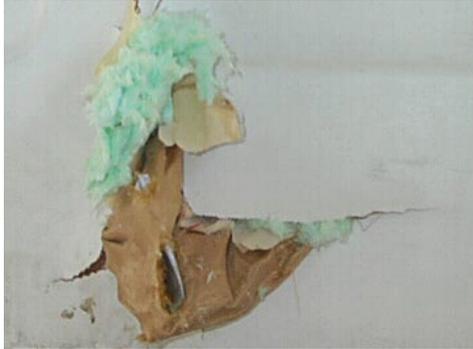
Figure 4. Fan Blade Fragment Stopped in Interior Wall Panel

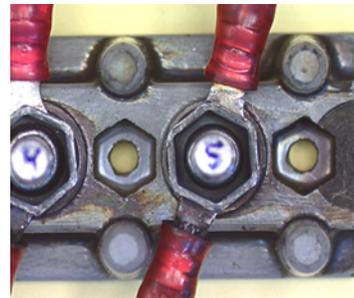
Figure 1. FQIS Terminal Strip With Deposit

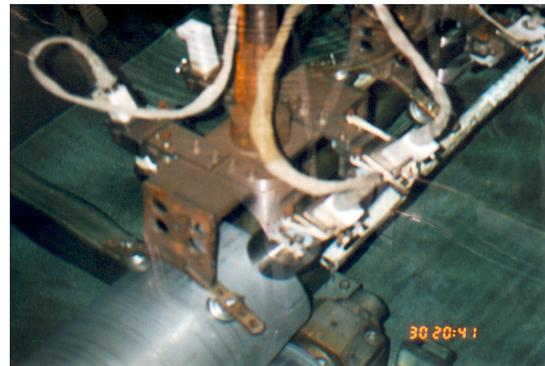
Figure 1. Nickel Billet Ultrasonic Inspection

transducer sweeps an annular section with greater precision than the existing conventional system, which relies on a single transducer to inspect along the entire radius.

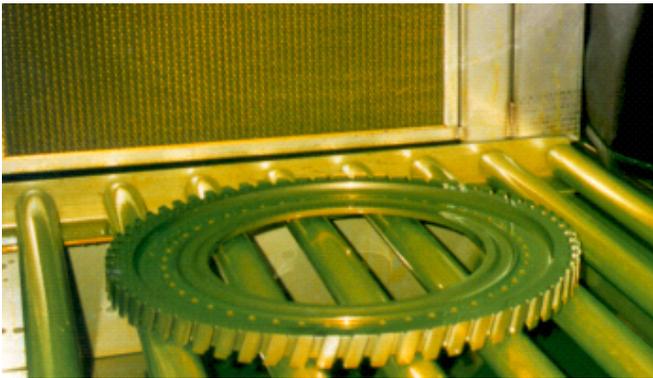
also be inspected during their service life, which includes the additional challenge of field-generated conditions. Figure 1(a) shows a part to which the penetrant has been applied. The penetrant solution enters the defect, excess penetrant is removed from the surface, and a developer is applied to draw the penetrant back out of the flaw so it is more readily visible to the inspector under blacklight. Figure 1(b) shows an example of a crack indication.

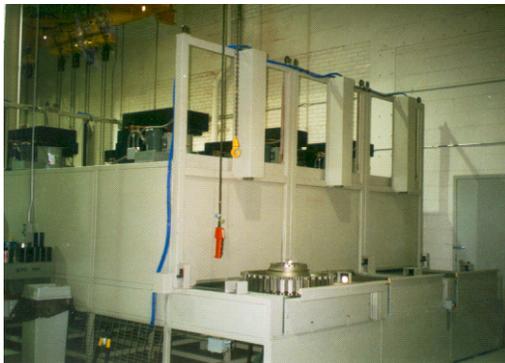
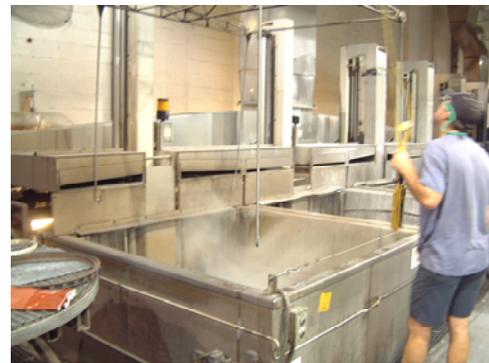
Figure 2. (a) Oven Dryer That Contains Three Furnaces and (b) Flash-Dry Tank Used to Process Components Prior to FPI

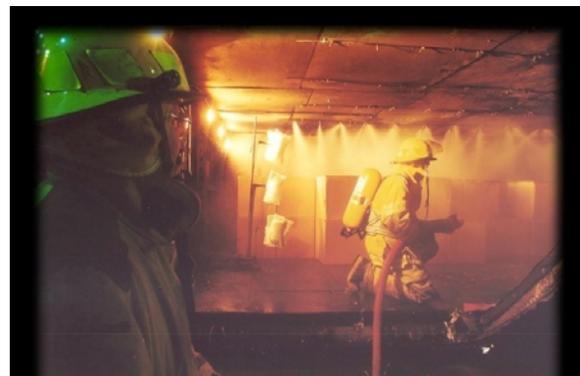
Figure 1. Testing of the Water Mist System

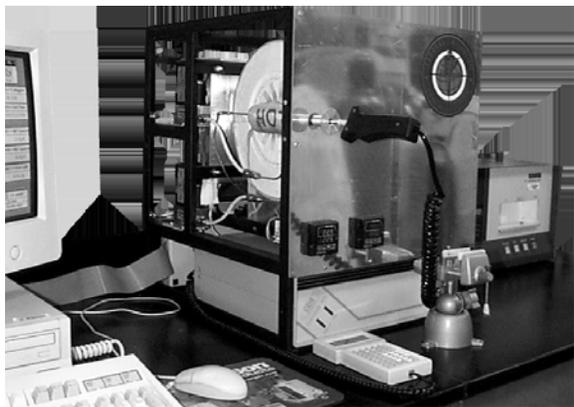
Figure 2. FAA Pyrolysis-Combustion Flow Calorimeter

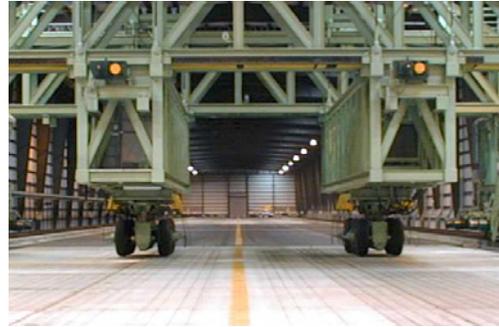
Figure 1. Wheel Loading Carriages

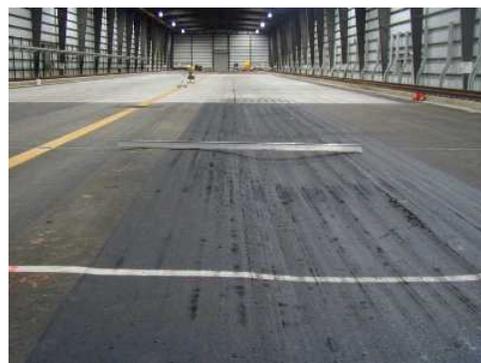
Figure 2. Failed Asphalt (Flexible) Pavement

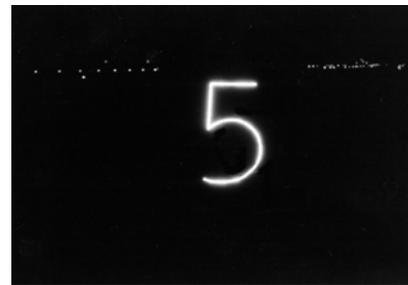
Figure 1. Fiber-Optic Runway Distance Remaining Sign at Night
