DOT/FAA/AR-99/20, P1

Development of a Supplemental Inspection Document for the Fairchild SA226 and SA227 Aircraft, Part 1

Technical Report

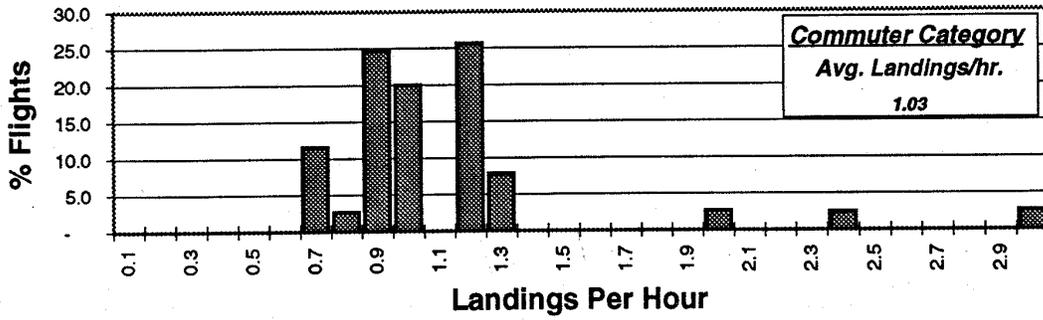
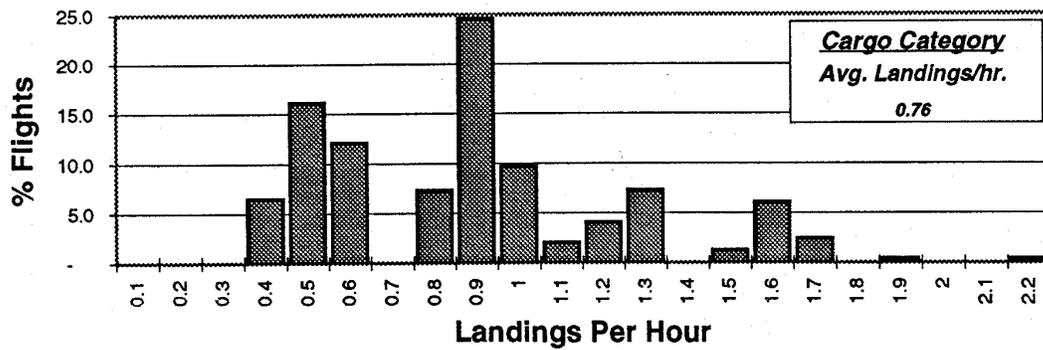
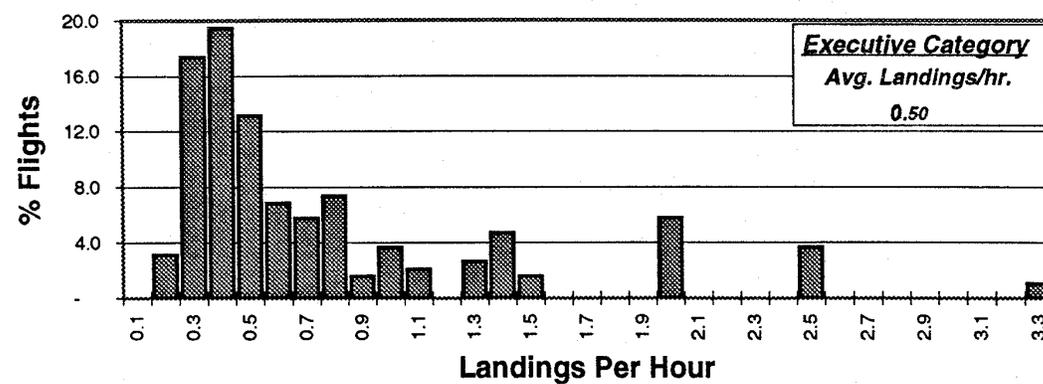
FIGURE 2-1 LANDING FREQUENCY COMPARISON

Figure 2-1 shows histograms of the three operation categories illustrating the number of flights vs. landings per hour.

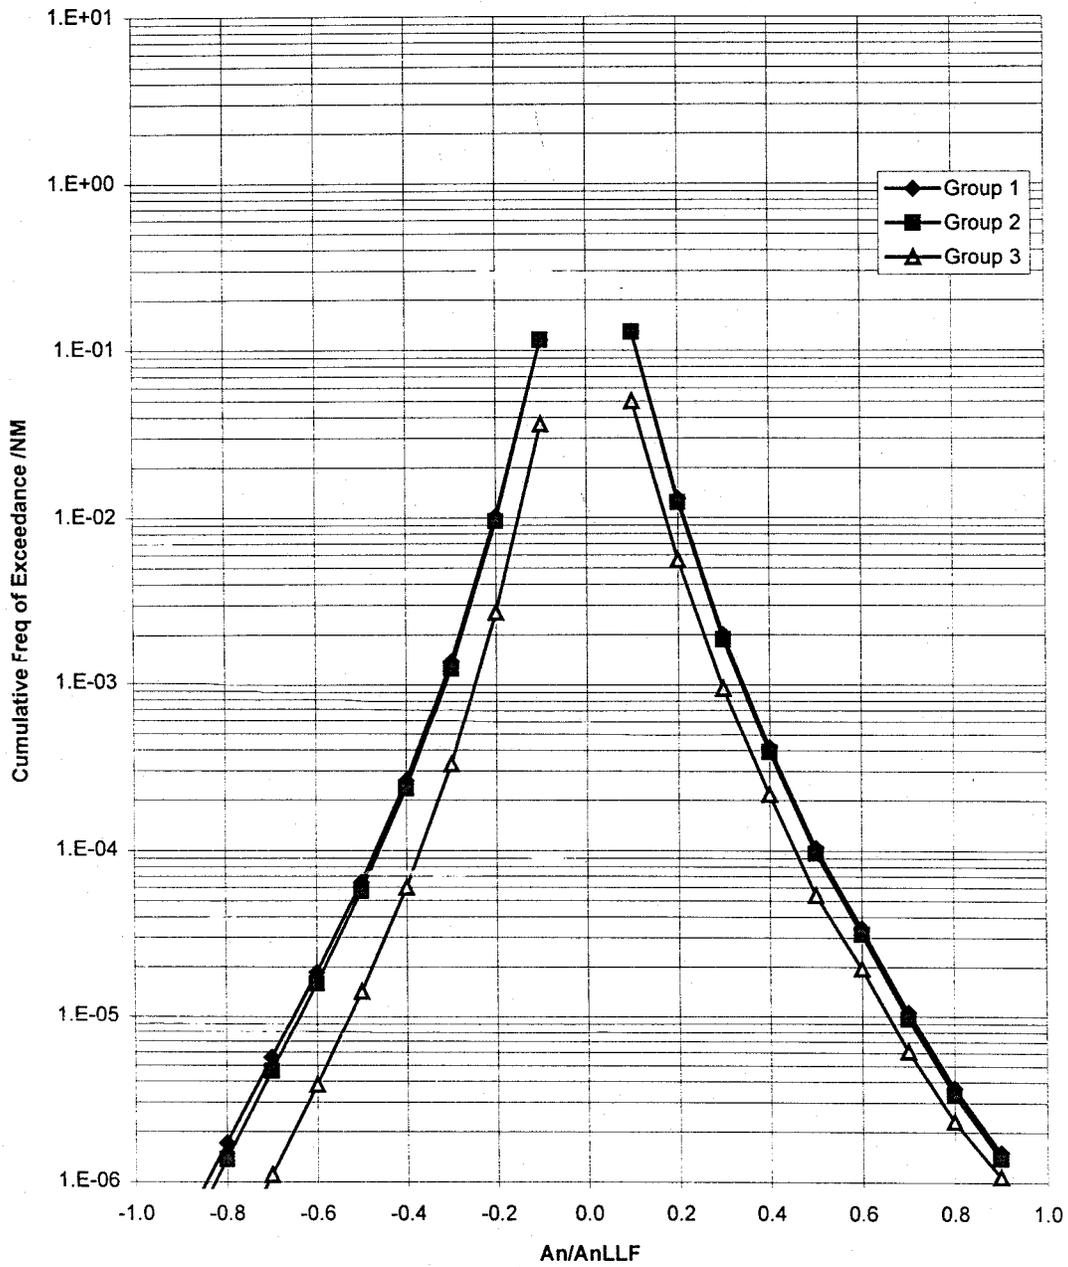
FIGURE 4-1 SA227 MANEUVER AND GUST SPECTRUM

Gust and Maneuver Load Spectra for Metro III

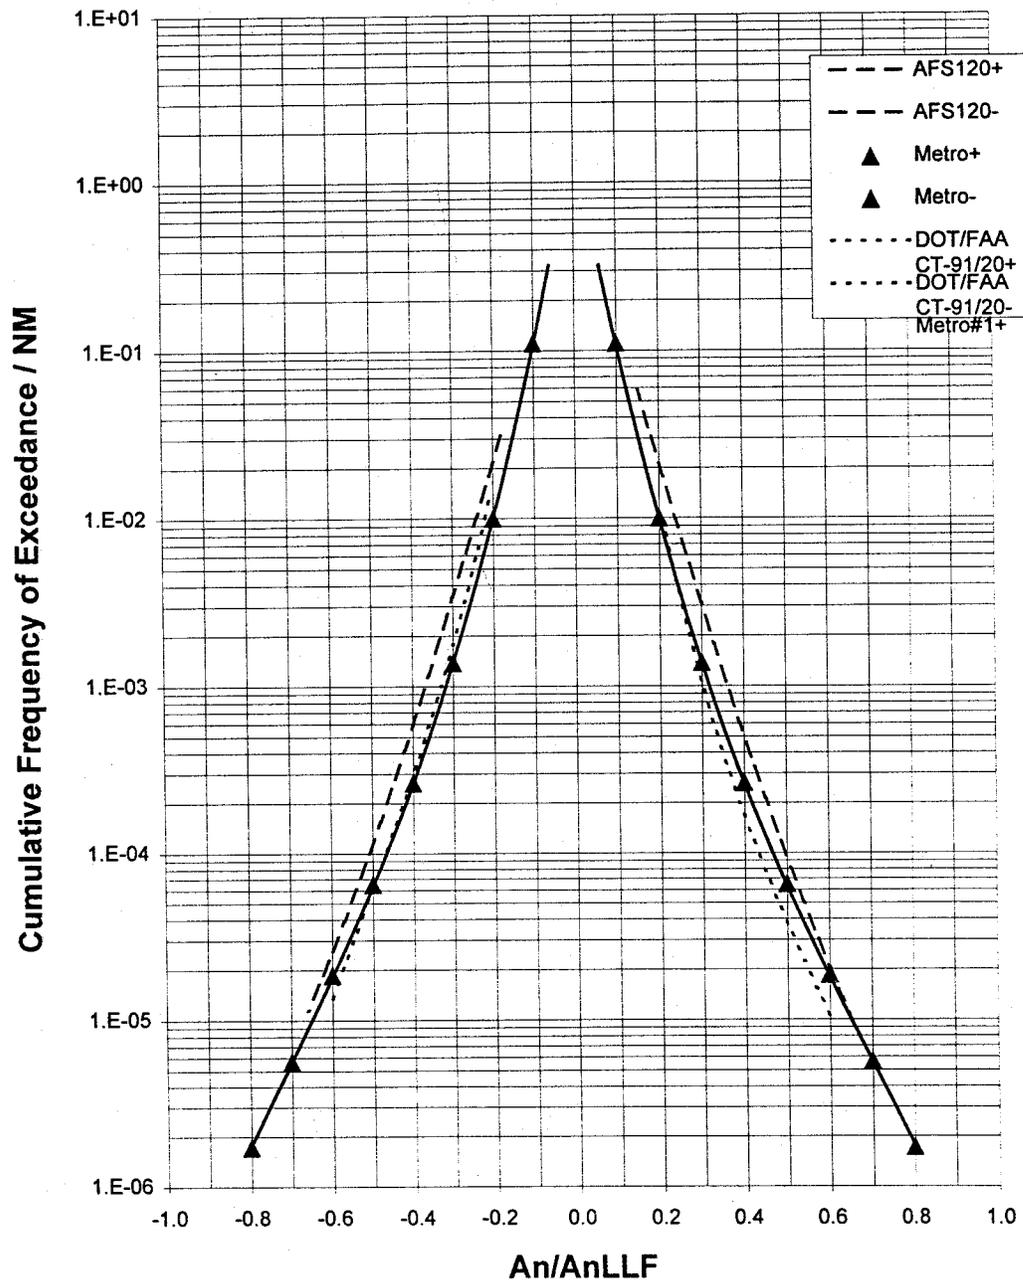
**FIGURE 4-2 GROUP 1 FLIGHT PROFILE
 VERTICAL GUST LOADS EXCEEDANCE COMPARISON**

Load Spectra Comparison Metro III
Gust, Group 1, 30 Min, 12,000 FT, 12,800 LB TO Wt.

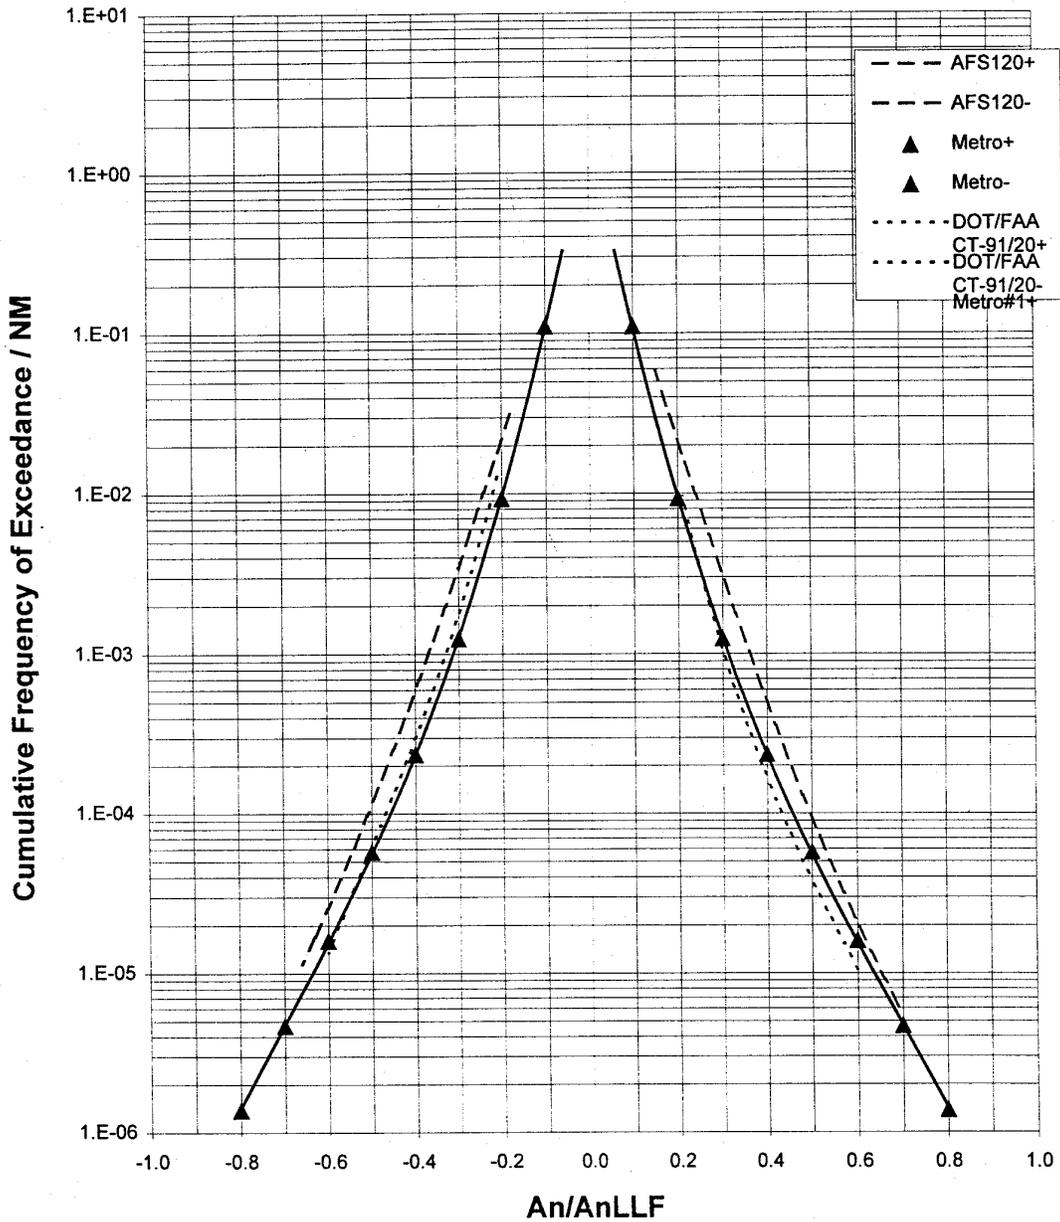
**FIGURE 4-3 GROUP 2 FLIGHT PROFILE
 VERTICAL GUST LOADS EXCEEDANCE COMPARISON**

Load Spectra Comparison for Metro III
Gust, Group 2, 60 Min, 16,000 FT, 13,300 LB TO Wt.

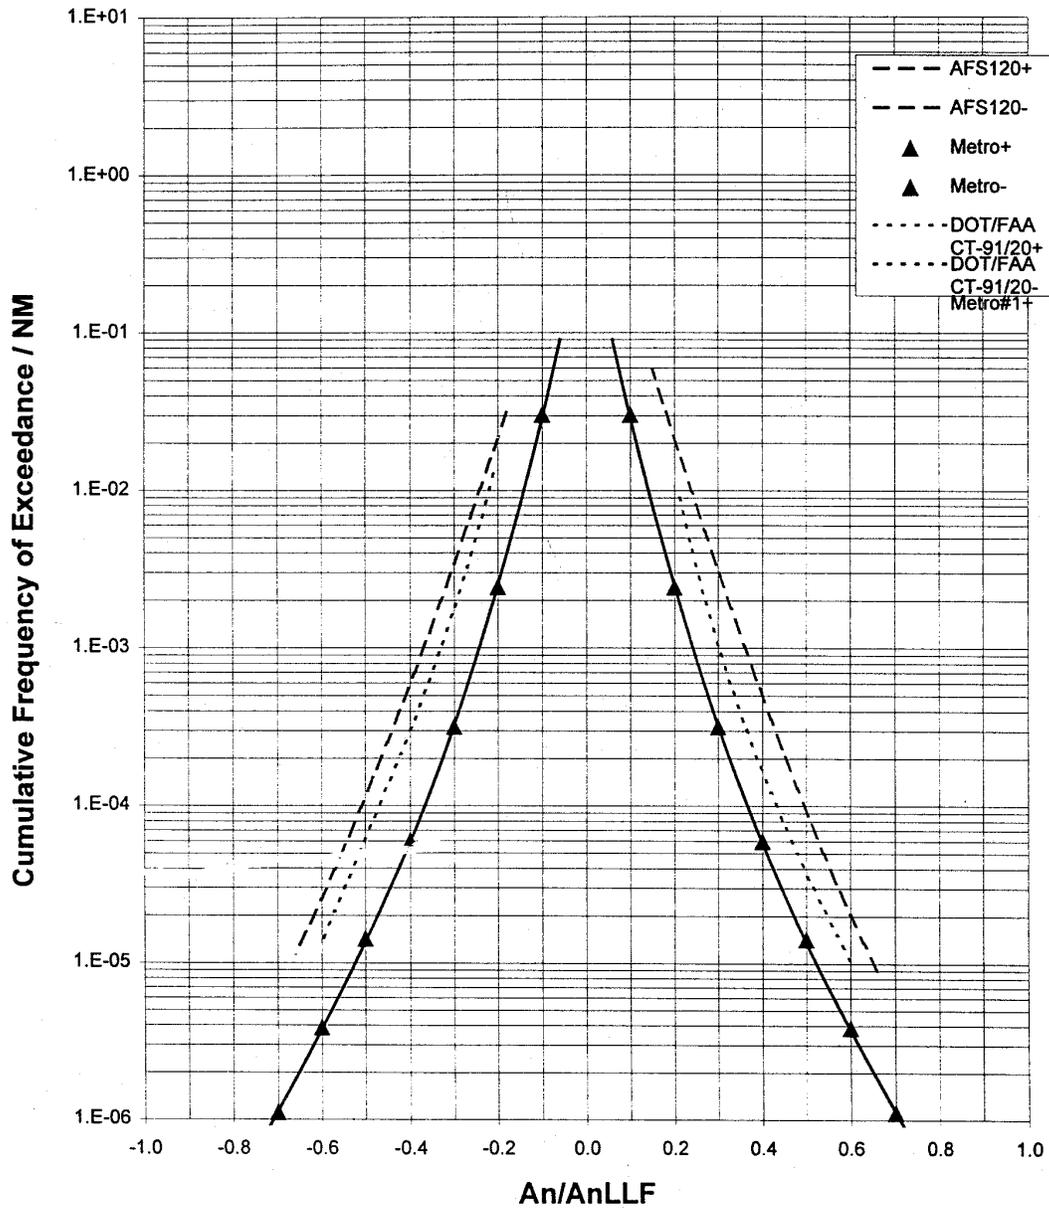
**FIGURE 4-4 GROUP 3 FLIGHT PROFILE
VERTICAL GUST LOADS EXCEEDANCE COMPARISON**

**Load Spectra Comparison for Metro III
Gust, Group 3, 120 Min, 20,000 FT, 13,800 LB TO Wt .**

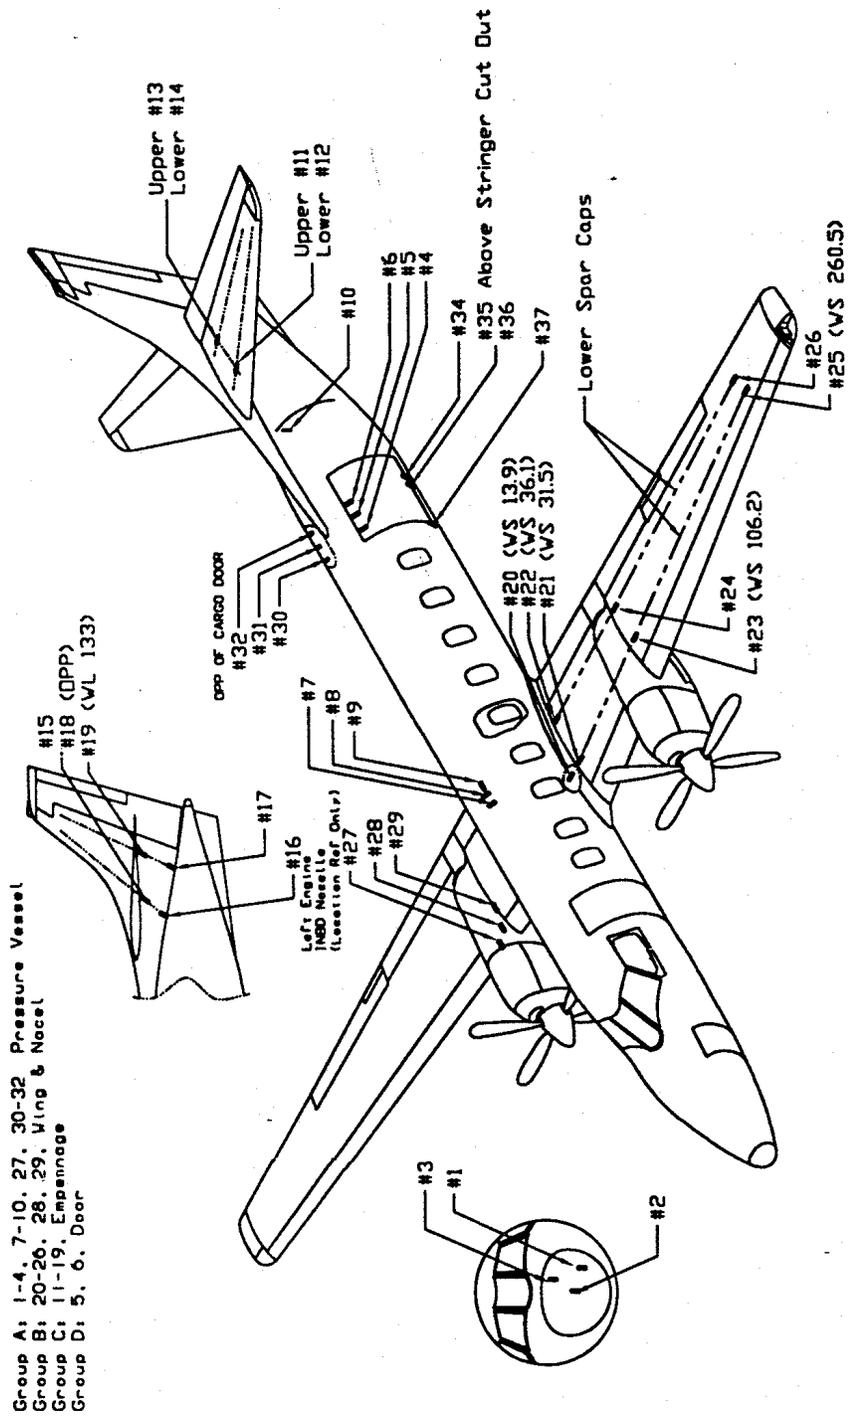
FIGURE 5-1 STRAIN GAGE LOCATIONS

A model SA227 DC aircraft serial number AC-557 was instrumented to measure strains at selected locations on the aircraft during typical flight maneuvers. A total of five flights were made to collect the data preceded by a calibration of the aircraft strain gages by the application of known loads to the aircraft. The location of the strain gages is shown on Figure 5-1.

Strain gages were located at three locations on the wing main and rear spar, on the horizontal tail main spar and rear spar near the root, and on the main and rear spar of the vertical tail. In addition strain gages were located at potentially high stress locations on the pressure vessel and nacelle. The strain gages were loaded with known loads to verify the gages were functioning properly. The data were recorded on the hard disk of a PC on the aircraft by a virtual instrument developed using LabView for Windows software. The analog to digital boards on the aircraft are capable of recording voltages equivalent to about 40-psi stress. For this reason some of the plots discussed are somewhat ragged looking when displaying very low stress levels.

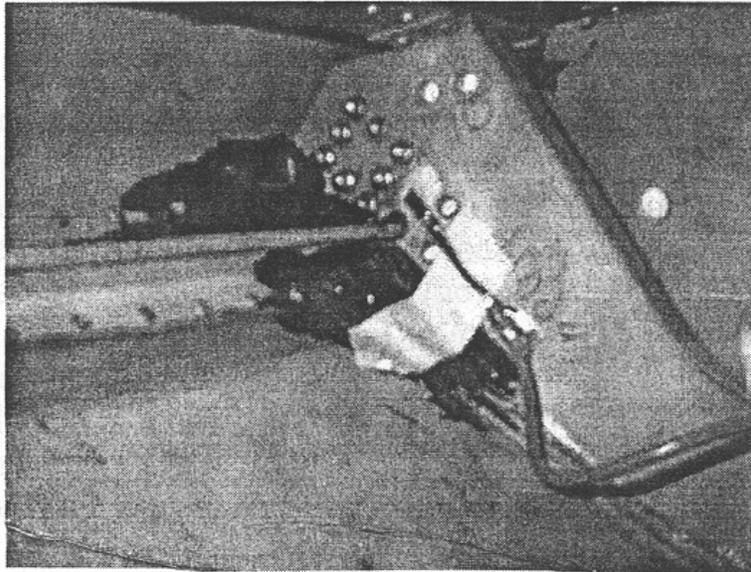
FIGURE 5-2 STRAIN GAGE 34

Four additional gages were mounted in the fuselage cargo door surround structure to measure stresses at the latches due to pressurization. The location of these gages is

shown in Figure 5-2 through Figure 5-4. The stresses measured by these gages are shown in Appendix D of reference 20.

The stress measured at gage 34 was in reasonable agreement with the calculated stress. The stress at gages 35 and 36 was unexpected and did not match the stresses which caused fatigue cracks at this location during the full-scale fatigue test. After the crack was discovered during the fatigue test, the frames at this location were increased in thickness from 0.040 to 0.071 inch the local lightening holes were removed, and the tooling holes were plugged. The new configuration is the one being used in the current test. These changes are not expected to change the sign of the local stresses. The compressive stresses now measured locally may be due to variations in the local engagement of the latches that would vary from aircraft to aircraft. For this reason any analysis must assume the maximum calculated stress in these frames.

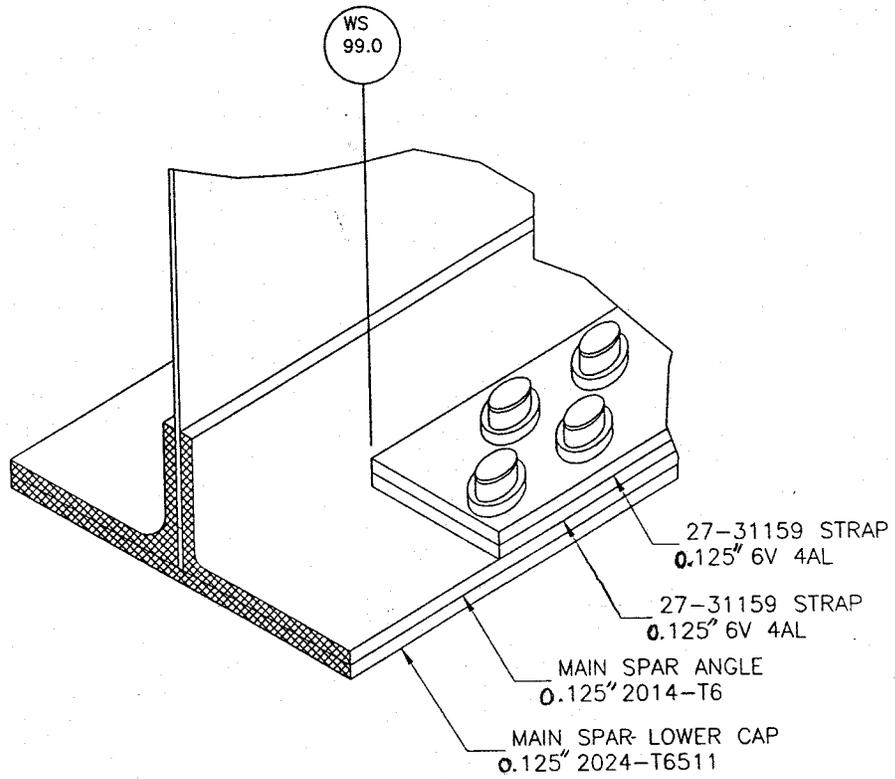
FIGURE 6-1 W1 - SA226 MAIN SPAR LOWER CAP AT WING STATION 99.0

9. Inspect	Difficult to inspect. Look for crack on exposed center ridge of spar cap.	a	11
Total Score			64

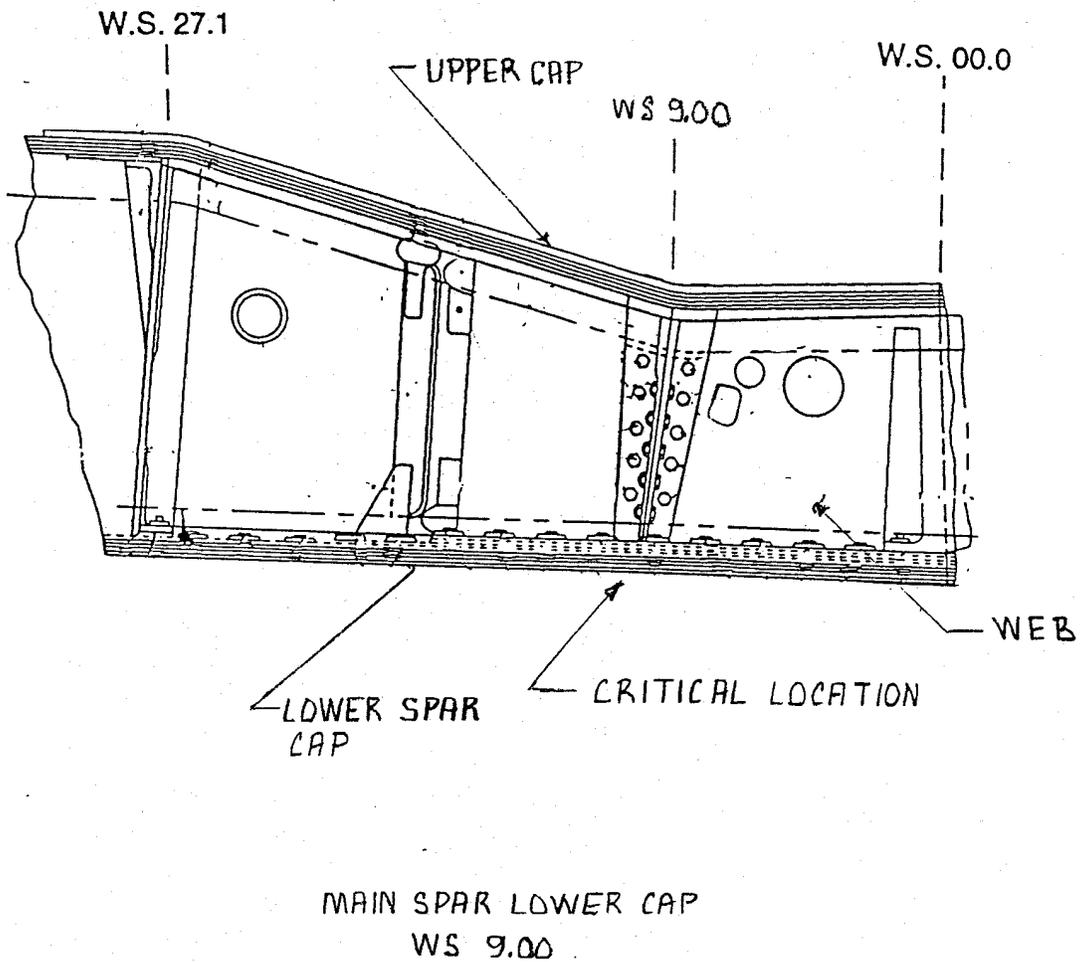
FIGURE 6-2 W2 - SA226 MAIN SPAR LOWER CAP AT WING STATION 9.0

7. K _t	Minor local bending.	c	3
8. Accidental Damage	Low probability of damage. Away from propellers and baggage and service vehicles.	d	2
9. Inspect	Difficult to inspect. Look for crack on exposed center ridge of spar cap.	a	11
Total Score			58

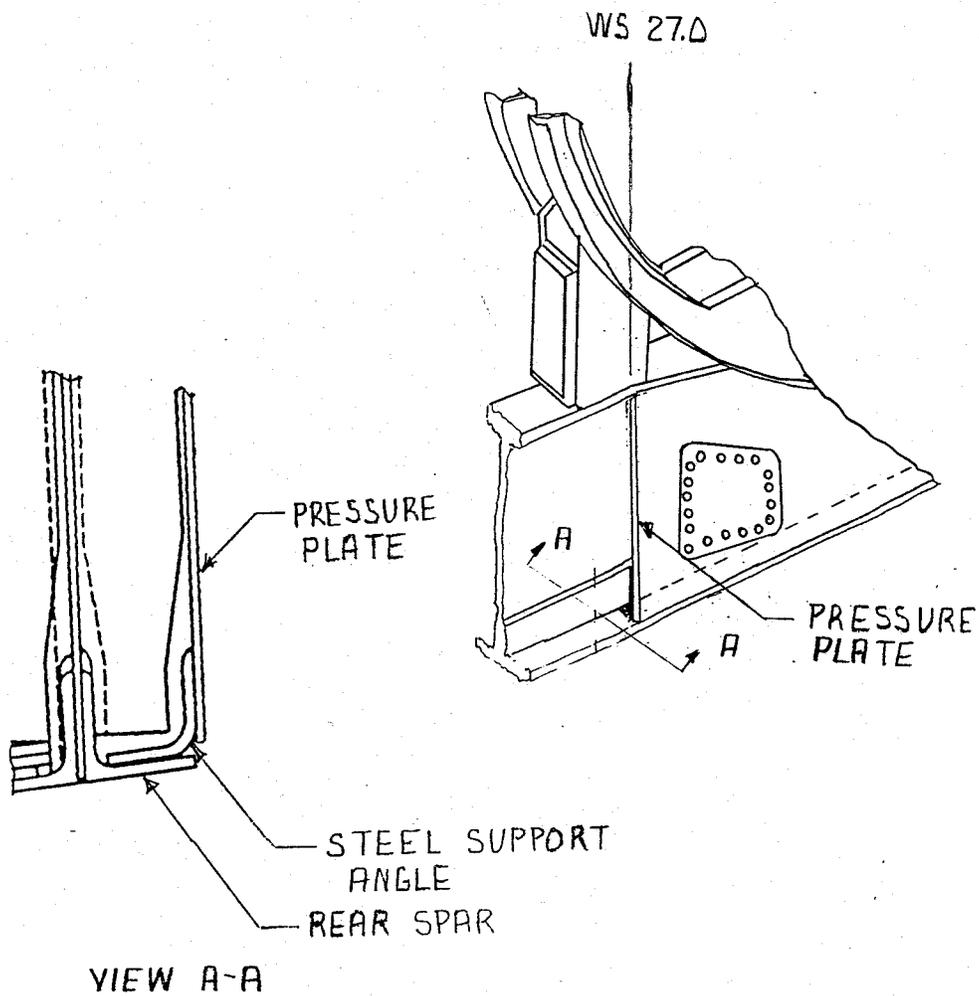
FIGURE 6-3 W3 - SA226 REAR SPAR LOWER CAP AT WING STATION 27.0

9. Inspect	Difficult to inspect. Modification may be needed.	a	12
Total Score			60

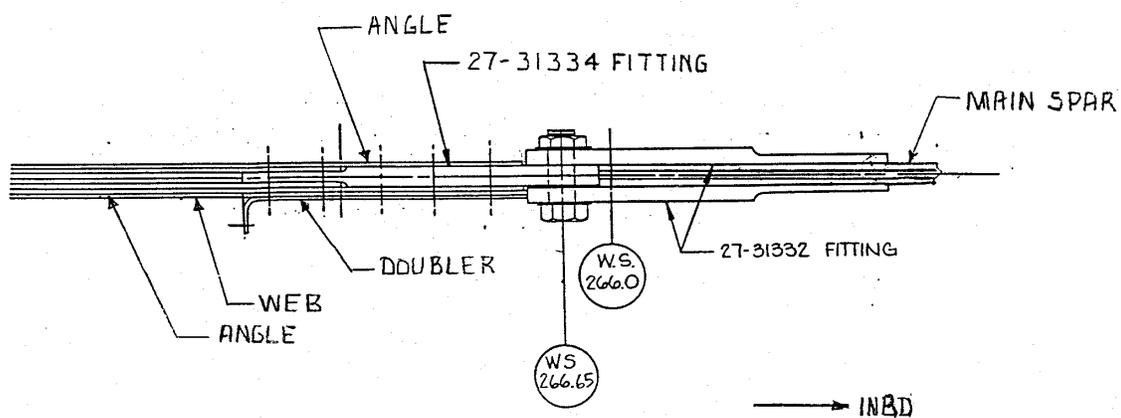
**FIGURE 6-6 W6 - SA227 WING EXTENSION FITTING MAIN
 SPAR LOWER SURFACE**

WING EXTENSION FITTING MAIN
 SPAR LOWER SURFACE
 VIEW LOOKING FWD

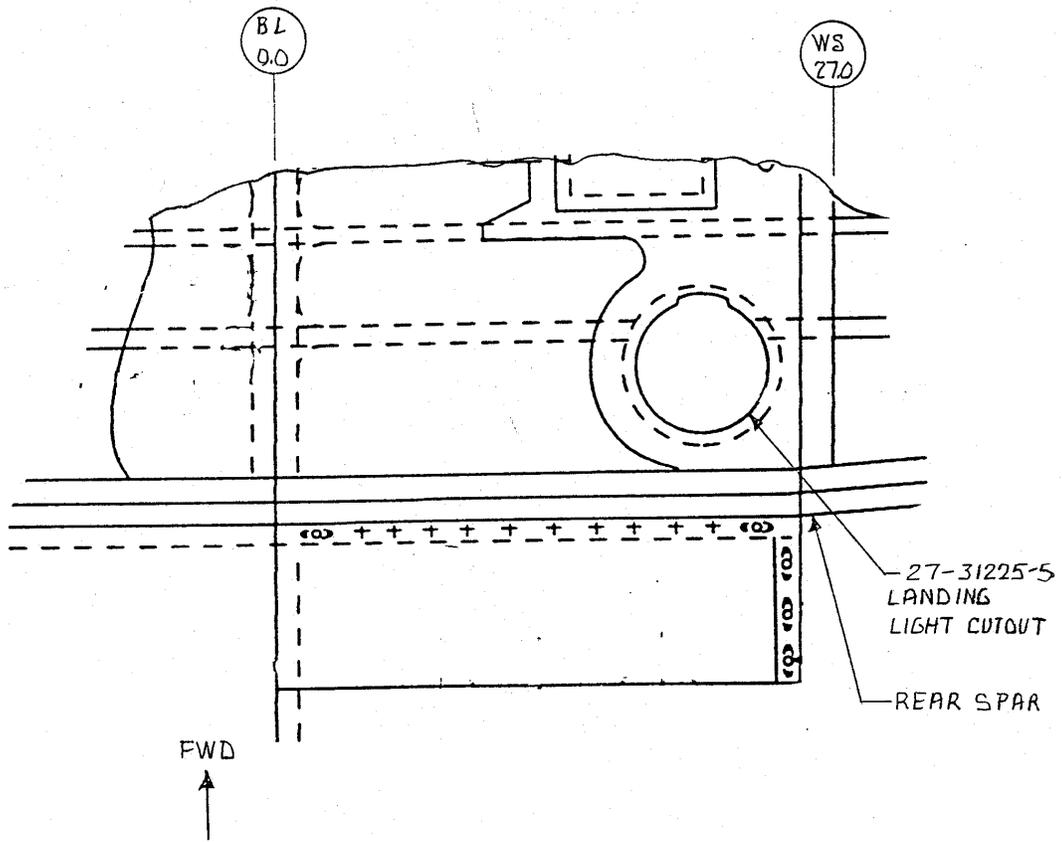
FIGURE 6-11 W11 - SA226 WING LOWER CENTER SECTION SKIN AT LANDING LIGHT CUTOUT

WING LOWER CENTER SECTION SKIN

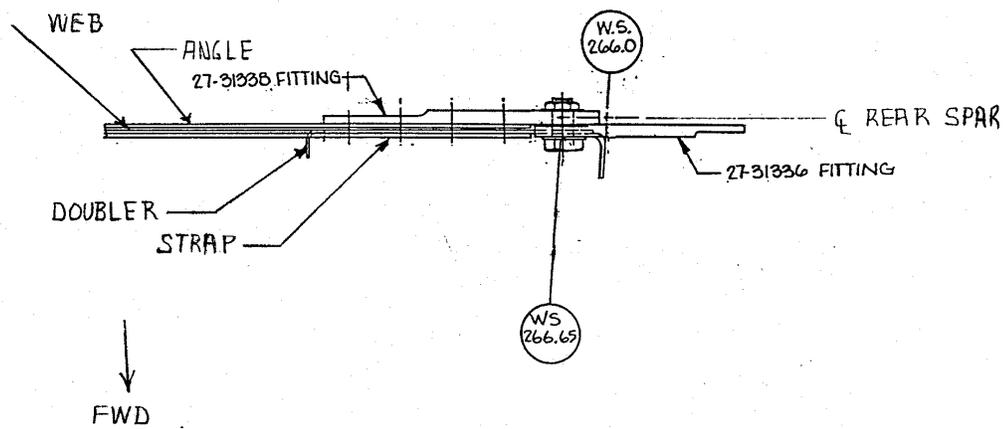
FIGURE 6-12 W12 - SA227 TIP EXTENSION FITTING REAR SPAR LOWER SURFACE (27-31335)

WING TIP EXTENSION FITTING
 LOWER SURFACE
 (SKIN NOT SHOWN)

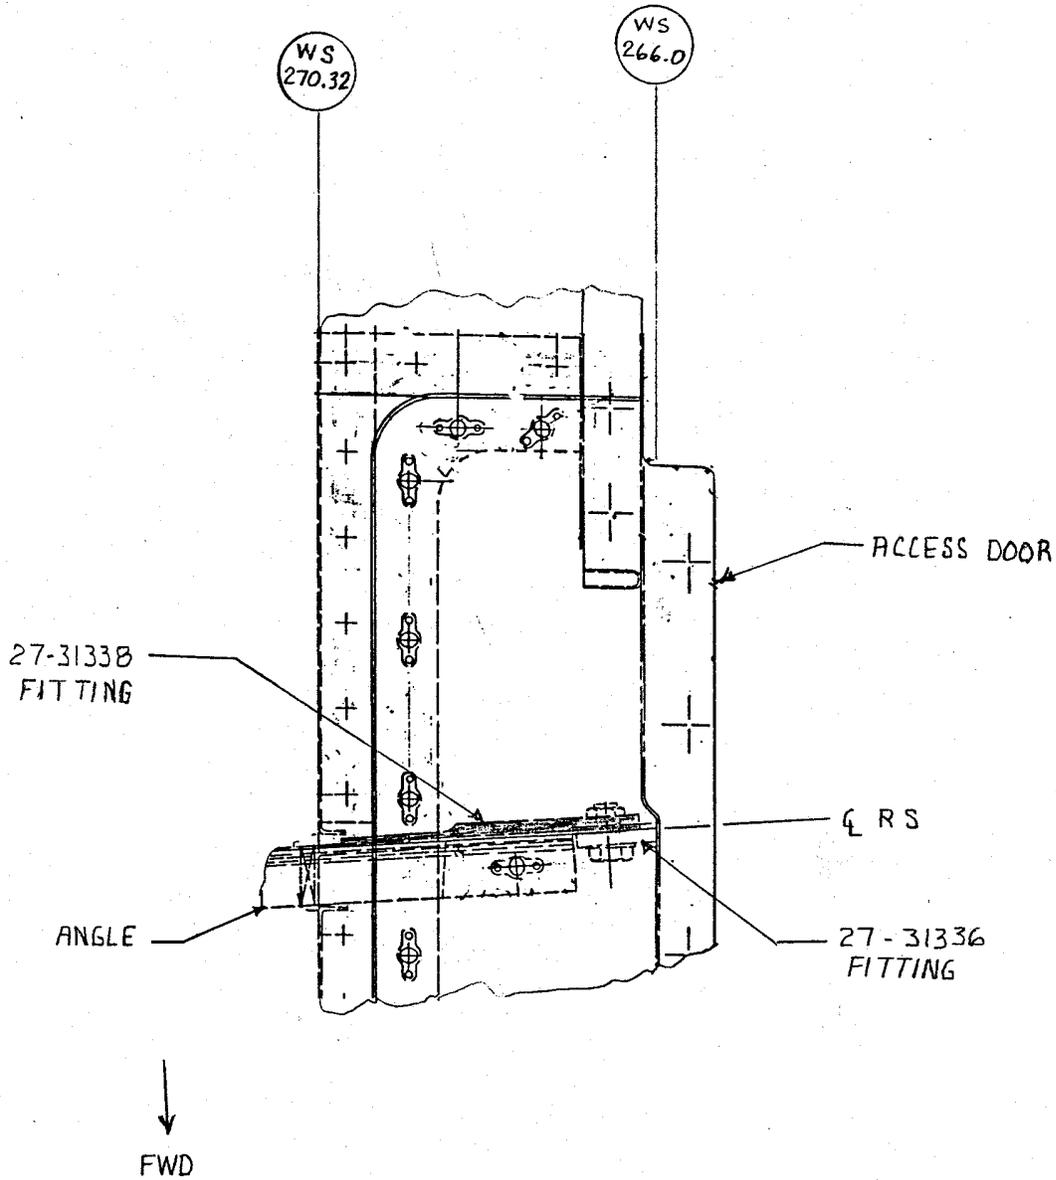
**FIGURE 6-13 W13 - SA227 TIP EXTENSION AT END OF
 OUTBOARD FITTING (REAR SPAR)**

TIP EXTENSION AT END OF OUTBOARD
 FITTING REAR SPAR LOWER SURFACE
 (SKIN NOT SHOWN)

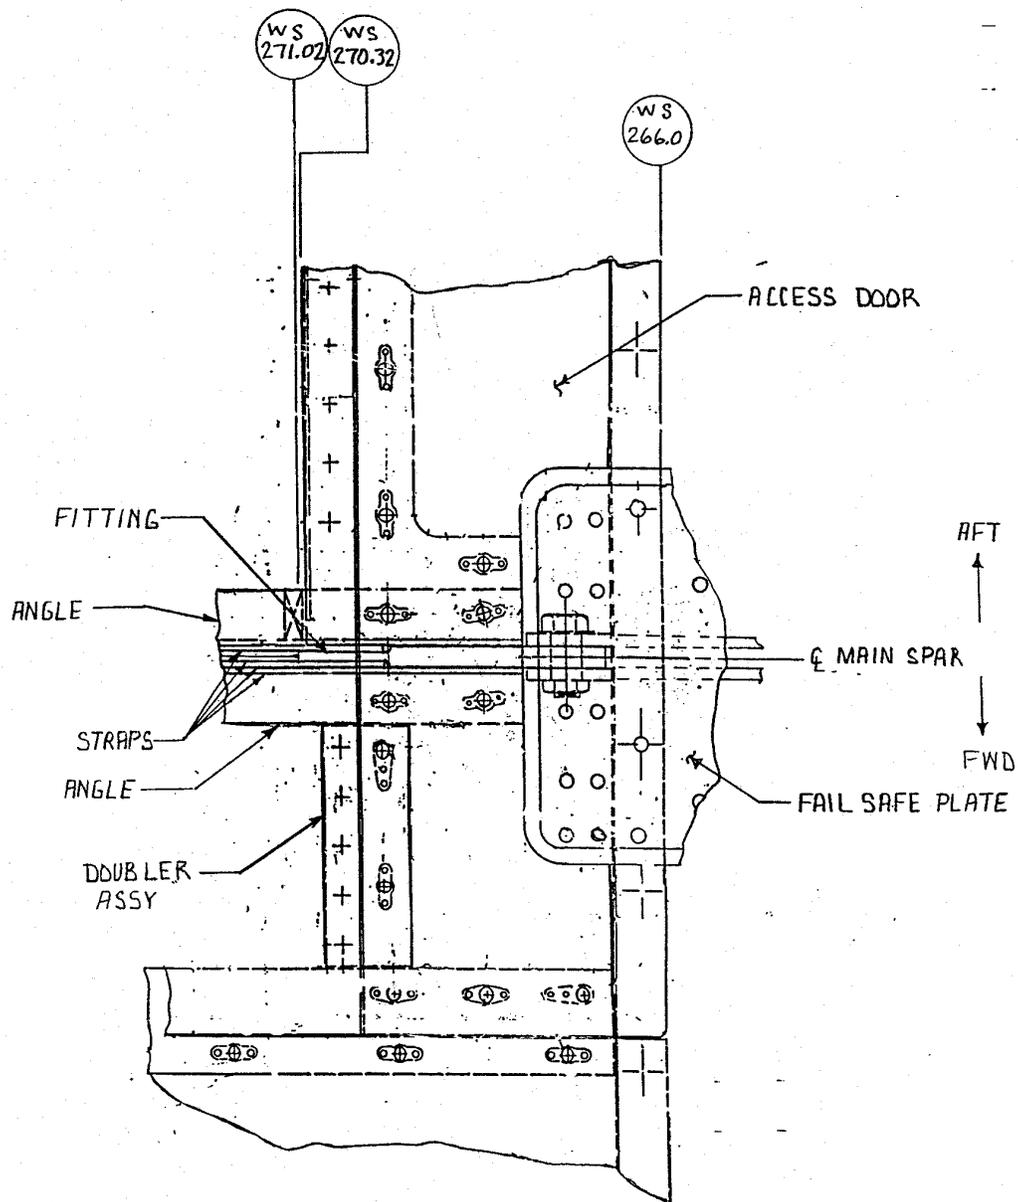
**FIGURE 6-14 W14 - SA227 TIP EXTENSION AT END OF
 OUTBOARD FITTING (MAIN SPAR)**

WING TIP EXTENSION AT END OF
 OUTBOARD FITTING MAIN SPAR
 LOOKING UP LOWER SURFACE
 (SKIN NOT SHOWN)

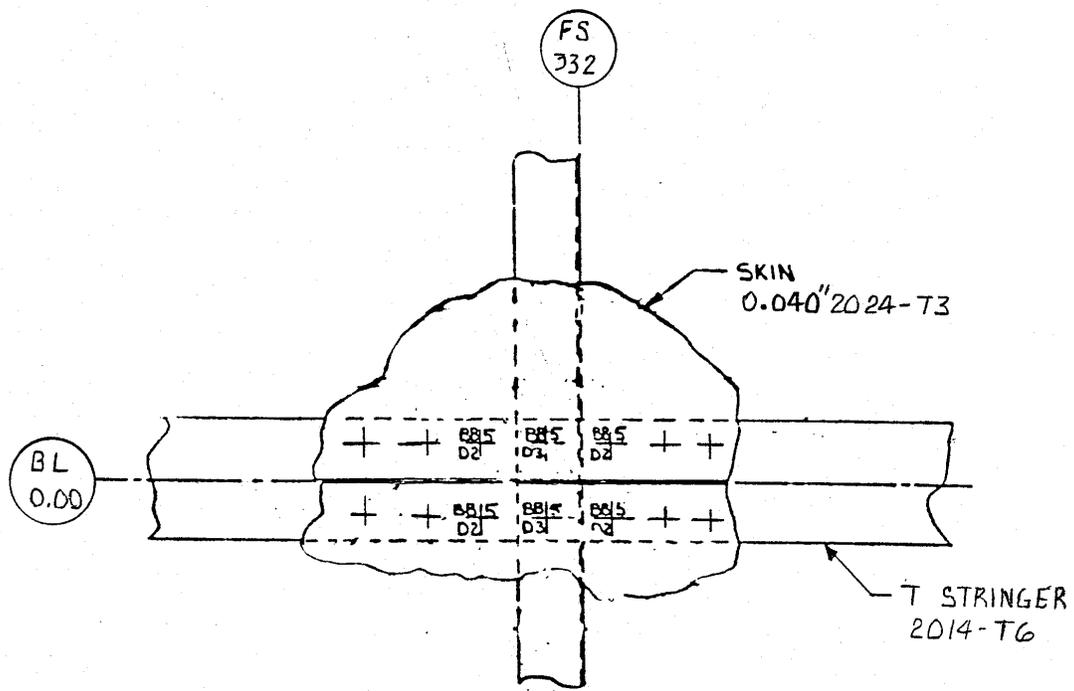
**FIGURE 6-15 F1 - SA226 T STRINGER, TOP CENTERLINE
 NEAR F.S. 330**

T STRINGER TOP CENTERLINE
 NEAR FS 330

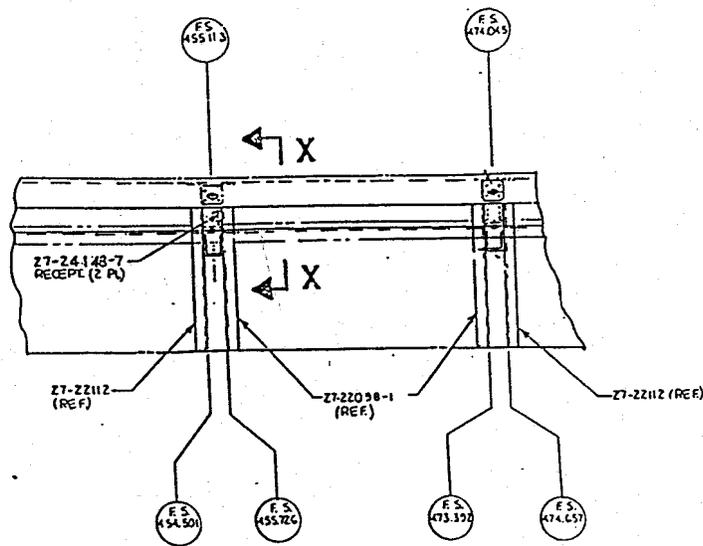
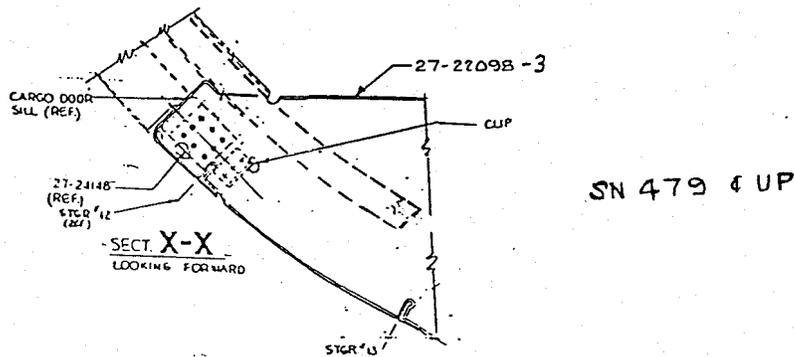
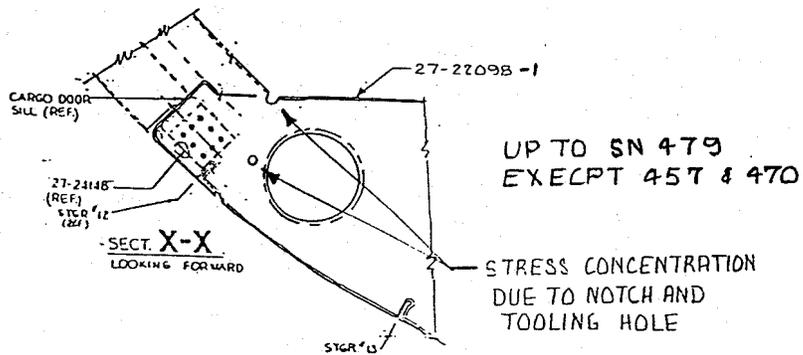
FIGURE 6-17 F4 - SA226 AND SA227 FUSELAGE FRAME AT FORWARD CARGO DOOR LATCH

VIEW LOOKING INBD - LH SIDE
SKIN & DOOR OMITTED FOR CLARITY

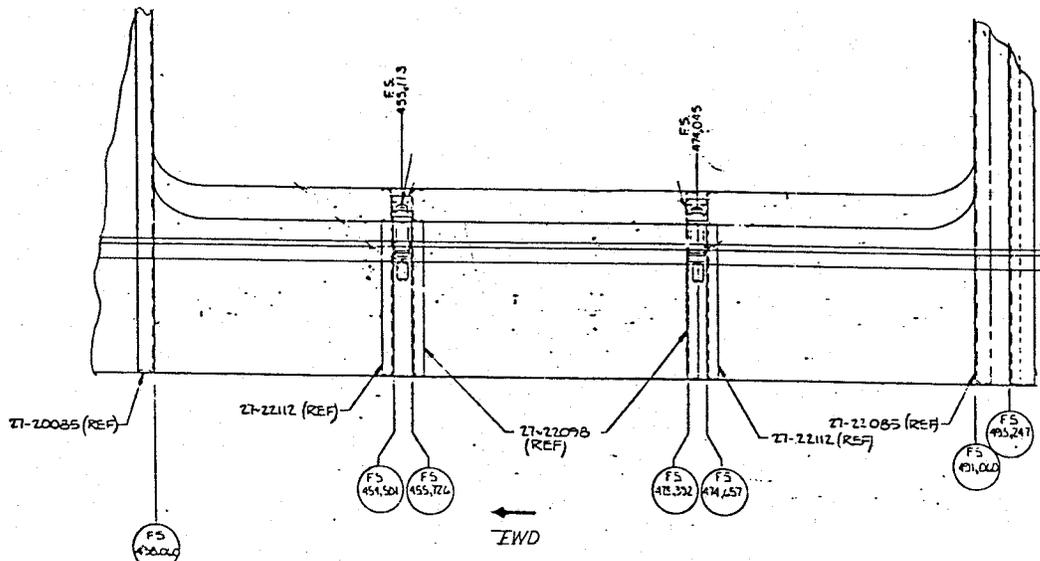
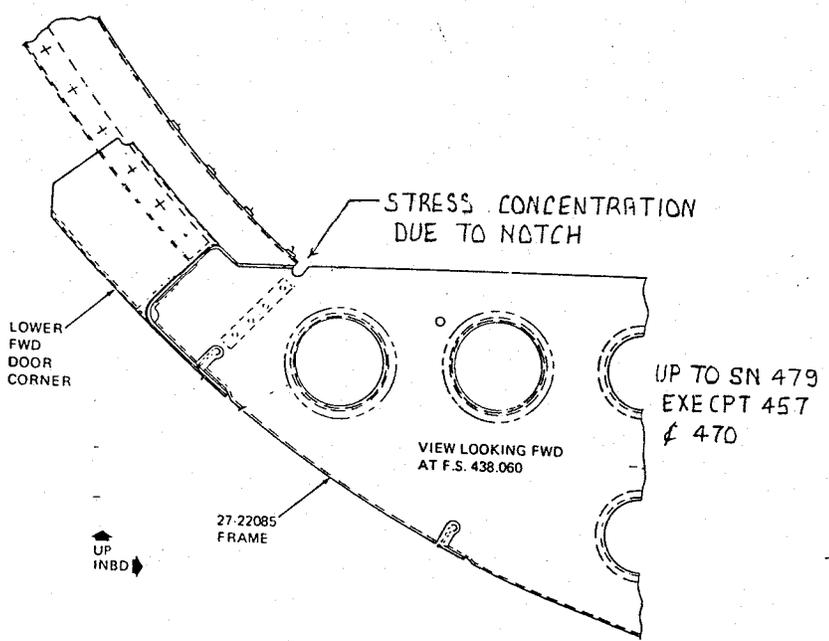
FIGURE 6-19 F6 - SA226 AND SA227 FUSELAGE FRAME AT CARGO DOOR SIDES

FUSELAGE FRAME AT CARGO DOOR SIDES
ITEM F6

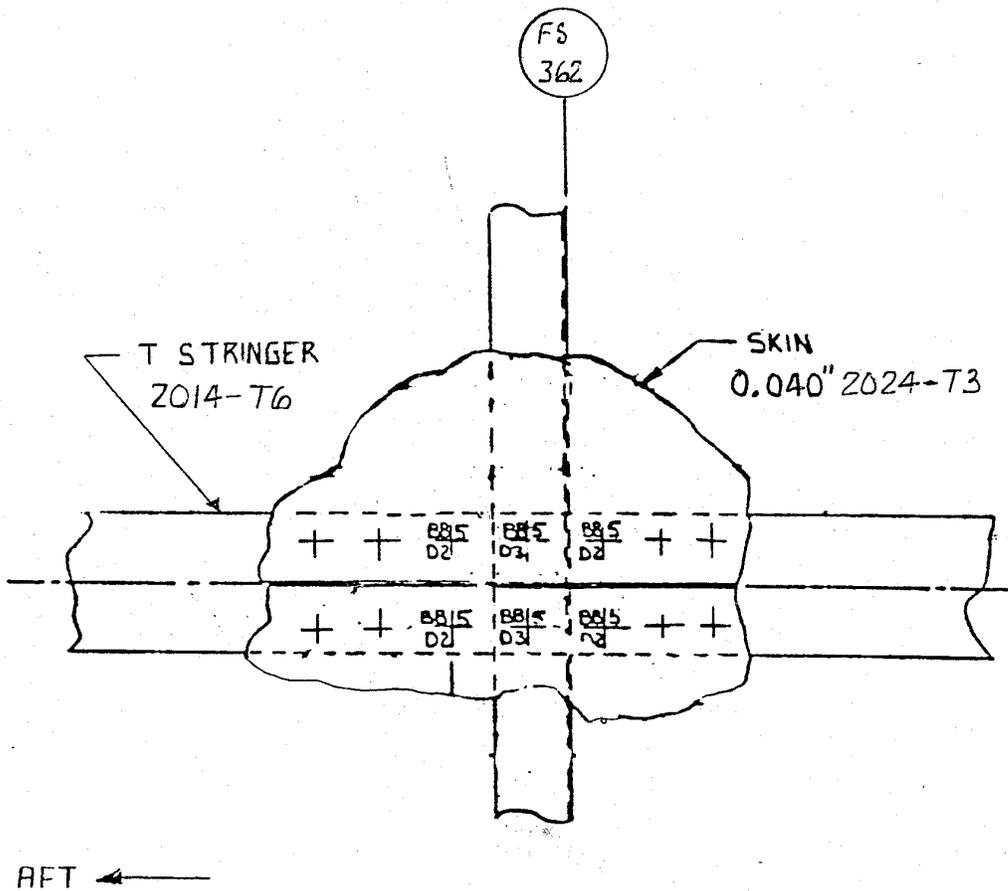
FIGURE 6-22 F9 - SA226 T STRINGER, BOTTOM CENTERLINE
AFT OF F.S. 362

T STRINGER
BOTTOM CENTERLINE
AFT OF FS 362

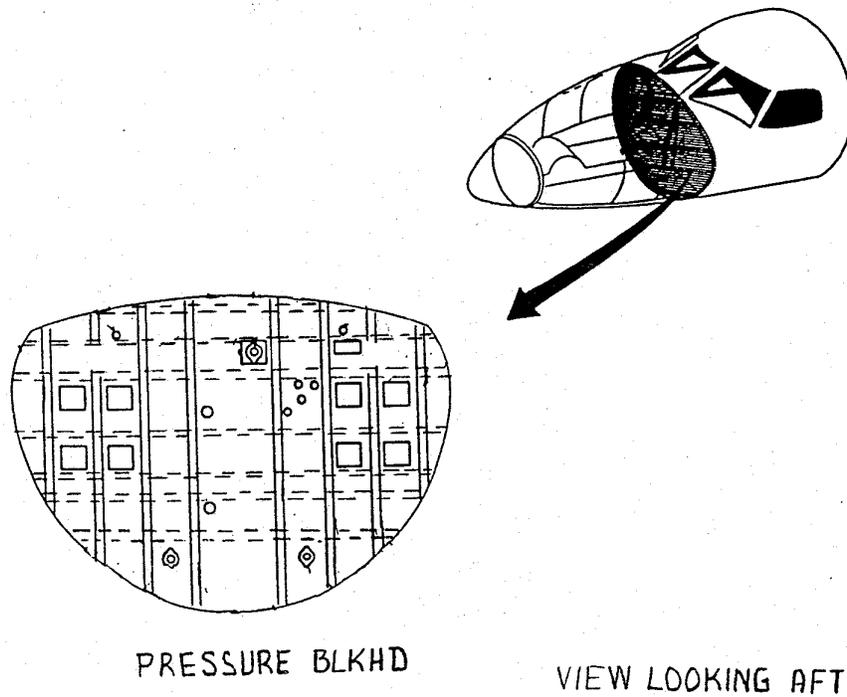
FIGURE 6-24 F11 - SA226 AND SA227 FORWARD PRESSURE BULKHEAD

Nose Section, Bulkhead - F.S.69.31

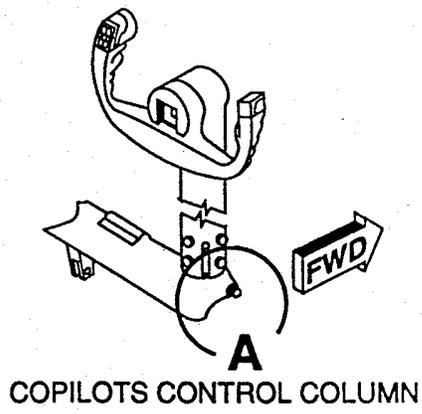
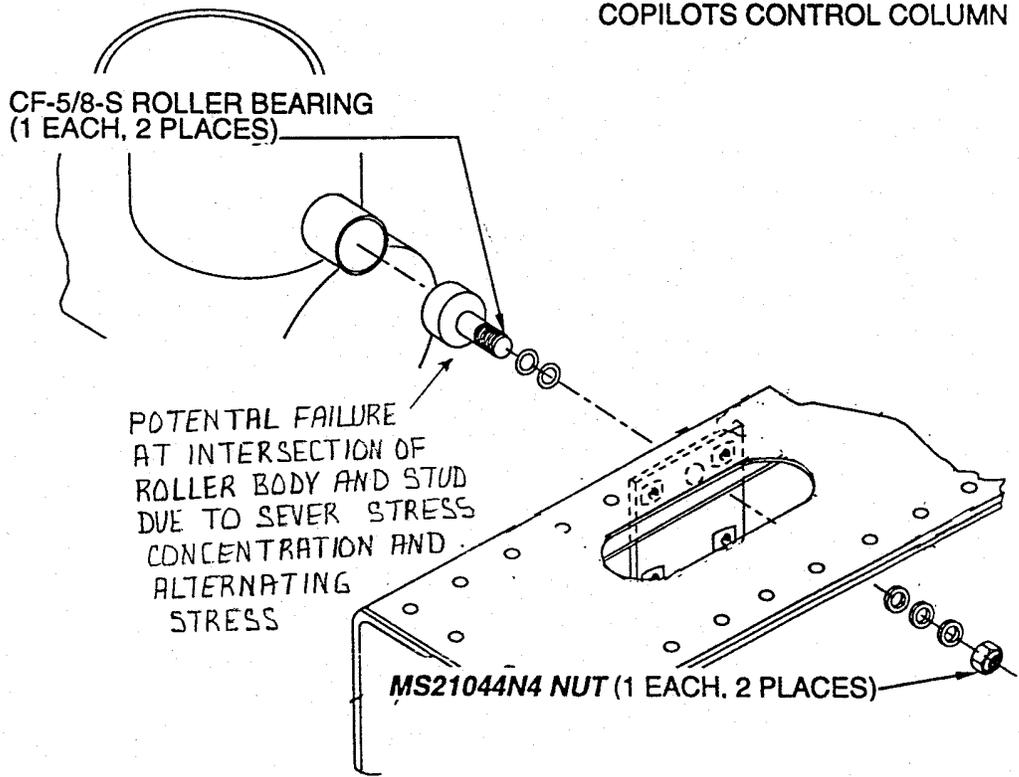
**FIGURE 6-26 F13 - SA226 AND SA227 CONTROL COLUMN
ROLLER BEARING**

DETAIL A
(PILOTS SIDE TYPICAL)

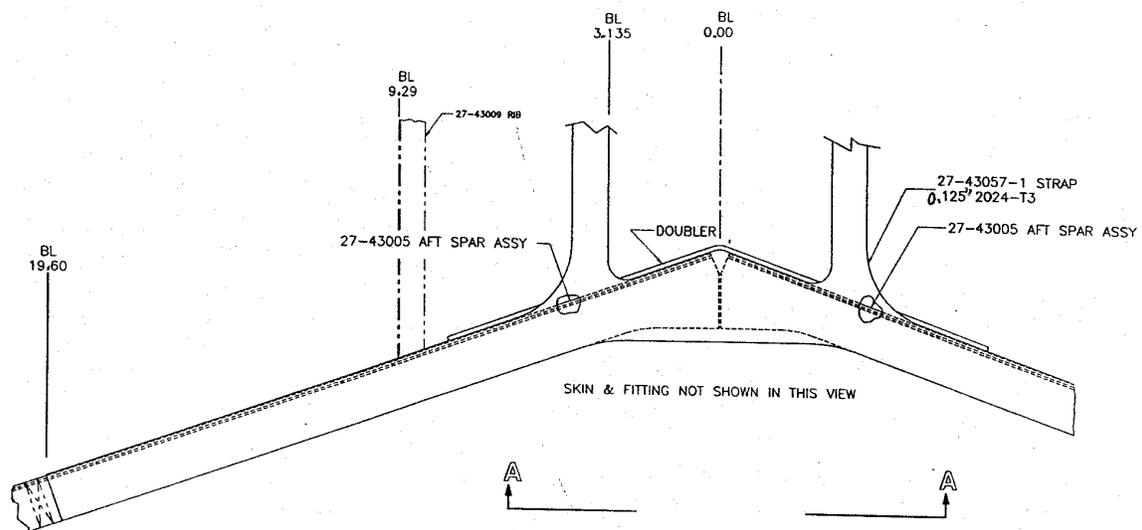
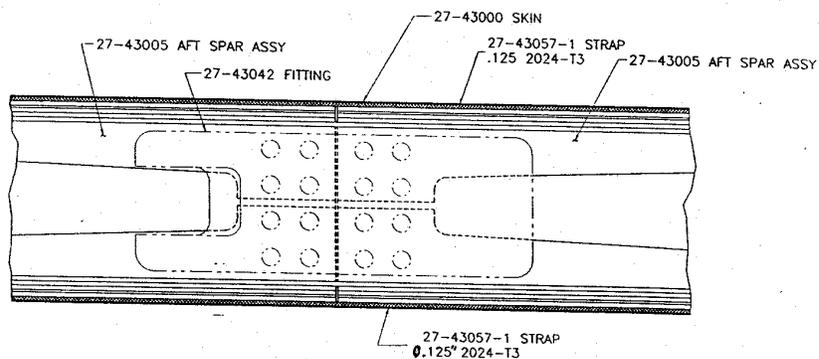
FIGURE 6-27 H1 - SA226 AND SA227 HORIZONTAL STABILIZER RIB STRAP AT REAR SPAR

VIEW **A-A**
 VIEW LOOKING FWD
 AT HORIZONTAL STABILIZER
 AFT SPAR
