DOT/FAA/AR-99/20, P1

Development of a Supplemental Inspection Document for the Fairchild SA226 and SA227 Aircraft, Part 1

Technical Report

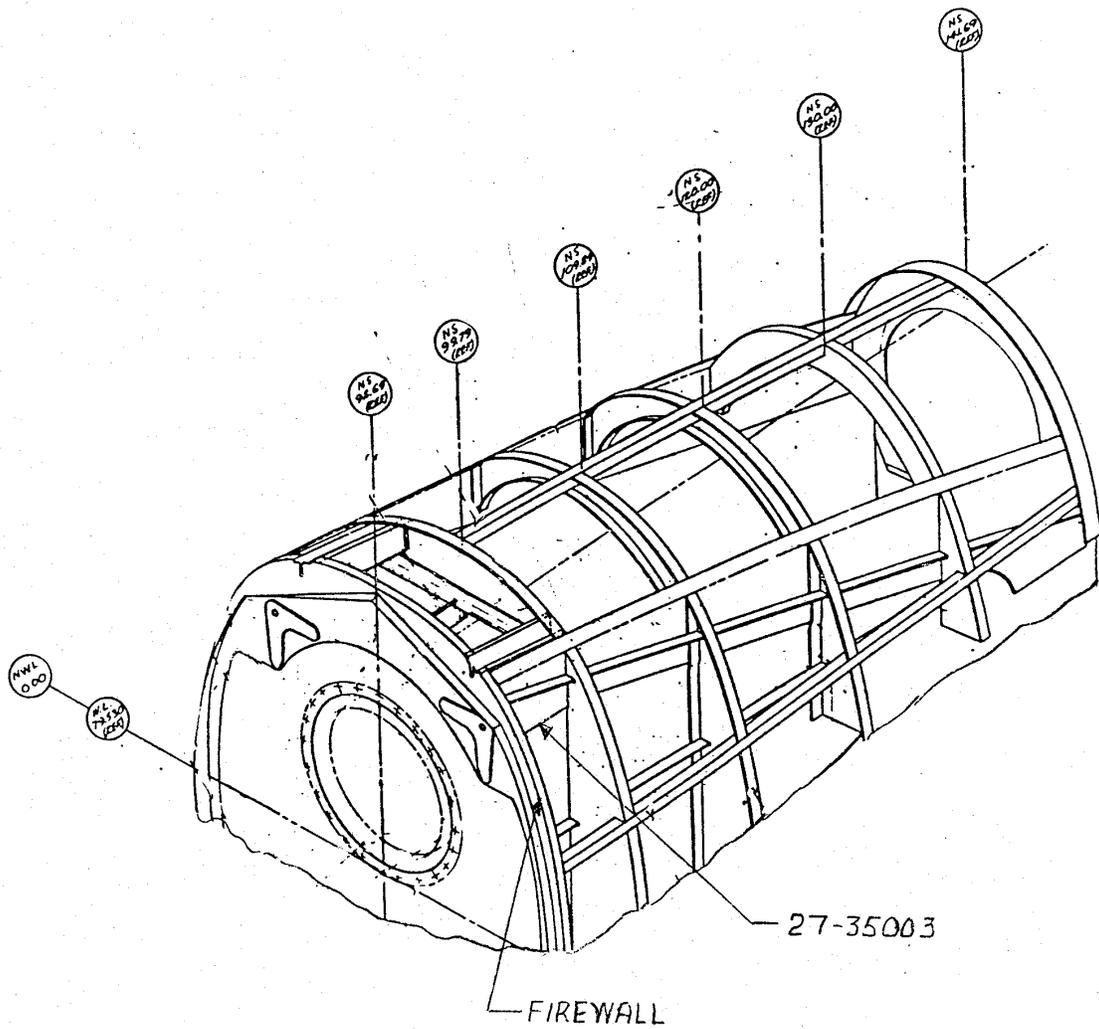
**FIGURE 6-29 N1 - SA226 AND SA227 NACELLE UPPER
LONGERON AT THE FIREWALL**

NACELLE UPPER LONGERON
AT FIREWALL

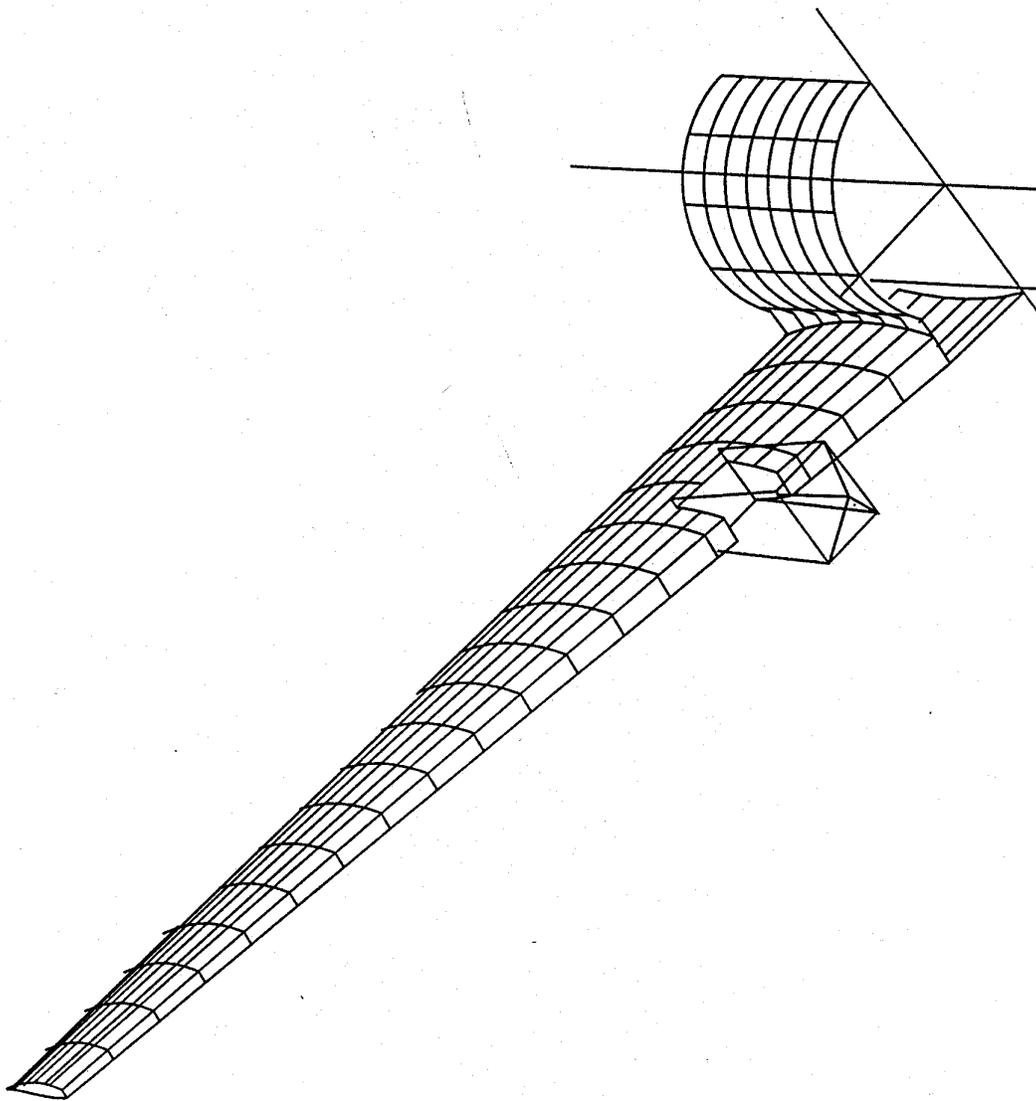
FIGURE 6-36 WING FINITE ELEMENT MODEL

The wing finite element model shown in Figure 6-36 was used to analyze the SA227 wing. The distributions were checked during the SA227 wing static test and shown to be within about 1% of the measured stress for the more heavily loaded portions of the wing. These analysis results can be used to determine stresses at locations other than the strain gage locations.

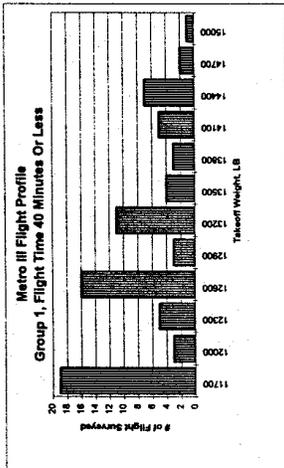
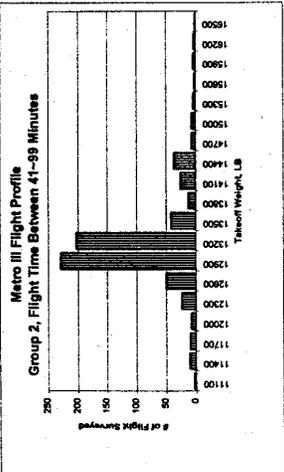
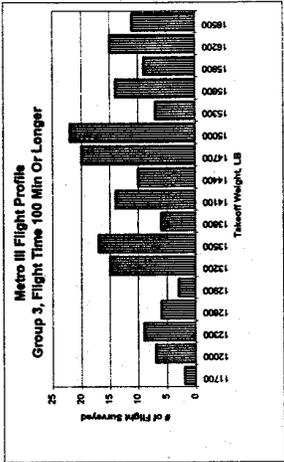
MISSION PROFILE SELECTION TAKEOFF WEIGHT COMPARISON

Wt. (+1 std dev) 13,765
Wt. Average 12,753
Wt. (-1 std dev) 11,741

Wt. (+1 std dev) 13,901
Wt. Average 13,274
Wt. (-1 std dev) 12,647

Wt. (+1 std dev) 14,916
Wt. Average 13,826
Wt. (-1 std dev) 12,737
