DOT/FAA/AR-99/34

Characterization of Early Stages of Corrosion Fatigue in Aircraft Skin

Phase II: Interpretation of Corrosion-Fatigue Fracture Surfaces in Alclad 2024-T3 Aluminum Alloy Sheet

Phase II Report

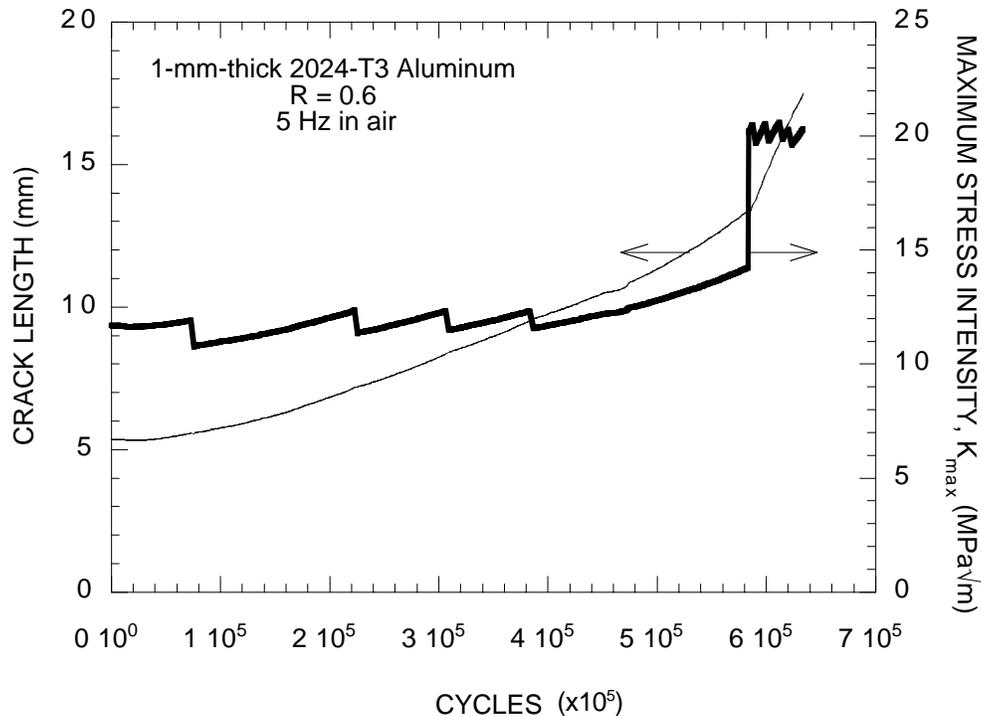
FIGURE 1. EFFECTS OF MAXIMUM STRESS INTENSITY CHANGE ON CRACK GROWTH RATE.

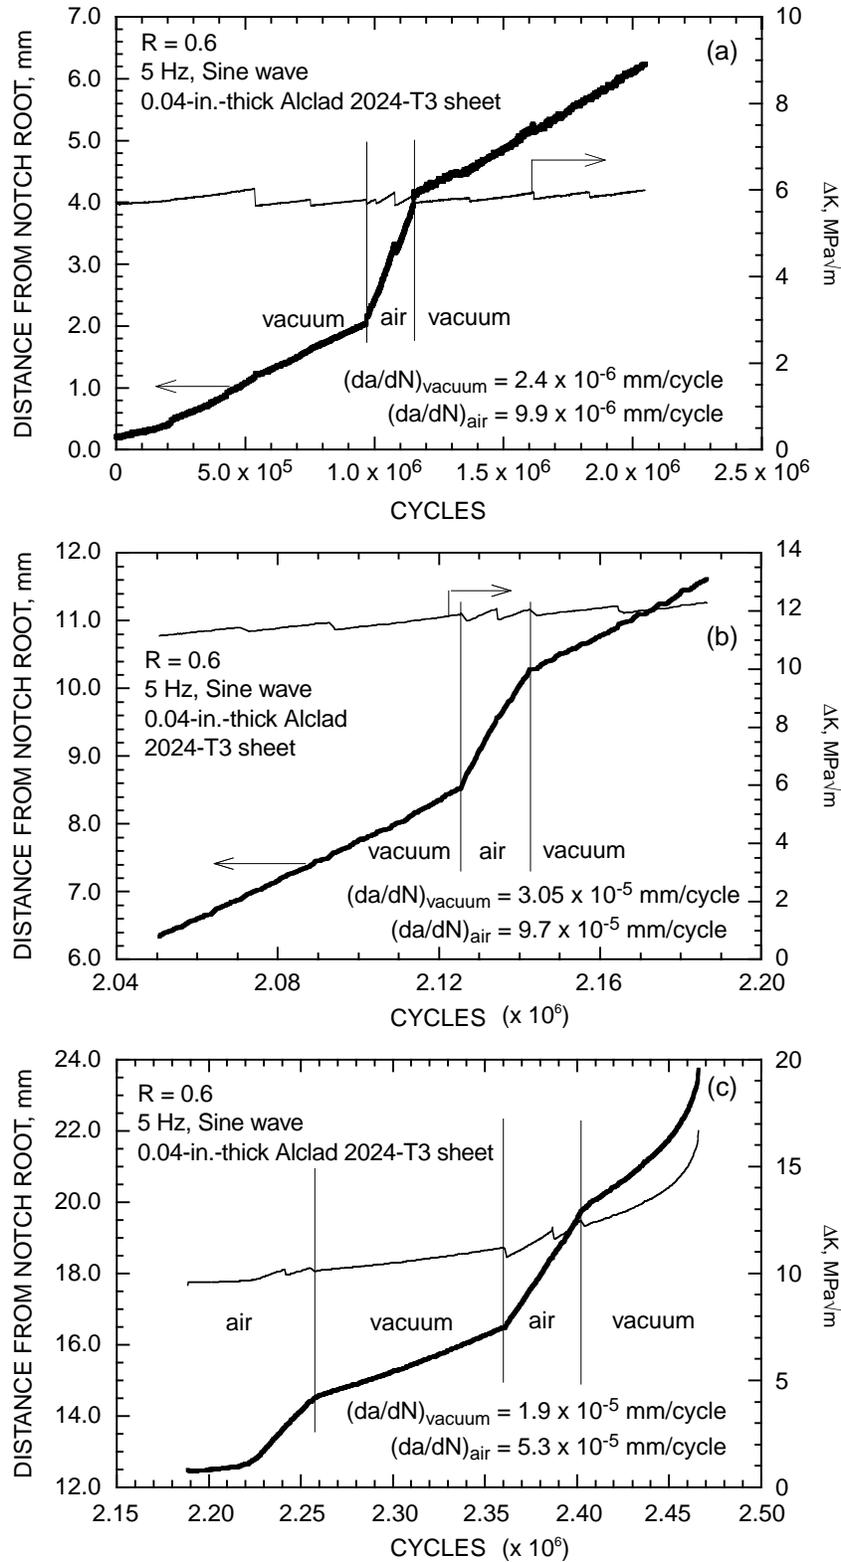
In these experiments, a vacuum of about 10^{-6} torr was imposed while the fatigue crack propagated a few millimeters. Then, the environment was suddenly changed to laboratory air as cyclic loading continued. Several changes in environment were imposed in this way under a range of loading conditions. The changes in environment immediately and reproducibly changed the crack growth rate such that the rate in air was about three times the rate under vacuum, as shown in figure 2(a), (b), and (c). The stress ratio, R , was constant at 0.6, and the load cycle frequency was 5 Hz in all tests.

FIGURE 2. CRACK GROWTH HISTORY OF A CYCLICALLY LOADED CENTER-CRACKED PANEL OF 2034-T3 ALUMINUM IN AIR AND UNDER VACUUM.

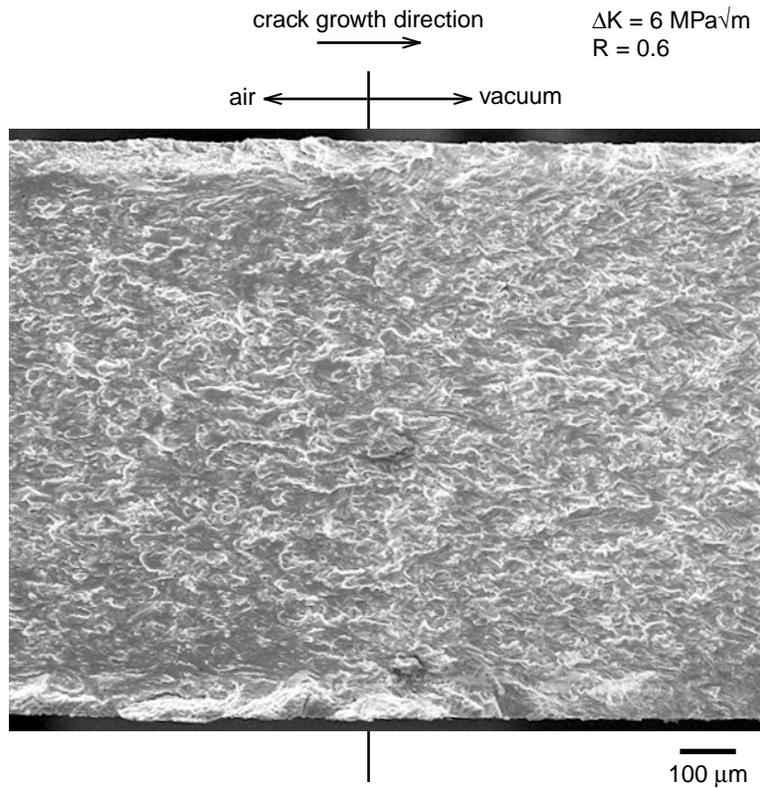
Figure 3 shows an example of the change in fracture surface appearance at the transition between crack propagation under vacuum and in air. There is a suggestion of denser features on the fracture surface generated in air; however, the difference is barely detectable by visual inspection. Examination of high-magnification SEM micrographs (see figure 4 for an example) shows no discernible difference in the fracture surface features for air and vacuum crack growth environments. We will show that Fourier analysis and FRASTA are capable of detecting and quantifying differences in fracture surface characteristics that are almost undetected by conventional SEM examination.

FIGURE 3. SEM MICROGRAPH SHOWING THE FATIGUE FRACTURE SURFACE MORPHOLOGY PRODUCED IN AIR AND UNDER VACUUM.

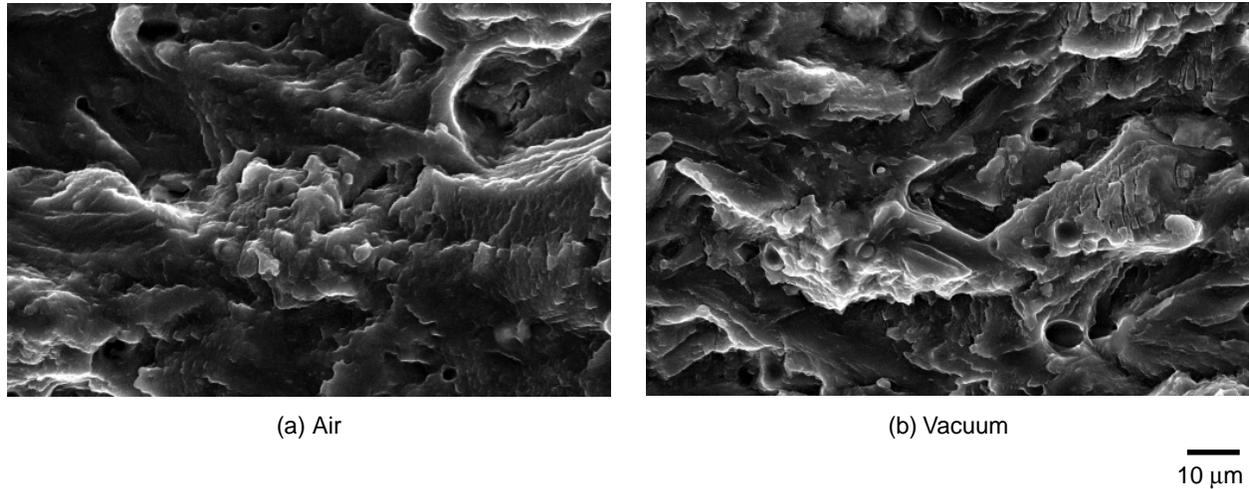
FIGURE 4. HIGH-MAGNIFICATION SEM MICROGRAPHS OF A FATIGUE FRACTURE SURFACE CREATED IN AIR AND UNDER VACUUM.

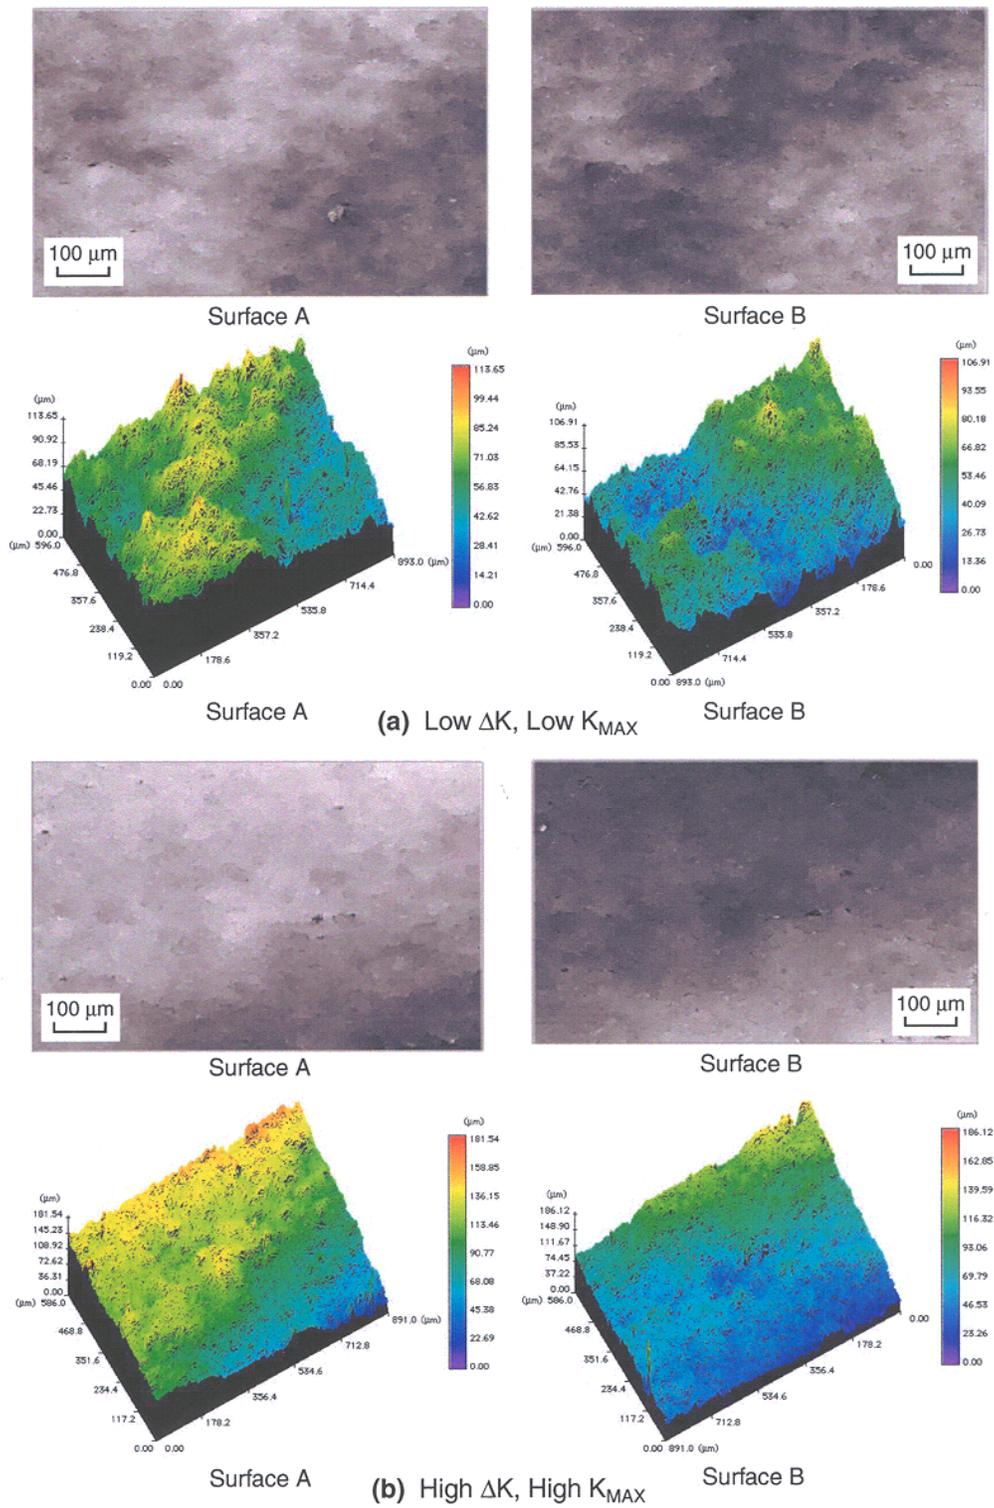
The topographies of a 1.0-mm-wide strip of the conjugate fracture surfaces in the center of the specimen were quantified with a COSLM in the crack growth direction. With the aid of computer software, the conjugate topographs were positioned and aligned with respect to each other to approximate the configuration of the fracture surfaces during the fatigue test, as shown schematically in figure 8. A cross-sectional view of the intersecting topographs shows the crack in profile, and a projection of the crack front configuration is obtainable in a plan view. Damage in the process zone ahead of the crack front is shown in both views. Areas where the topographs overlap are shown in black and are interpreted as areas where the material is unbroken; areas where

FIGURE 5. GRAY-SCALE IMAGES AND PERSPECTIVE VIEWS OF THE TOPOGRAPHICS OF CONJUGATE FRACTURE SURFACES PRODUCED UNDER LOW AND HIGH ΔK AND K_{MAX} FATIGUE CONDITIONS.

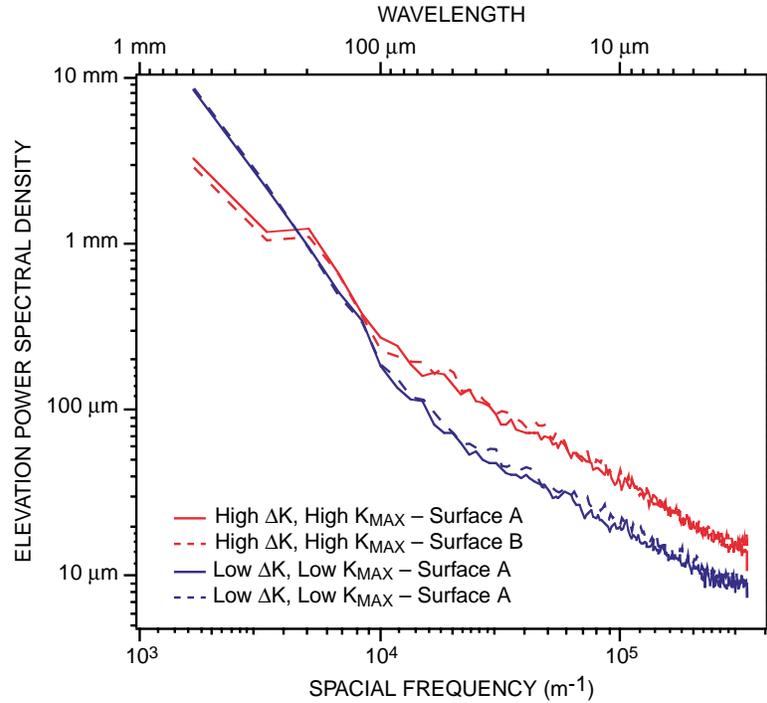
FIGURE 6. FAST FOURIER TRANSFORM ELEVATION POWER SPECTRAL DENSITY CURVES FOR CONJUGATE FATIGUE FAILURE SURFACES PRODUCED UNDER HIGH AND LOW ΔK AND K_{max} FATIGUE CONDITIONS.

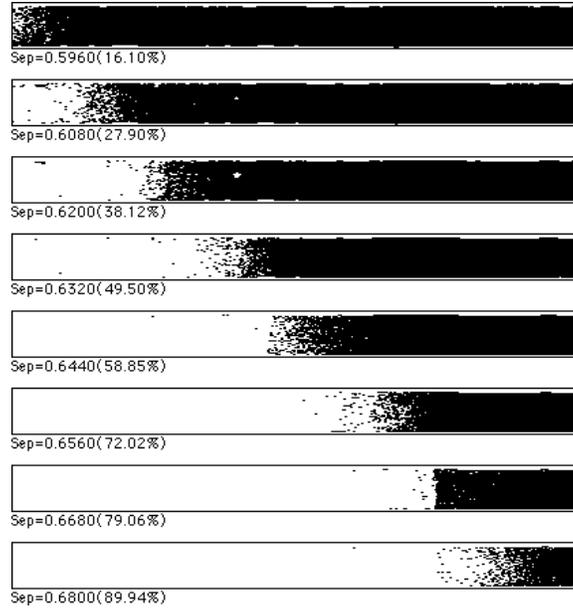
When the topographs are displaced normal to the crack plane, the line of intersection moves and crack growth is simulated. Figure 9 is a series of plan projection views of the crack at increasing topograph displacements. The transition between the white area and black area is a zone, rather than a line, and results from our choice of a large elevation range to characterize a large area of fracture surface. Better crack front definition can be obtained if a smaller area with a concomitant smaller elevation range is selected. Nevertheless, an average crack front can be defined by calculating the percentage of white (fractured) area in a plot and dividing by the plot height, and an effective crack growth rate (with respect to topograph displacement) can be obtained by plotting the percent fractured area against topograph displacement. This curve may be thought of as a fracture progression curve (FPC), indicating the relative (to crack opening displacement) growth history of a crack.

FIGURE 9. A SERIES OF PLAN VIEWS OF A CRACK FRONT AT INCREASING TOPOGRAPH DISPLACEMENTS. WHITE AREAS INDICATE SEPERATED MATERIAL; BLACK AREAS INDICATE INTACT MATERIAL

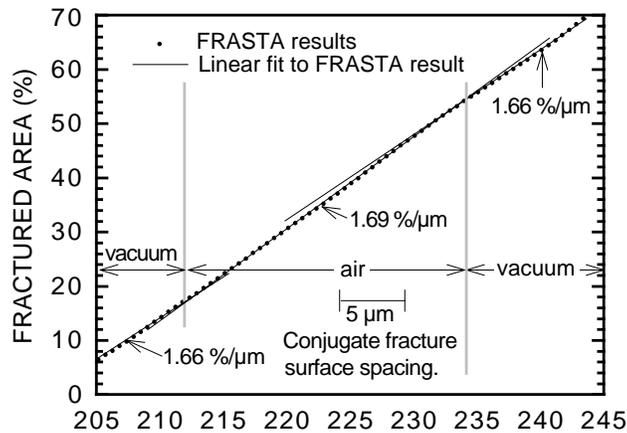
Results from the previous specimens showed that, under steady state fatigue loading, the area increase rate varies monotonically and the FPC is linear or a smoothly varying function without inflections. However, figure 10 shows that, when a change in environment is imposed (i.e., a change from vacuum to air back to vacuum), a deviation from the steady state slope is produced. The slopes for vacuum and air environments were measured to be $1.66\%/ \mu\text{m}^{**}$ and $1.69\%/ \mu\text{m}$ in vacuum and air, respectively.

FIGURE 10. EFFECT OF ENVIRONMENT ON FRACTURE PROGRESSION CURVE (FPC).

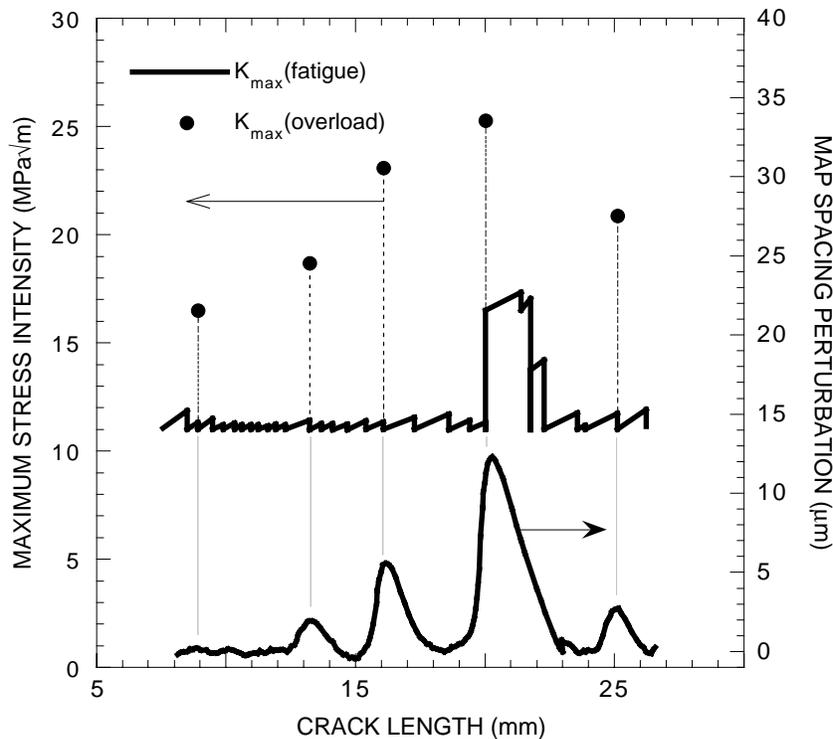
The positions of the overloads, as a function of half crack length, are shown by data points corresponding to the left ordinate of figure 11. The figure compares K_{max} during the cyclic loading intervals with K_{max} imposed by the overload. The small variations in K_{max} during the cyclic loading are a consequence of small amounts of crack growth under intervals of constant load cycling. Fatigue crack propagation could not be reinitiated at 11 MPa \sqrt{m} after the overload to 25.5 MPa \sqrt{m} , so higher stress intensity levels (17 and 14 MPa \sqrt{m}) were used to restart fatigue crack growth.

FIGURE 11. COMPARISON OF OVERLOAD HISTORY TO PERTURBATIONS IN FRACTURE PROGRESSION CURVE (FPC).

Figure 12 shows that overloads above $16.5 \text{ MPa}\sqrt{\text{m}}$ produce a perturbation from the steady-state slope. The FPC slope initially decreases, then increases, and then returns to the baseline slope. The positions of the peaks in the perturbations correspond to the crack lengths at which the overloads were applied. These deviations begin before the overload is applied, as shown in figure 11.

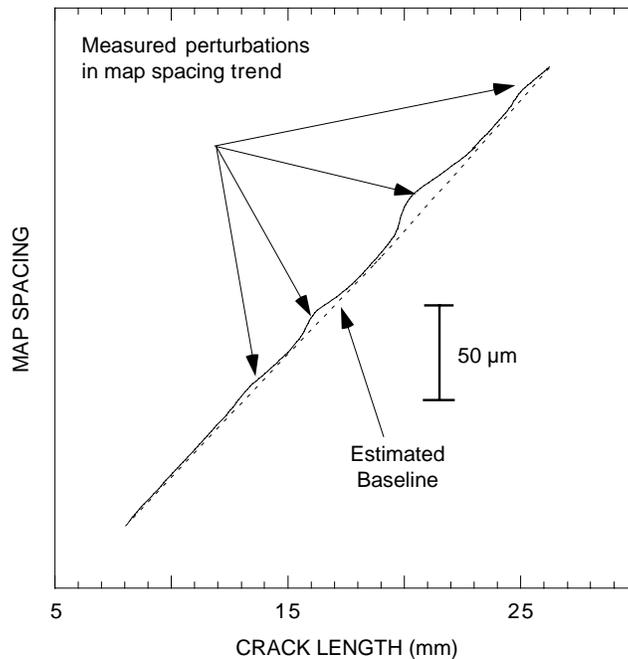
FIGURE 12. FRACTURE PROGRESSION CURVE (FPC) WITH BASELINE.

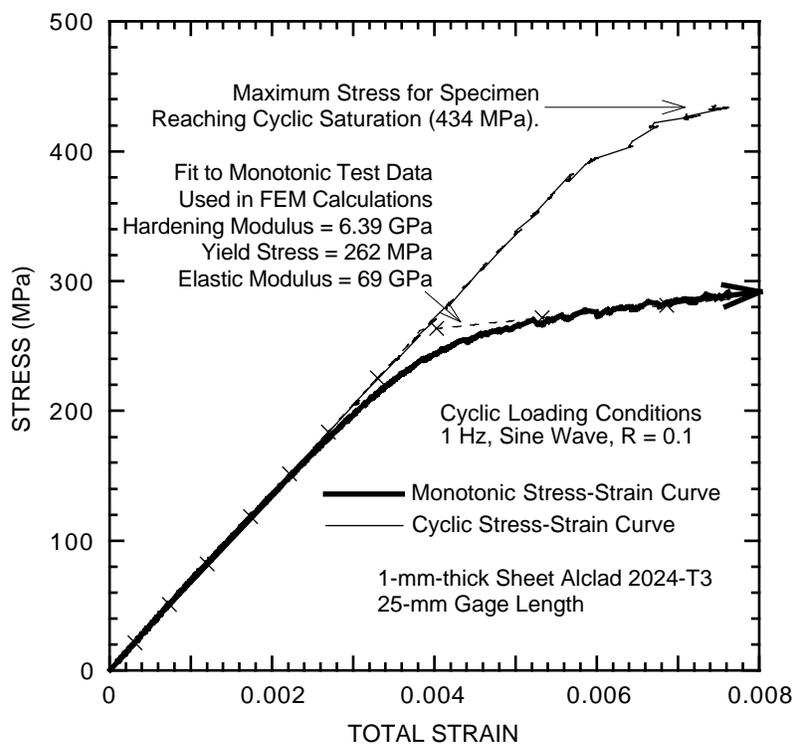
Finite element method simulations of the crack tip response require appropriate constitutive models that describe the nonelastic deformation behavior. Figure 13 compares the cyclic stress-strain response with the monotonic stress-strain response at low strain levels. These results show substantial cyclic strain hardening. The results in figure 13 formed the basis of the constitutive equations used in the finite element method (FEM) calculations described in section 3.5.

FIGURE 13. MONOTONIC AND CYCLIC STRESS-STRAIN BEHAVIOR OF 2024-T3 ALUMINUM ALLOY.

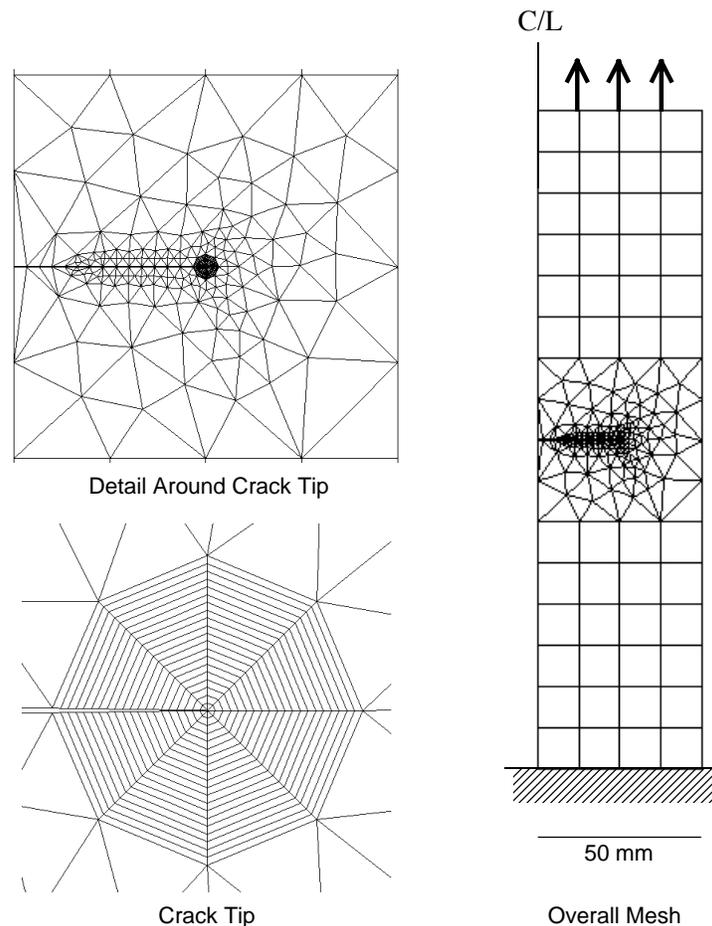
FIGURE 14. FINITE ELEMENT MESH AROUND CRACK TIP IN CENTER-CRACKED PANEL SPECIMEN.

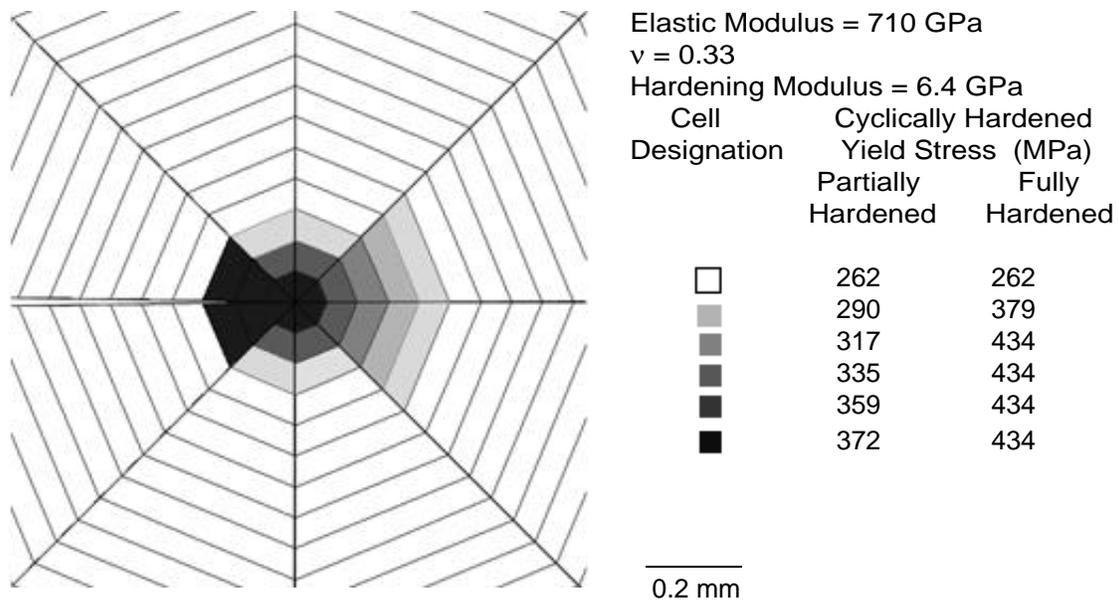
FIGURE 15. CYCLICALLY HARDENED AREAS NEAR CRACK TIP.

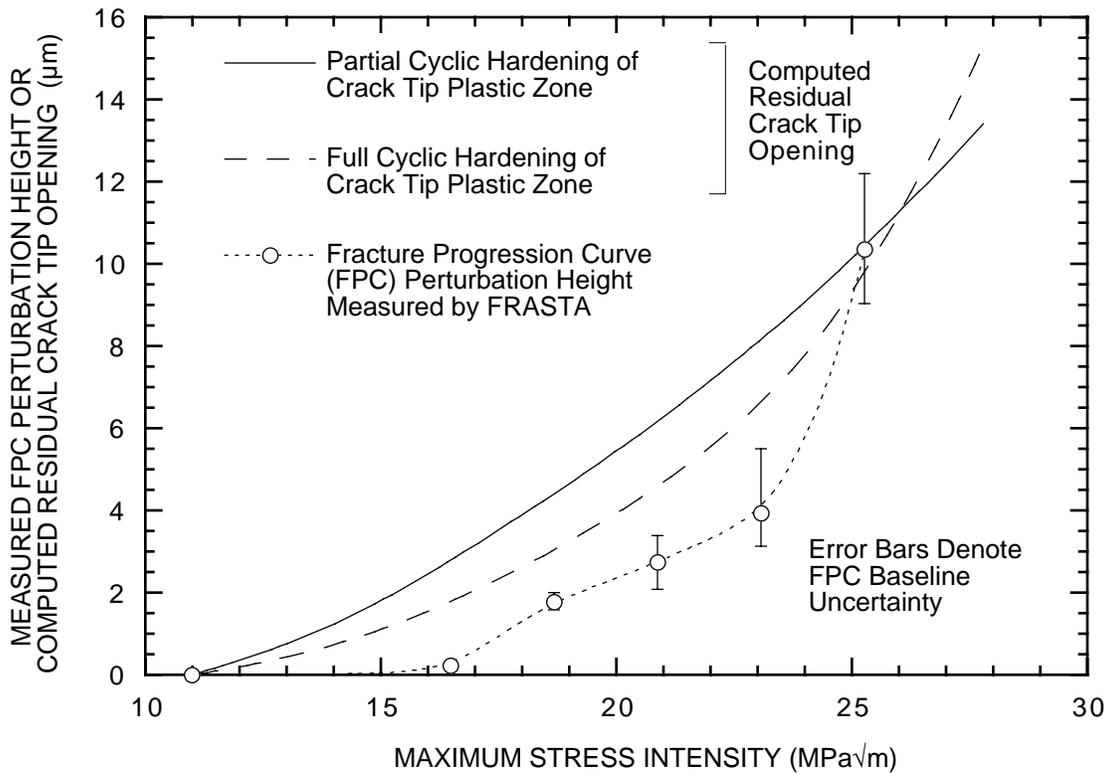
FIGURE 17. COMPARISON OF COMPUTED AND MEASURED FPC PERTURBATION HEIGHTS RESULTING FROM OVERLOADS.

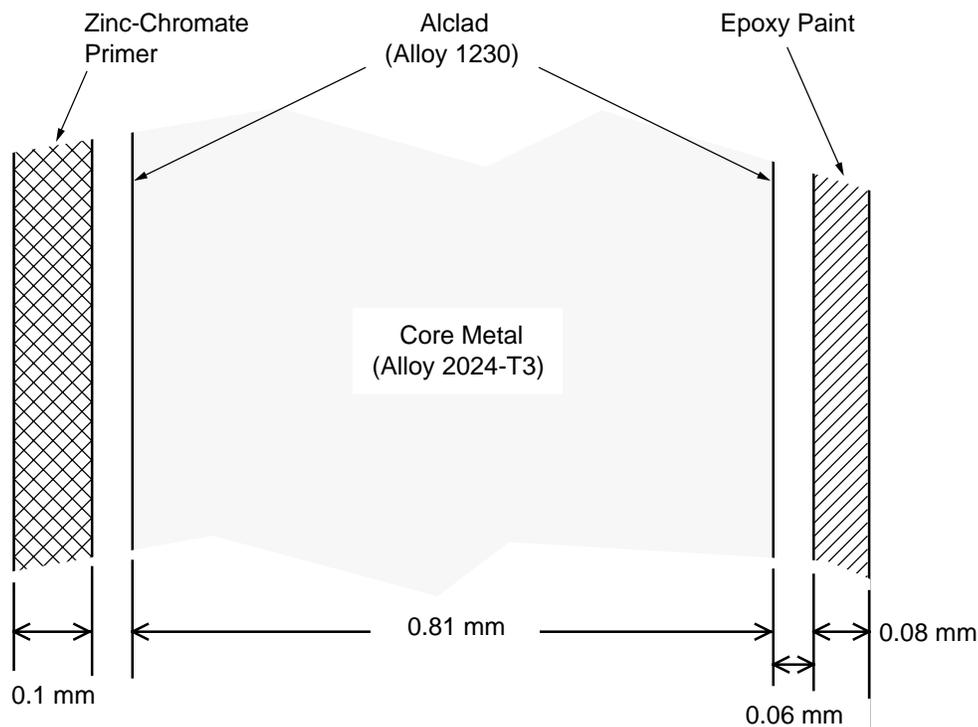
A tapered tensile coupon was cut from Section 360 (above the windows) of a Boeing 737 aircraft that had been retired from service in 1992 after 56,228 flight hours. The skin consisted of a 0.81-mm-thick (0.032-in.) core of 2024-T3 aluminum alloy, clad layers on both sides that were about 0.06 mm thick (0.002 in.), a paint layer on the outer surface about 0.08 mm thick (0.003 in.), and a corrosion inhibitor layer on the inside that was about 0.10 mm thick (0.004 in.), as sketched in figure 18. Microhardness tests showed that the core and the clad had Vickers hardnesses of 120.4 ± 1.5 and 32.2 ± 2.3 kg/mm², respectively.

FIGURE 18. CROSS SECTION OF REPRESENTATIVE AIRCRAFT SKIN.

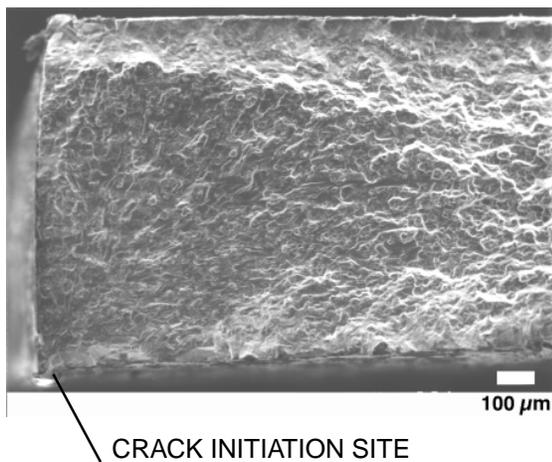
Figure 19 shows a scanning electron microscope (SEM) photograph of one of the two fracture surfaces. Crack nucleation occurred at the lower left corner. Figure 20 shows higher-magnification photographs of the conjugate surfaces in the vicinity of crack nucleation. The fracture surfaces in the clad are smooth and crystallographic. The markings on the surface of the 2024-T3 core material indicate the crack propagation directions. The photograph of the corner area in Figure 20 shows a corrosion pit at the outer edge near the corner and two inadvertently damaged areas on Surface B that occurred after the test. These damaged areas do not reflect microfailure activity during the fracture process and must be omitted in analyzing the fracture surface topography.

FIGURE 19. SEM MICROGRAPH OF FRACTURE SURFACE SHOWING AREA WHERE CRACK INITIATED.

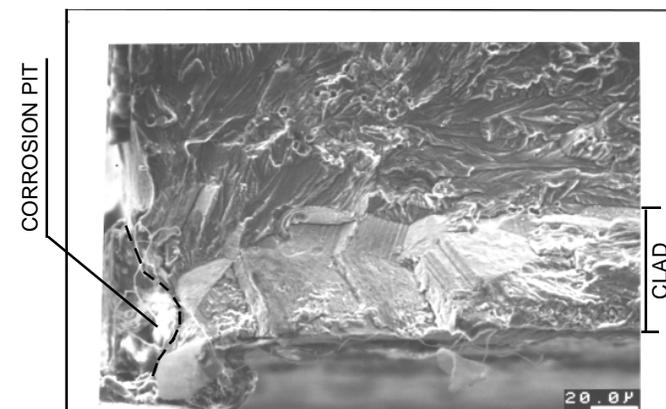
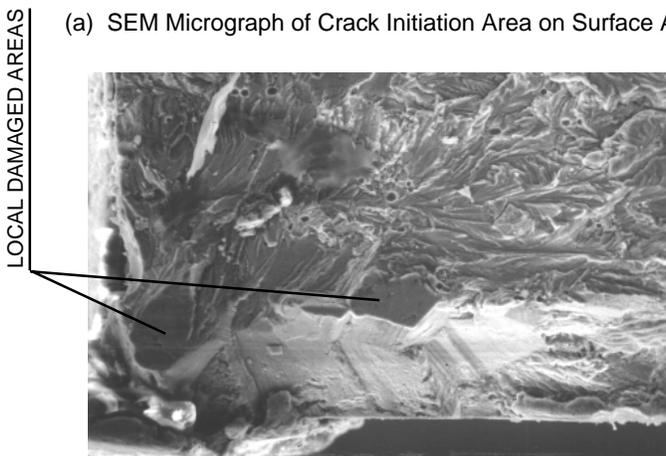
(a) SEM Micrograph of Crack Initiation Area on Surface A

(b) SEM Micrograph of Matching Area on Surface B (Horizontally Flipped)

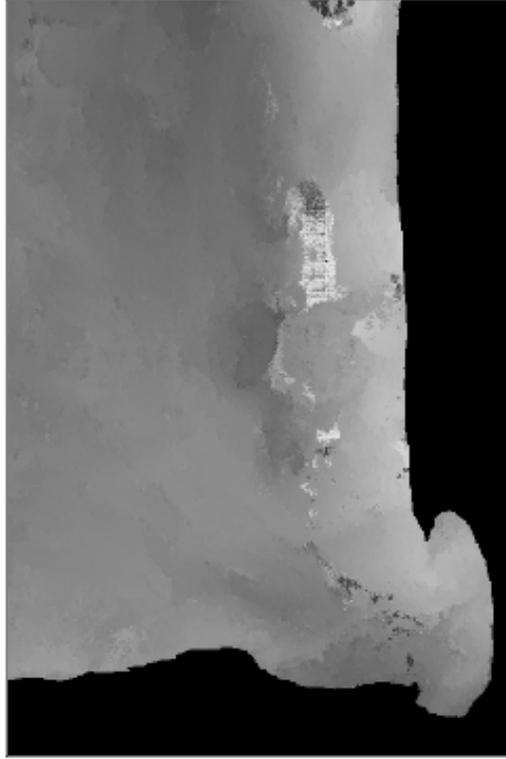
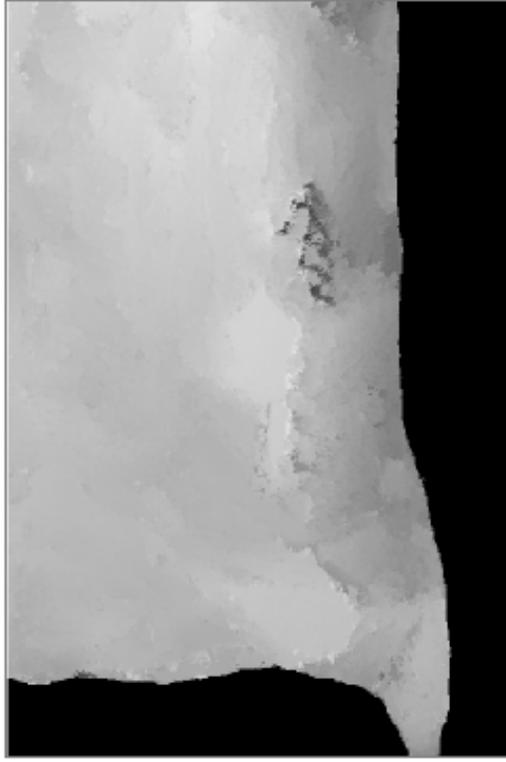
(a) Contrast Image of Surface A

(b) Gray-scale Topography Image of Surface A

(c) Contrast Image of Surface B (Horizontally Flipped)

(d) Gray-scale Topography Image of Surface B (Horizontally Flipped)

FIGURE 21. CONTRAST AND GRAY-SCALE TOPOGRAPHY IMAGES OF CONJUGATE SURFACES OF THE CRACK INITIATION SITE. (IMAGES OF SURFACE B WERE HORIZONTALLY FLIPPED TO SHOW THE CORRESPONDENCE BETWEEN THE CONJUGATE SURFACES.)

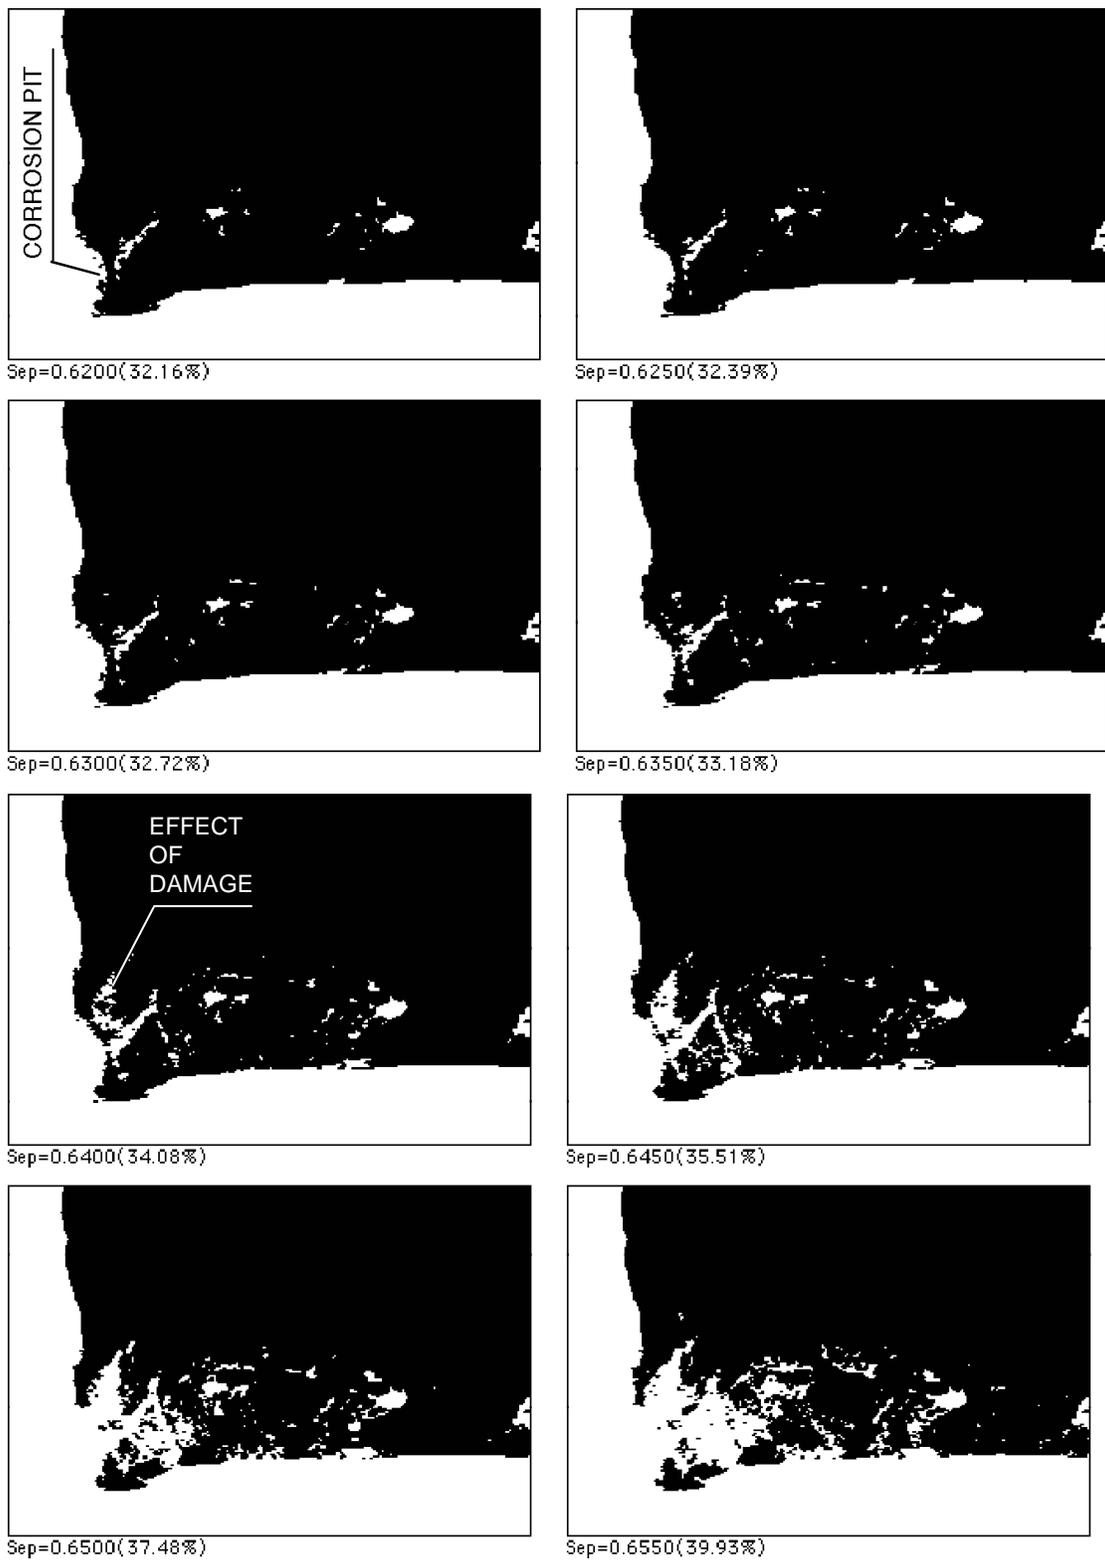
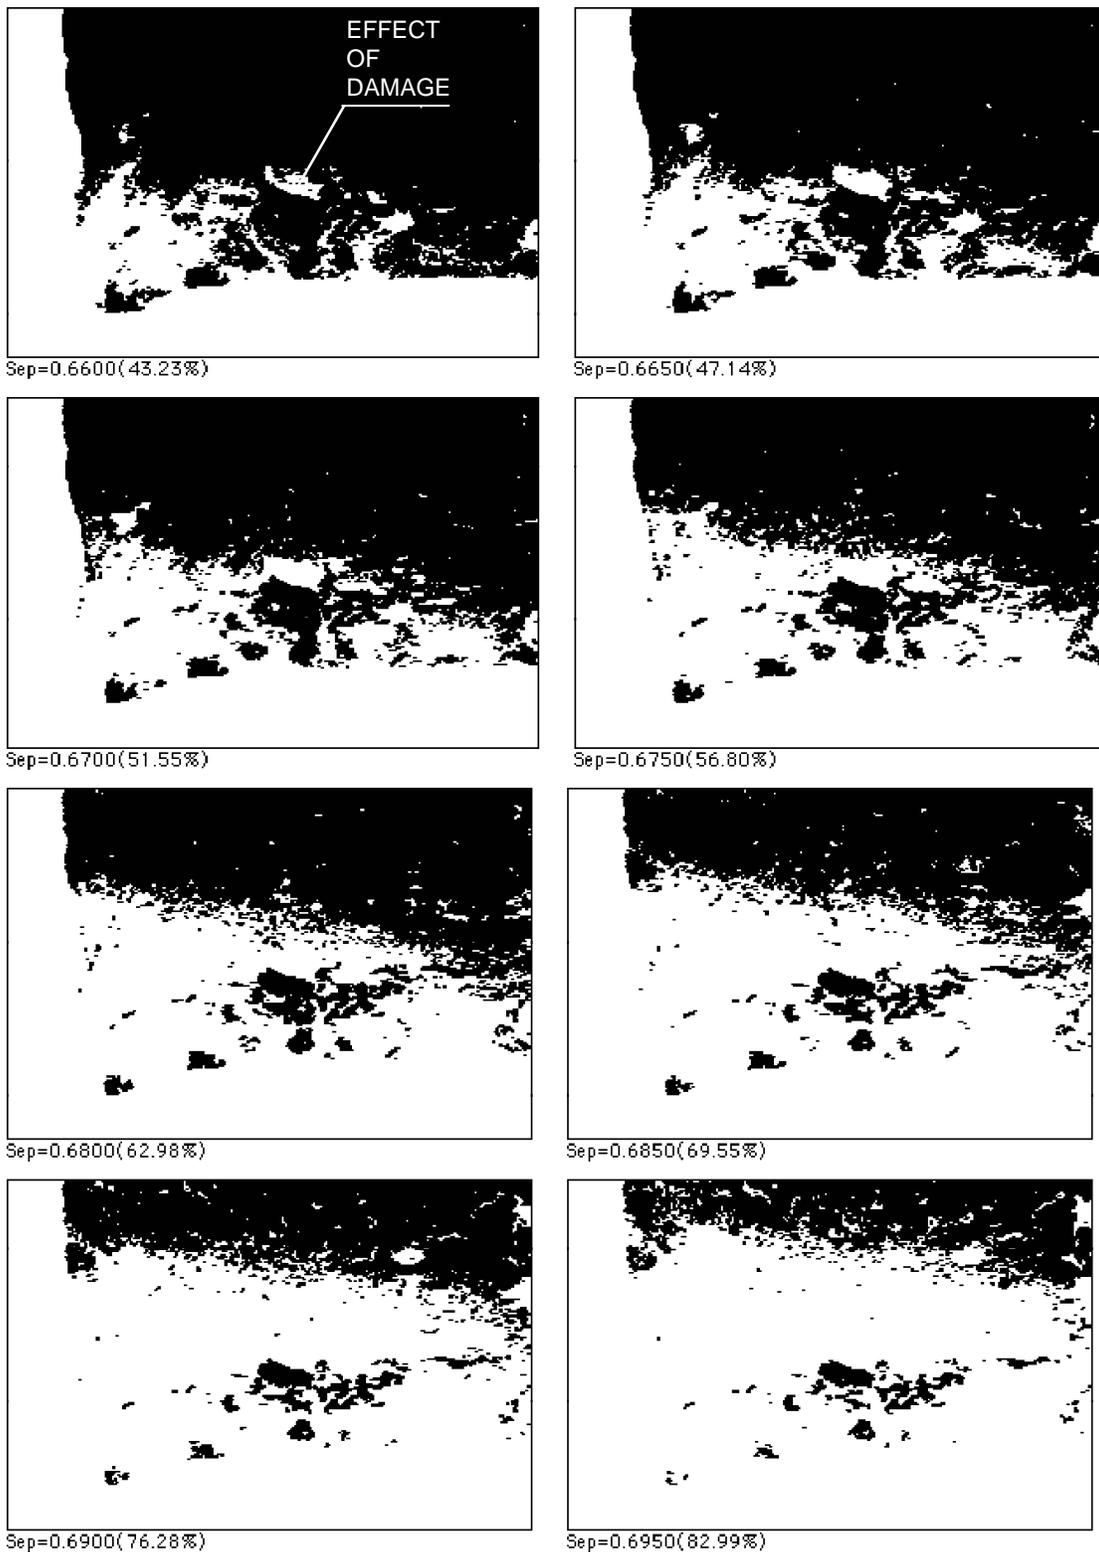
FIGURE 22. A SERIES OF FAPPS PRODUCED BY FRASTA SHOWING CRACK FORMATION AND GROWTH PROCESS (CONTINUED).

FIGURE 22. A SERIES OF FAPPS PRODUCED BY FRASTA SHOWING CRACK FORMATION AND GROWTH PROCESS (CONCLUDED).

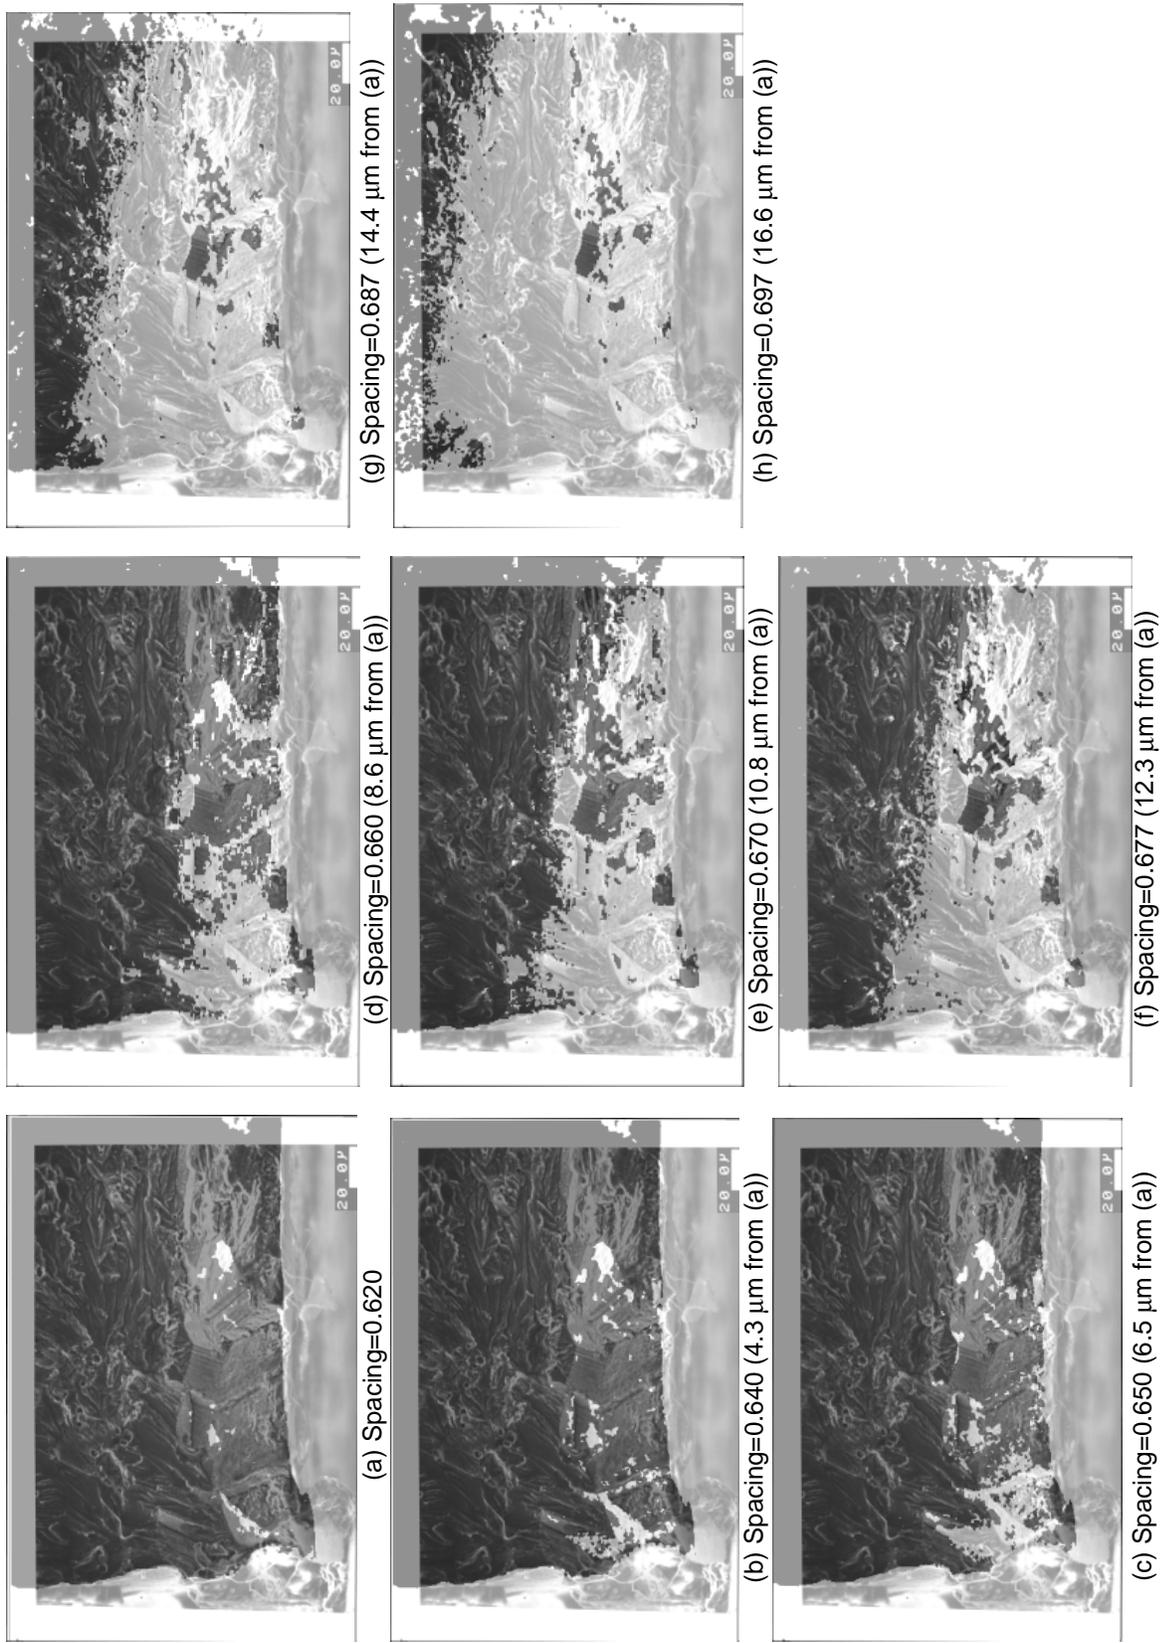
FIGURE 23. SUPERPOSITION OF FAPPS ON SEM MICROGRAPH RELATING FRACTURE PROCESSES TO MICROSTRUCTURAL FEATURES.

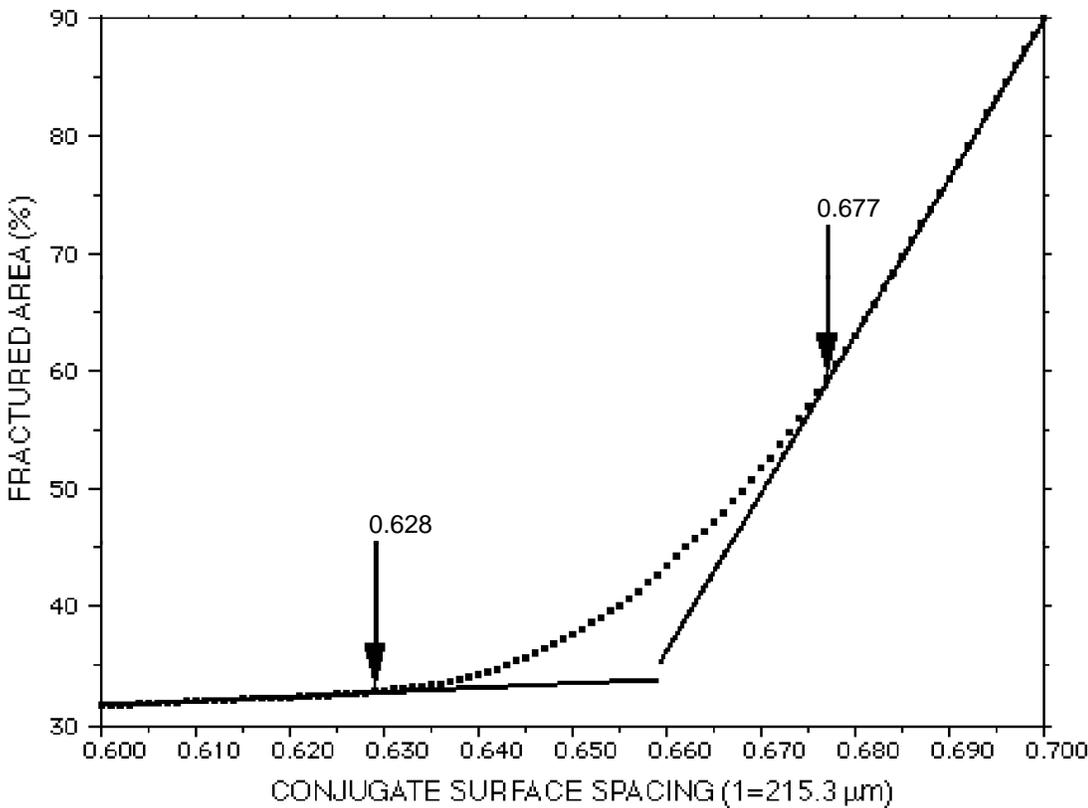
FAPPs also provide the relative crack propagation rate when the amount of white area in each FAPP in a series is plotted versus topograph displacement. Figure 24 provides such a plot from the information in figure 22. Above a spacing of 0.677, the crack attains a constant growth rate and, as can be seen in figure 22, an apparent steady state thumbnail shape. When the crack has reached this (relatively large) size and

(mature, thumbnail) shape, its behavior may be describable by fracture mechanics equations. Below 0.677 to a spacing of about 0.628, the growth rate is nonlinear, suggesting the transition from local microcrack formation, growth, and coalescence to become a long crack that is possibly describable by the Paris law. Below a spacing of 0.628, the rate of increase in separated area is much lower; however, these states may not be realistic because they are created by overclosing of the spacing between conjugate surfaces. These results suggest that the plot of fractured area increases as a function of conjugate surface spacing may provide a means to define the boundary between an engineering crack whose behavior can be described by fracture mechanics and a small crack where continuum fracture mechanics may not apply.

FIGURE 24. FRACTURED AREA INCREASE RATE AS A FUNCTION OF CONJUGATE SURFACE SPACING. CRACK FORMATION PERIOD IS BETWEEN THE SPACING OF 0.628 AND 0.677. BEYOND THE SPACING OF 0.677, FATIGUE CRACK GROWTH APPEARS TO BE DOMINANT.
