DOT/FAA/AR-99/34

Characterization of Early Stages of Corrosion Fatigue in Aircraft Skin

Phase II: Interpretation of Corrosion-Fatigue Fracture Surfaces in Alclad 2024-T3 Aluminum Alloy Sheet

Phase II Report

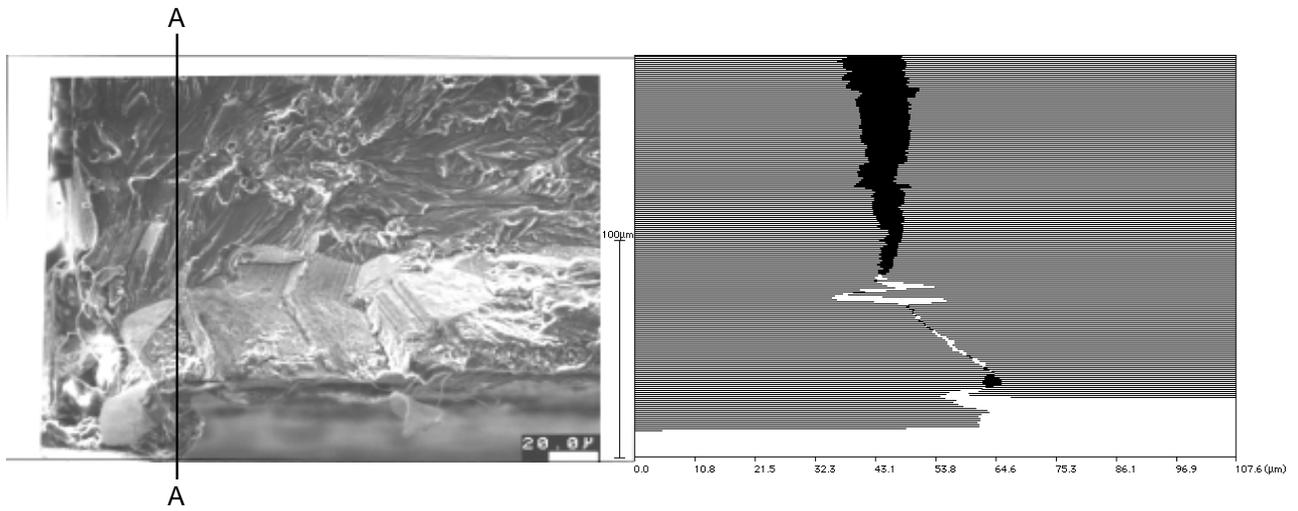
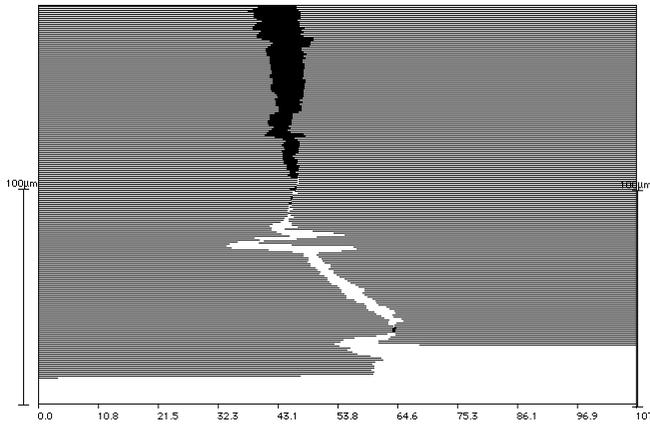
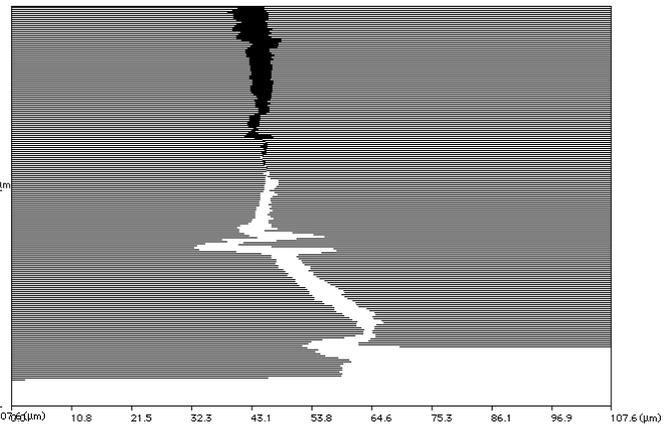
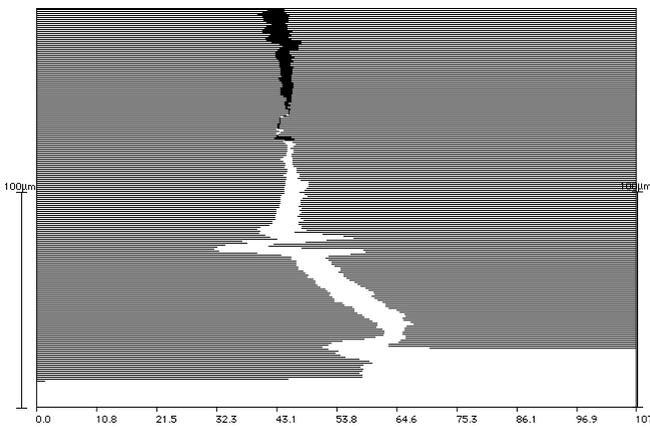
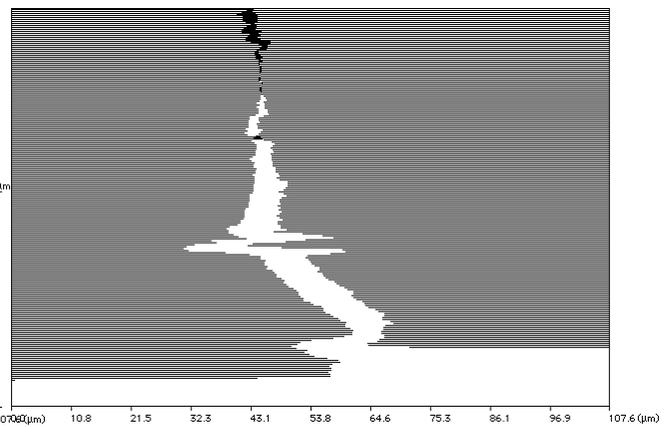
Cross-sectional views of topograph pairs show the out-of-plane path of the crack, the crack front profile, and the crack tip opening displacement and angle. Figures 25 and 26 provide cross-sectional views along lines A-A and B-B, respectively. Figure 25 shows that the crack propagates through the clad at roughly 30 degrees to the tensile axis and that, in this initial phase of growth, the crack surfaces are quite smooth. Such observations are consistent with Stage I fatigue.²⁰ After reaching the core material, the crack path changes to be normal to the nominal tensile direction and the crack tip remains sharp and constant. (The large spikes near the position of the interface between the cladding and the core alloy are probably artifacts caused by noise in the elevation data due to lack of reflected light at that particular spot.)

(a) SEM Micrograph Showing the Line of Sectioning.

FIGURE 25. A SERIES OF XSPS MADE ALONG THE LINE A-A IN THE THICKNESS DIRECTION. CRACK TIP MOVEMENT SEEMS TO BE STEPWISE WITH A NEARLY FIXED CRACK TIP OPENING DISPLACEMENT.

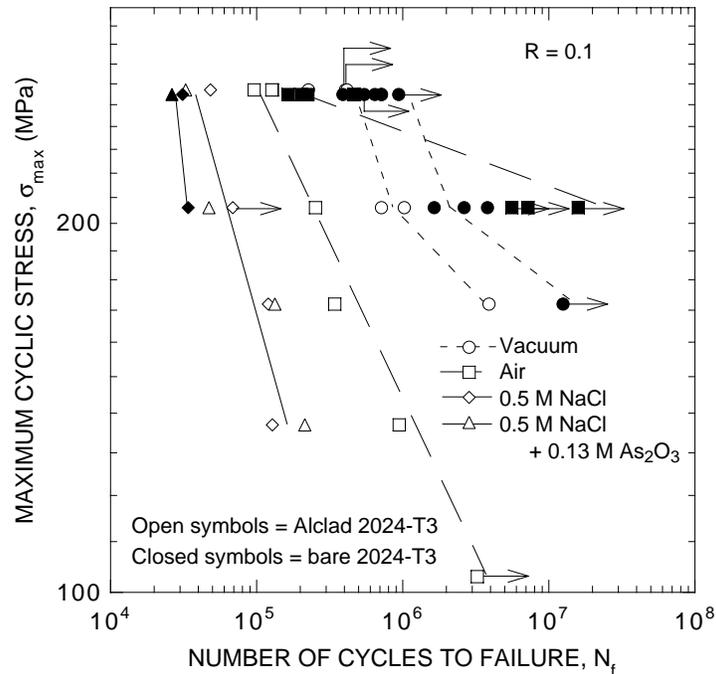
the trends of the stress dependence of fatigue life of bare material in air and under vacuum. The fatigue life in air was a factor of 3 less than the fatigue life under vacuum at a maximum fatigue stress of 255 MPa; however, at 207 MPa, the relative magnitudes of the fatigue life were reversed.

FIGURE 27. EFFECTS OF STRESS, CLADDING, AND ENVIRONMENT ON THE FATIGUE LIFE OF 2024-T3 ALUMINUM.

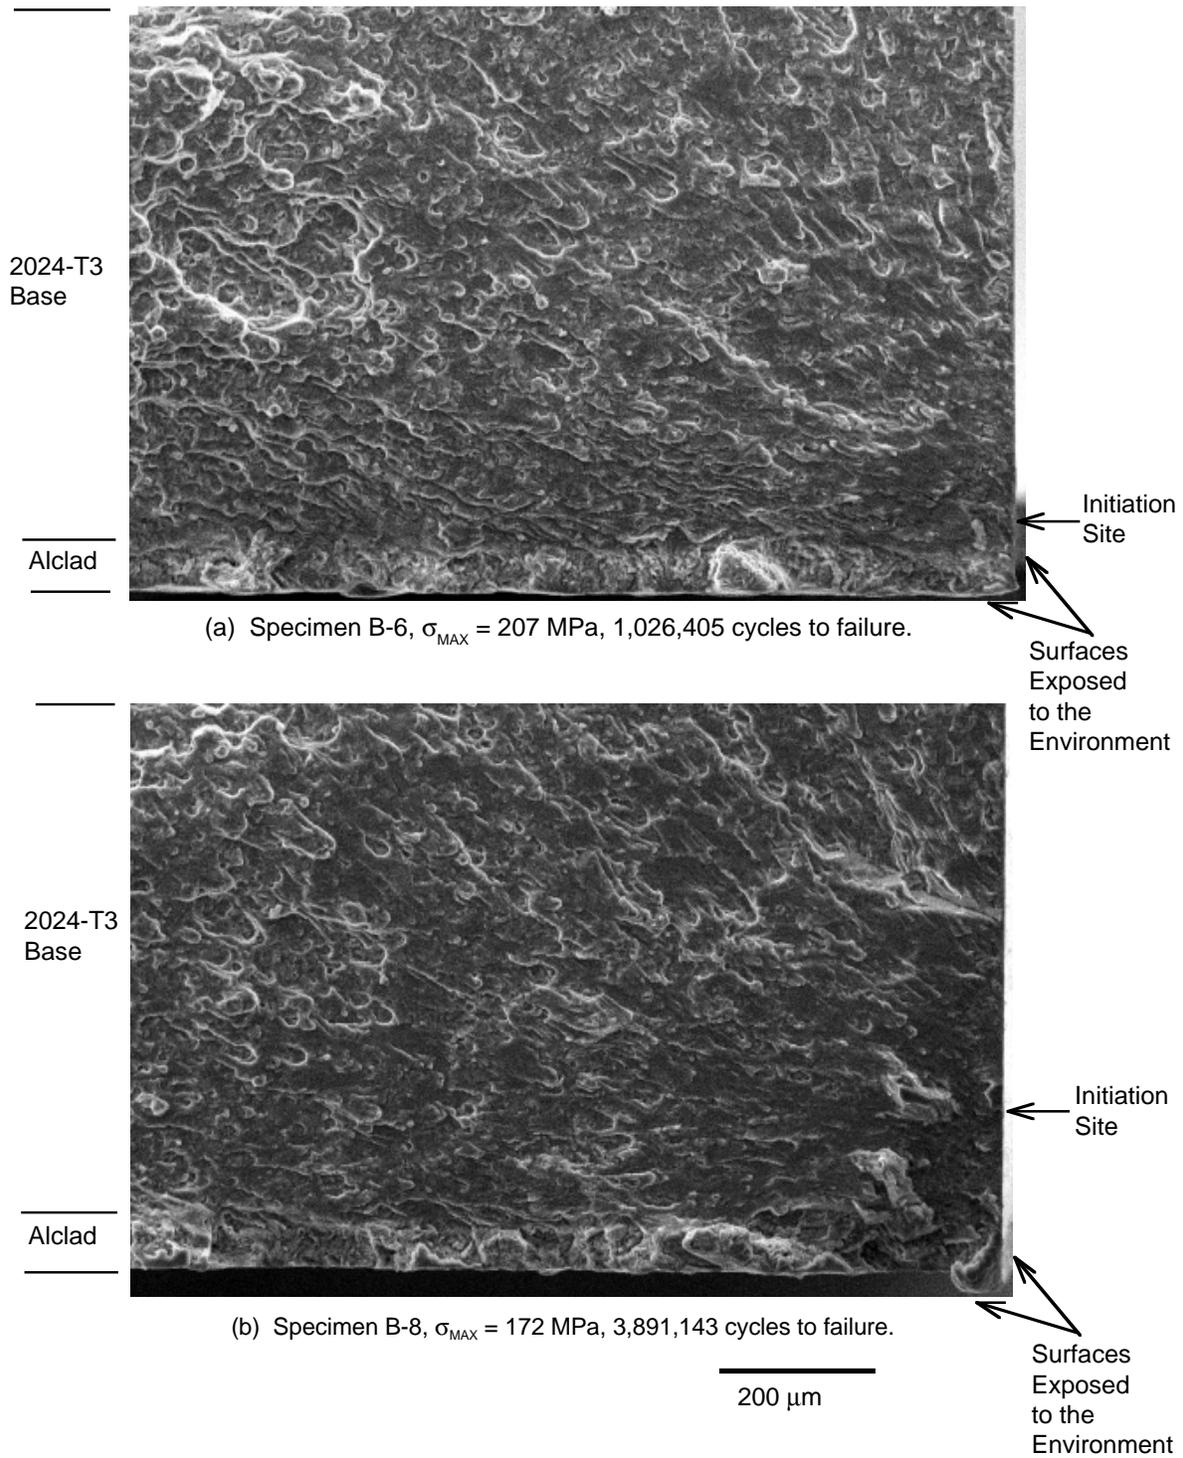
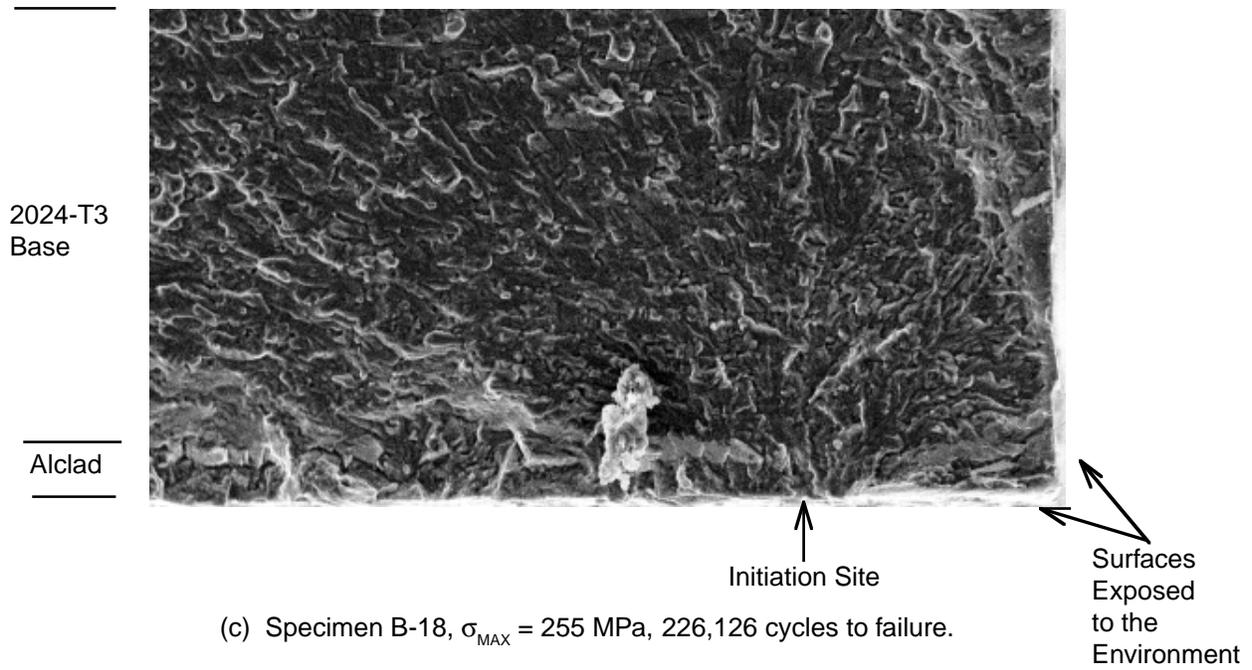
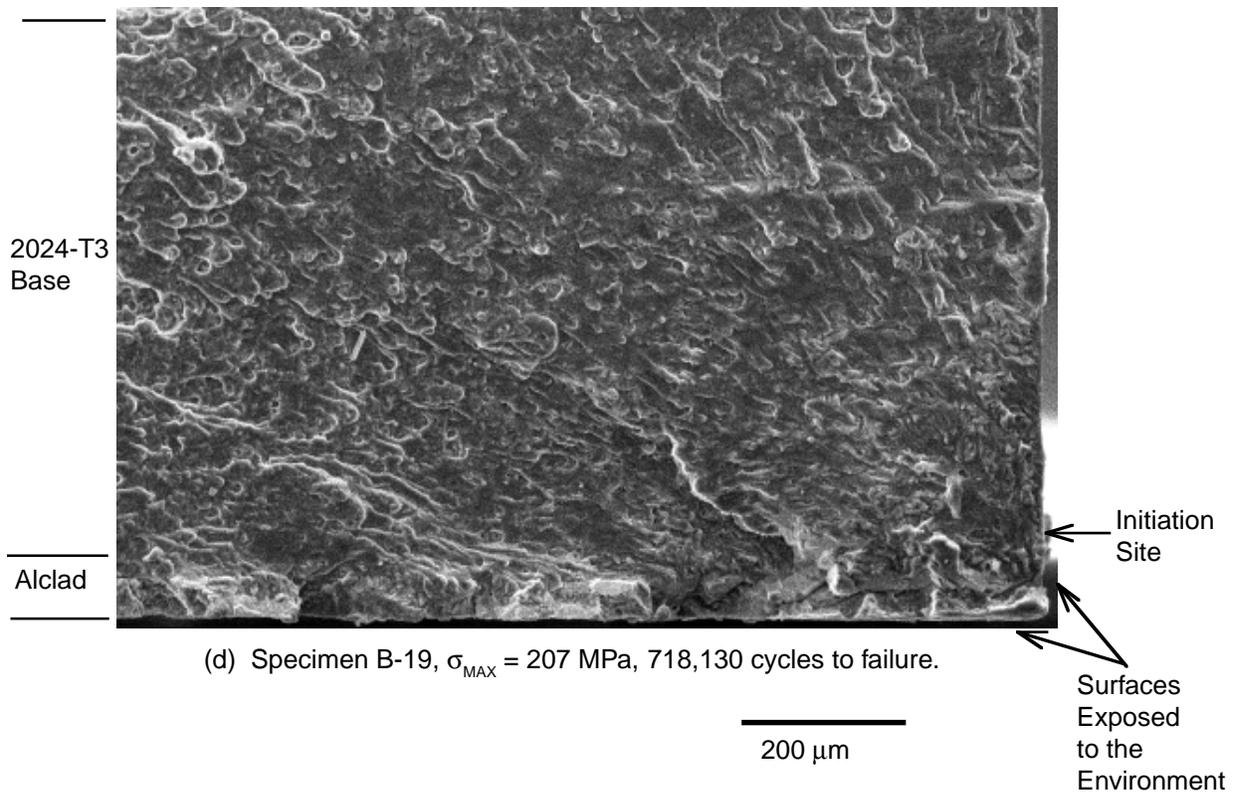
FIGURE 28. FRACTURE SURFACE APPEARANCE OF ALCLAD 2024-T3 FATIGUE SPECIMENS TESTED IN VACUUM.

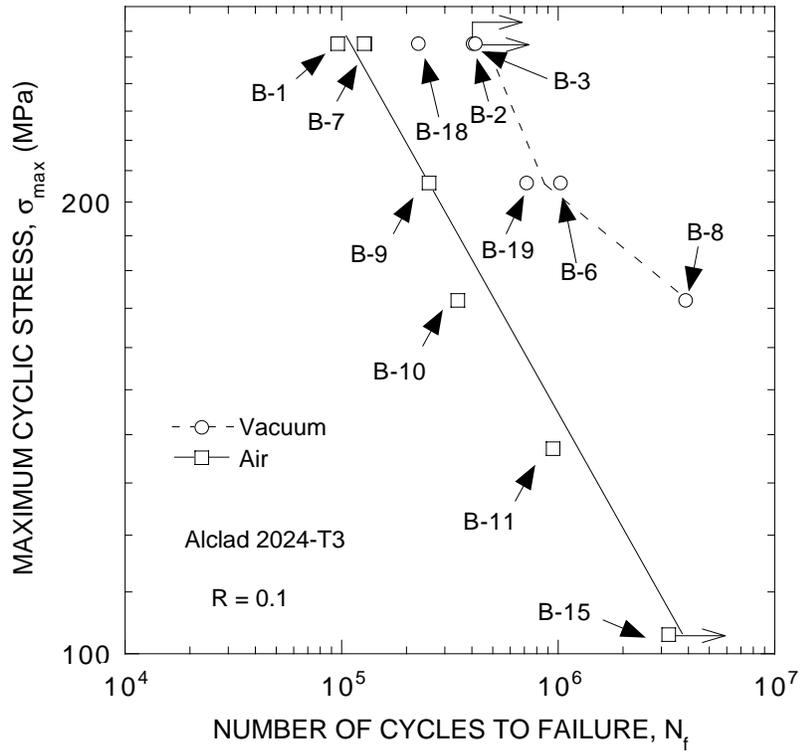
FIGURE 29. COMPARISON OF FATIGUE LIFE OF ALCLAD 2024-T3 ALUMINUM UNDER VACUUM AND IN AIR.

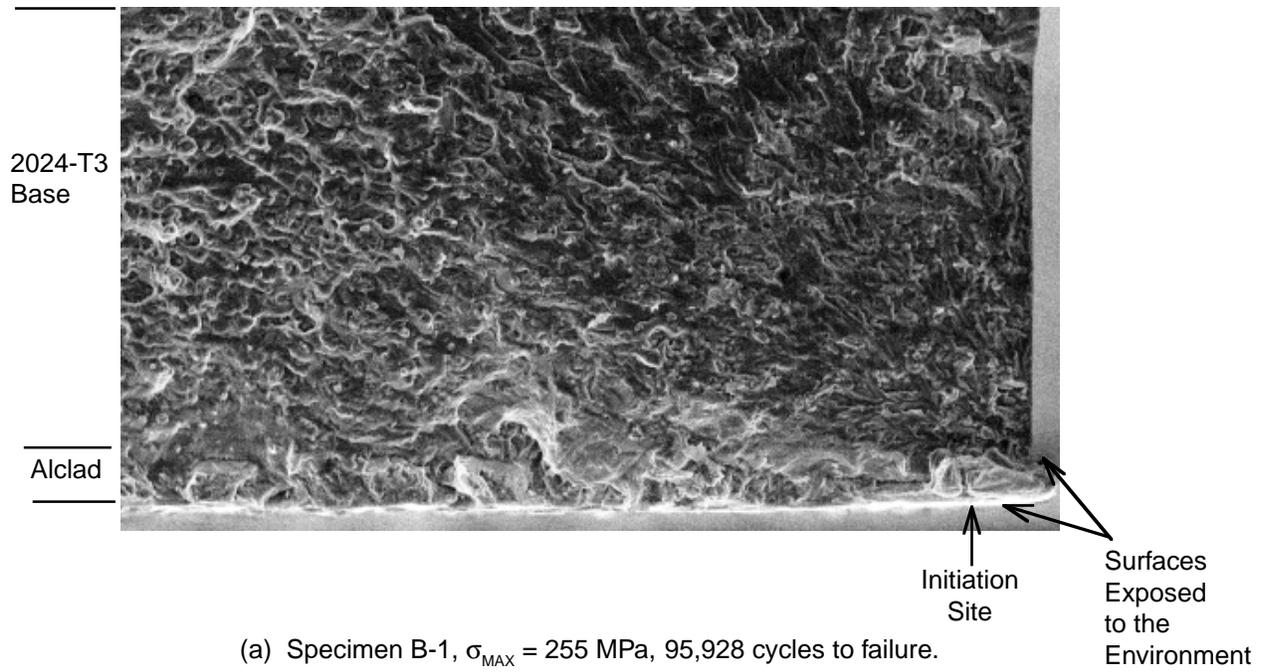
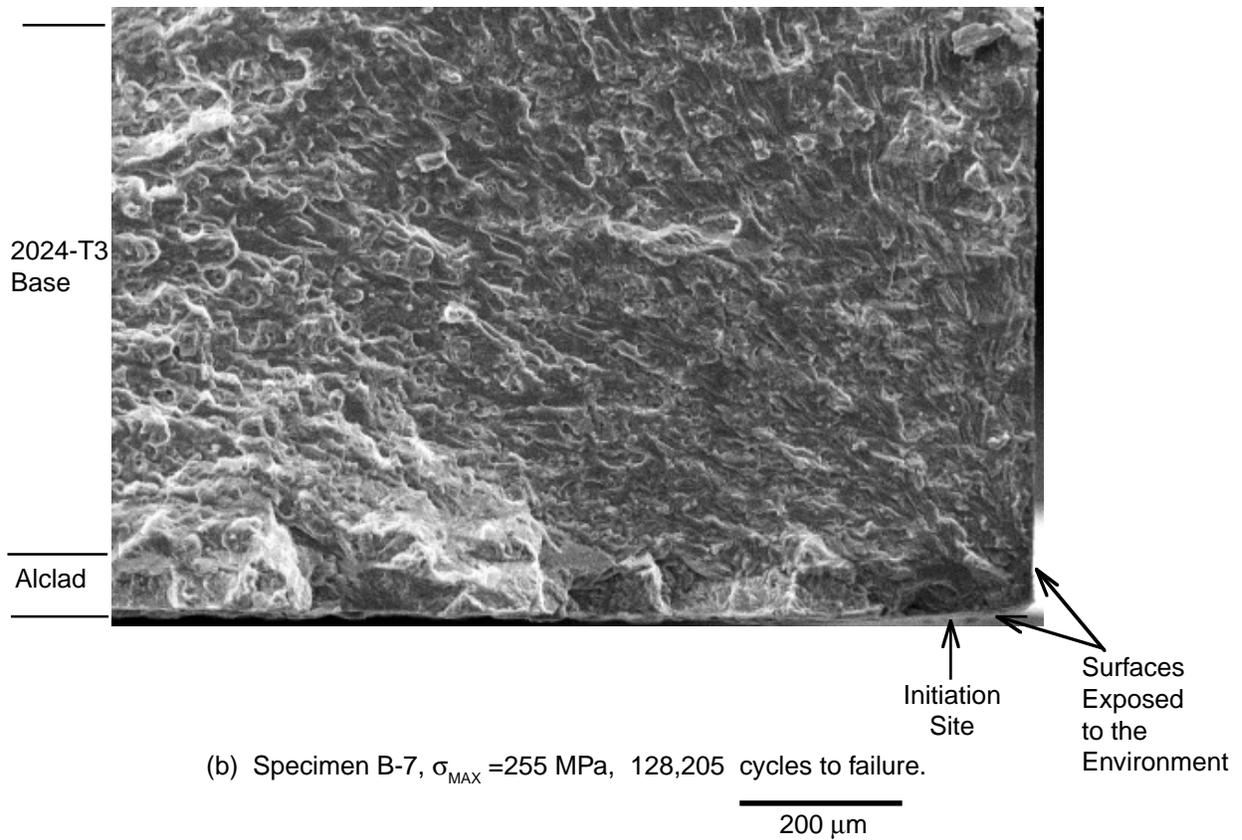
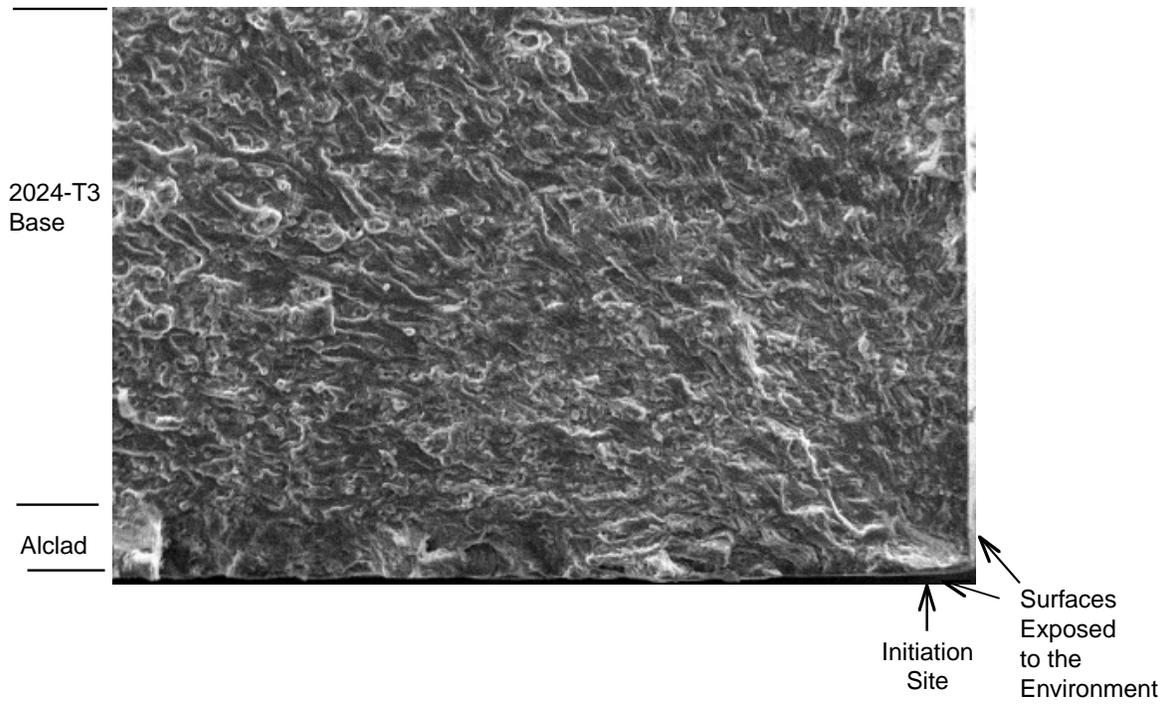
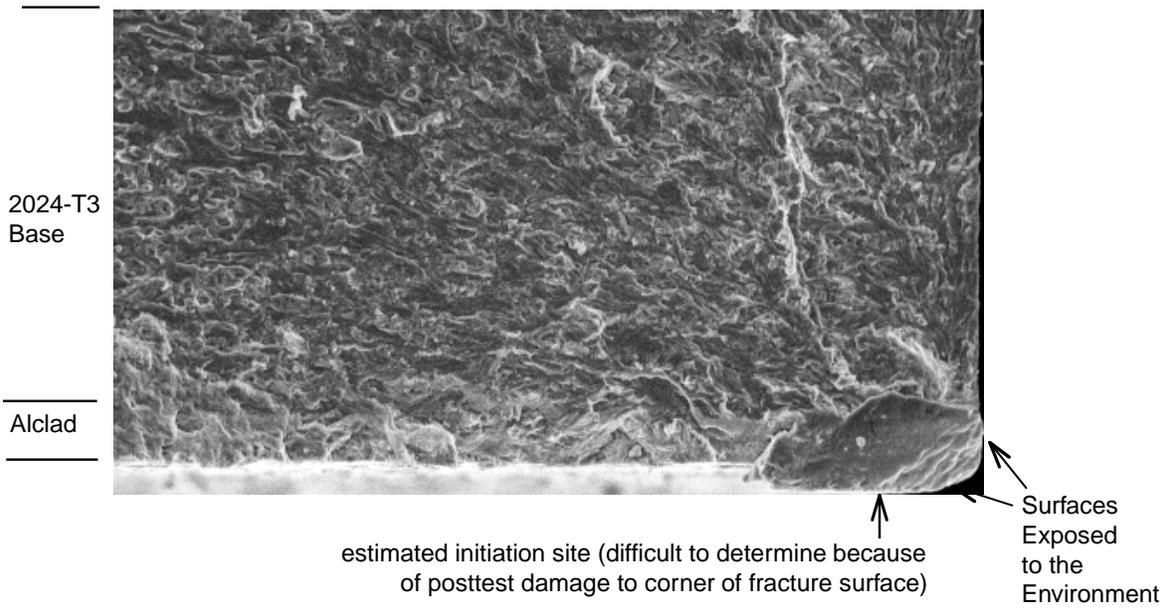
FIGURE 30. FRACTURE SURFACE APPEARANCE OF ALCLAD 2024-T3 FATIGUE SPECIMENS TESTED IN AIR.

(c) Specimen B-9, $\sigma_{MAX} = 207$ MPa, 253,201 cycles to failure.

(d) Specimen B-10, $\sigma_{MAX} = 172$ MPa, 344,564 cycles to failure.

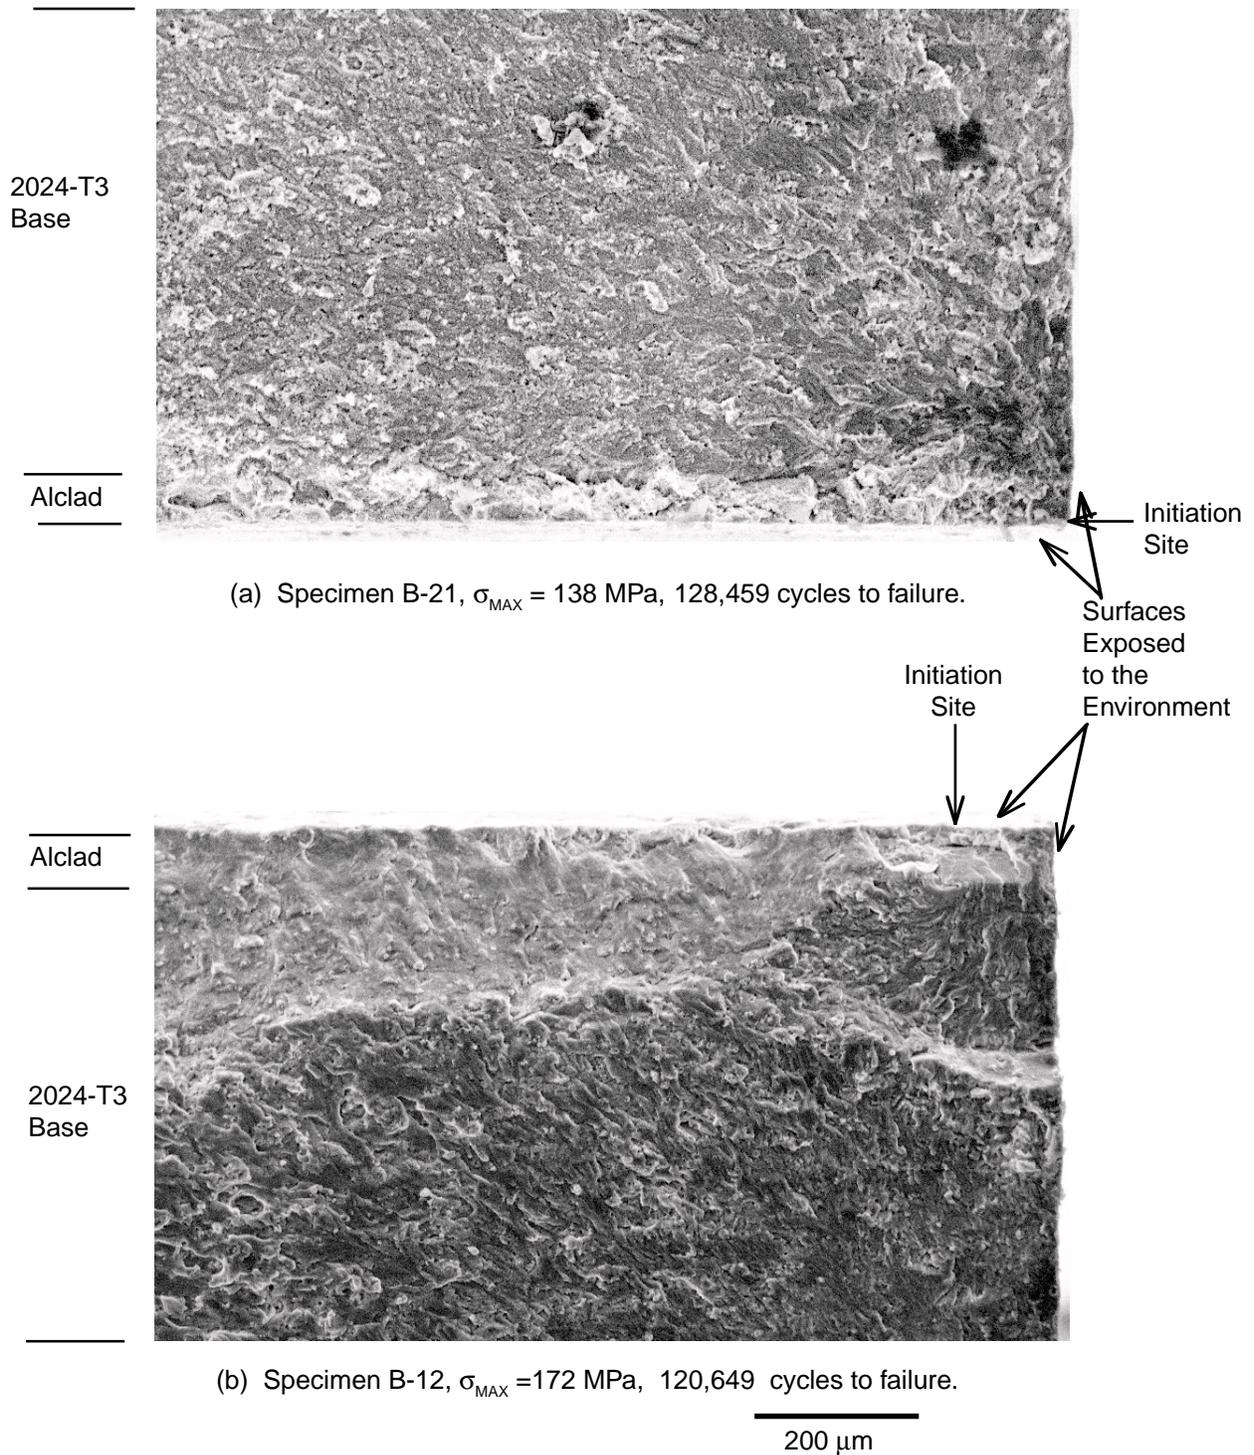
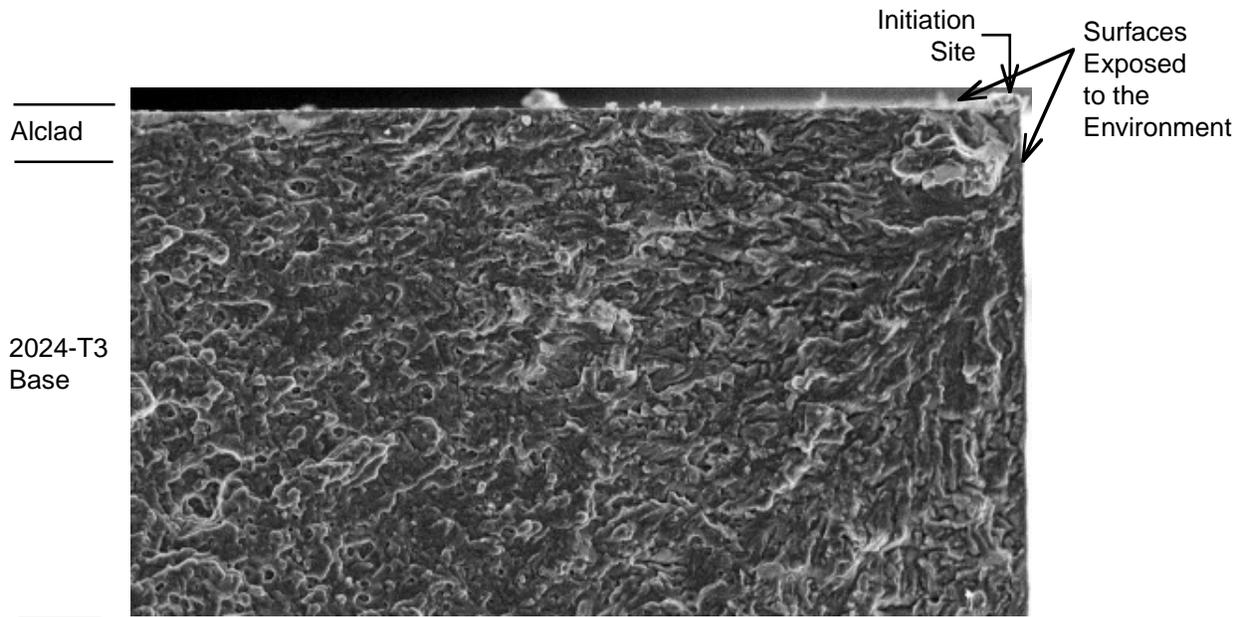
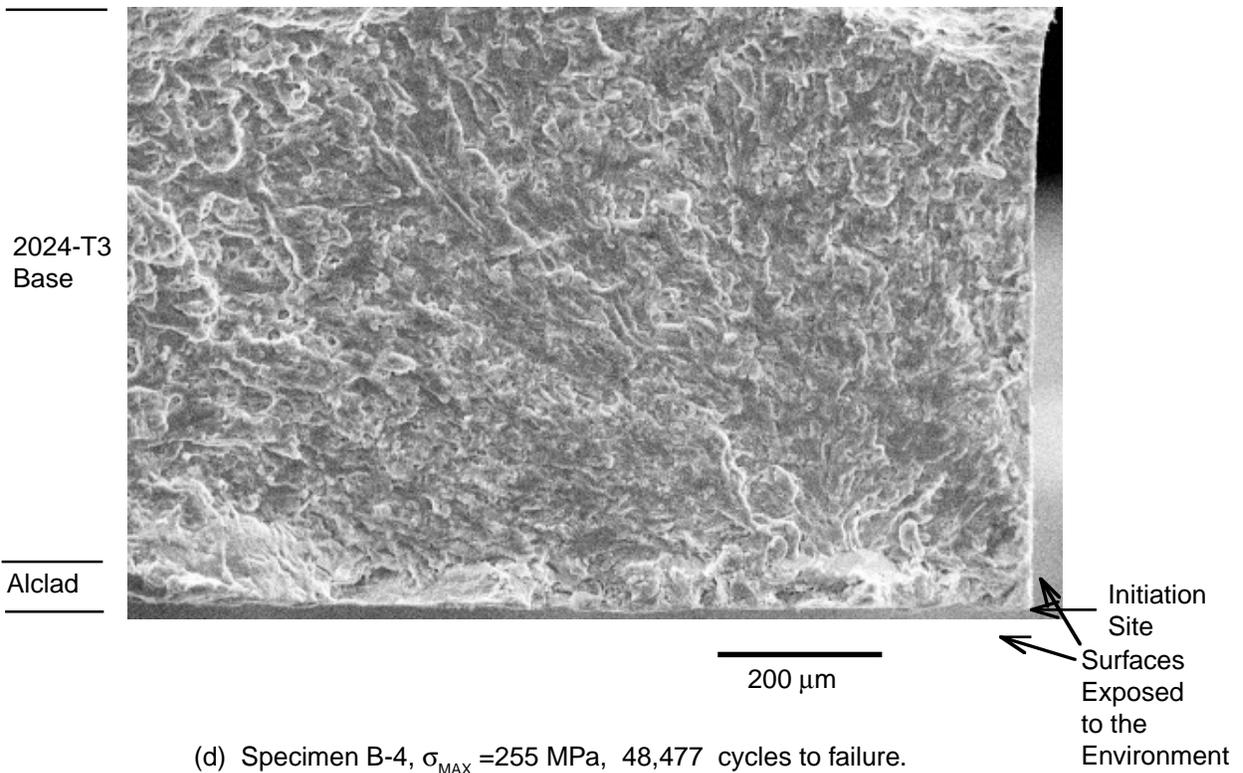
FIGURE 31. FRACTURE SURFACE APPEARANCE OF ALCLAD 2024-T3 FATIGUE SPECIMENS TESTED IN 0.5 M NaCl SOLUTION.

(c) Specimen B-14, $\sigma_{MAX} = 207$ MPa; 68,963 cycles to failure.

(d) Specimen B-4, $\sigma_{MAX} = 255$ MPa, 48,477 cycles to failure.

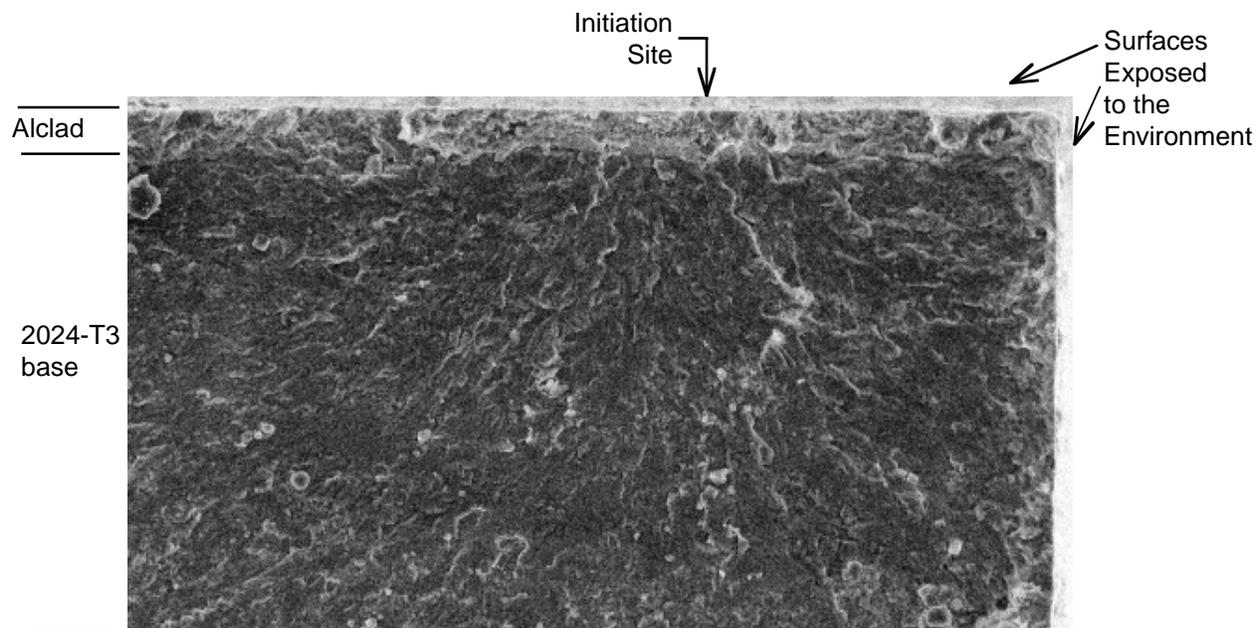
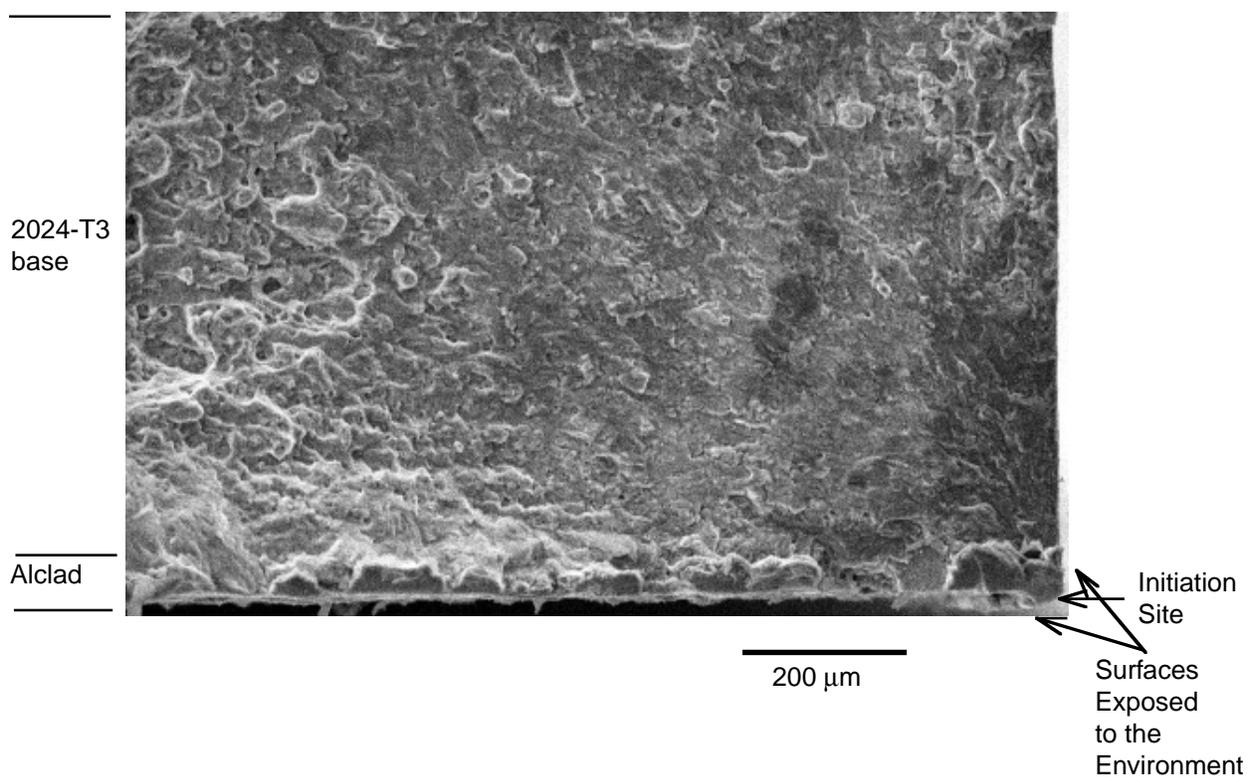
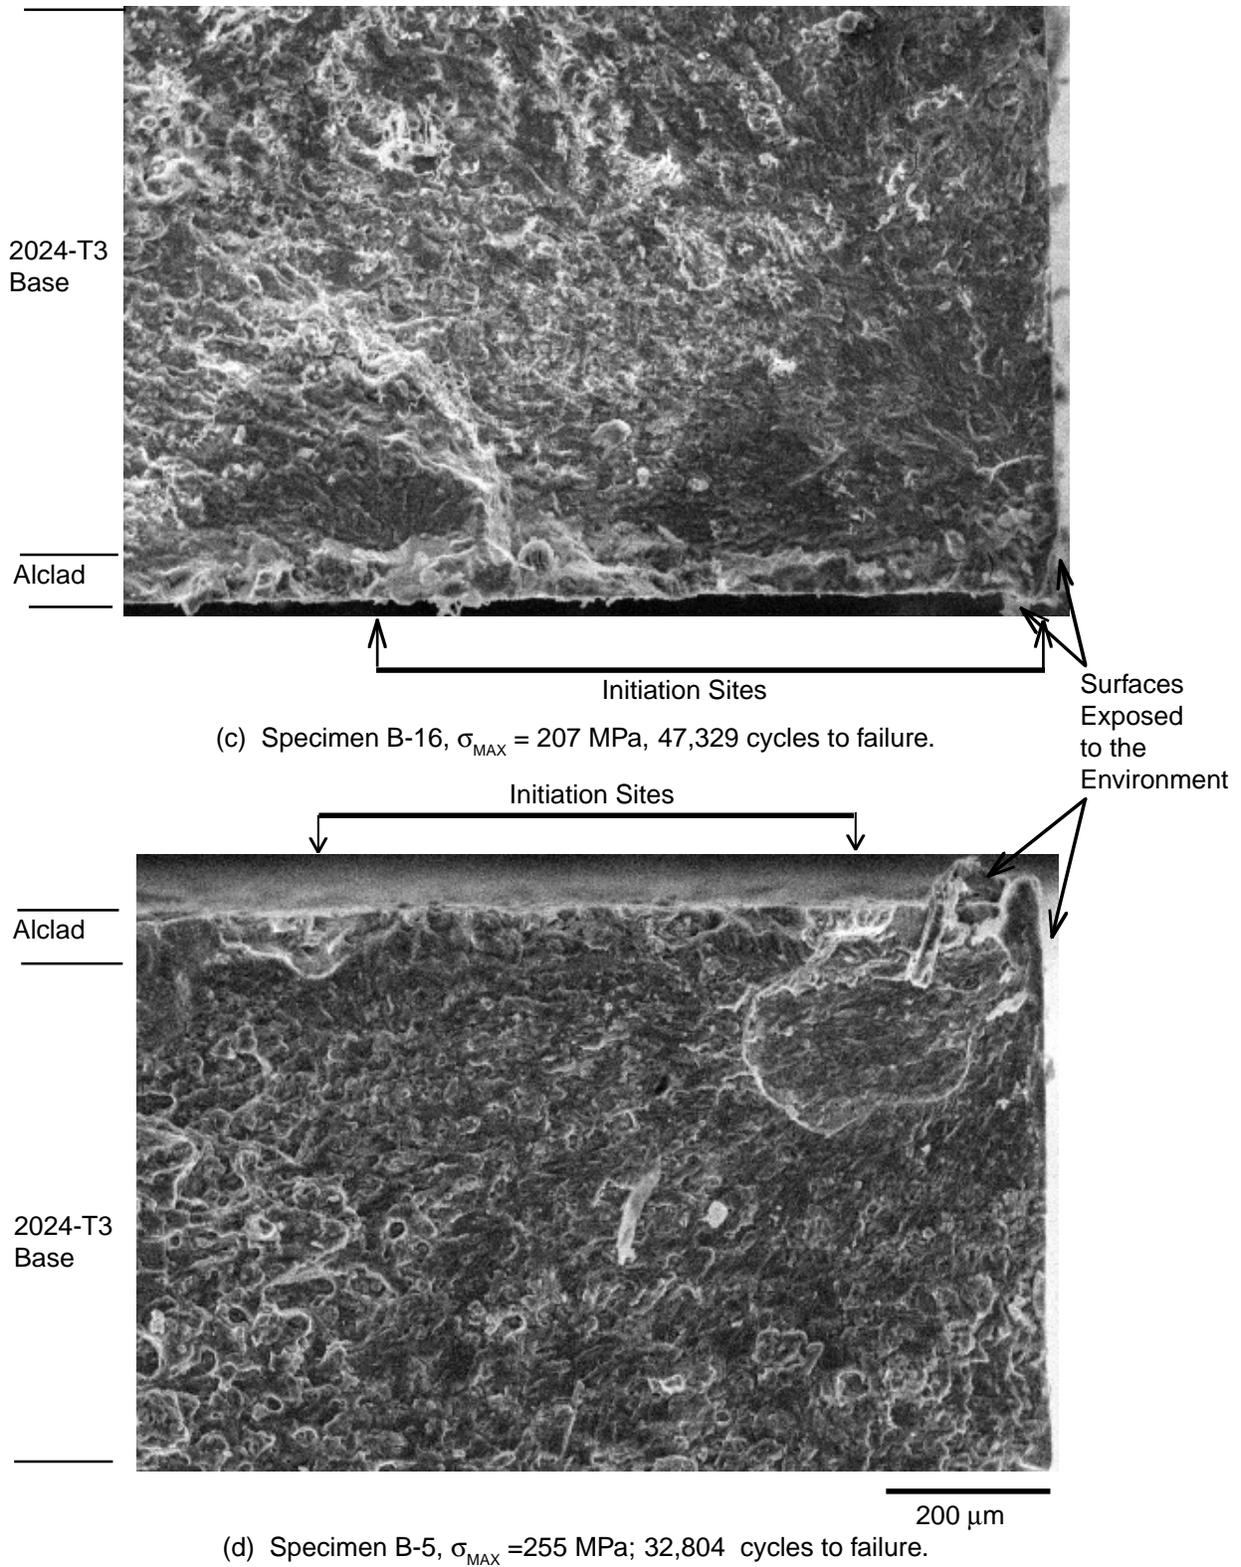
(a) Specimen B-22, $\sigma_{MAX} = 138$ MPa, 214,108 cycles to failure.

(b) Specimen B-20, $\sigma_{MAX} = 172$ MPa, 133,278 cycles to failure.

FIGURE 32. FRACTURE SURFACE APPEARANCE OF ALCLAD 2024-T3 FATIGUE SPECIMENS TESTED IN 0.5 M NaCl SOLUTION + 0.13 M As_2O_3 .

specimens tested under the same conditions (compare the cycles to failure of Specimen B-18 with the cycles for Specimen B-2 and B-3 in figure 32).

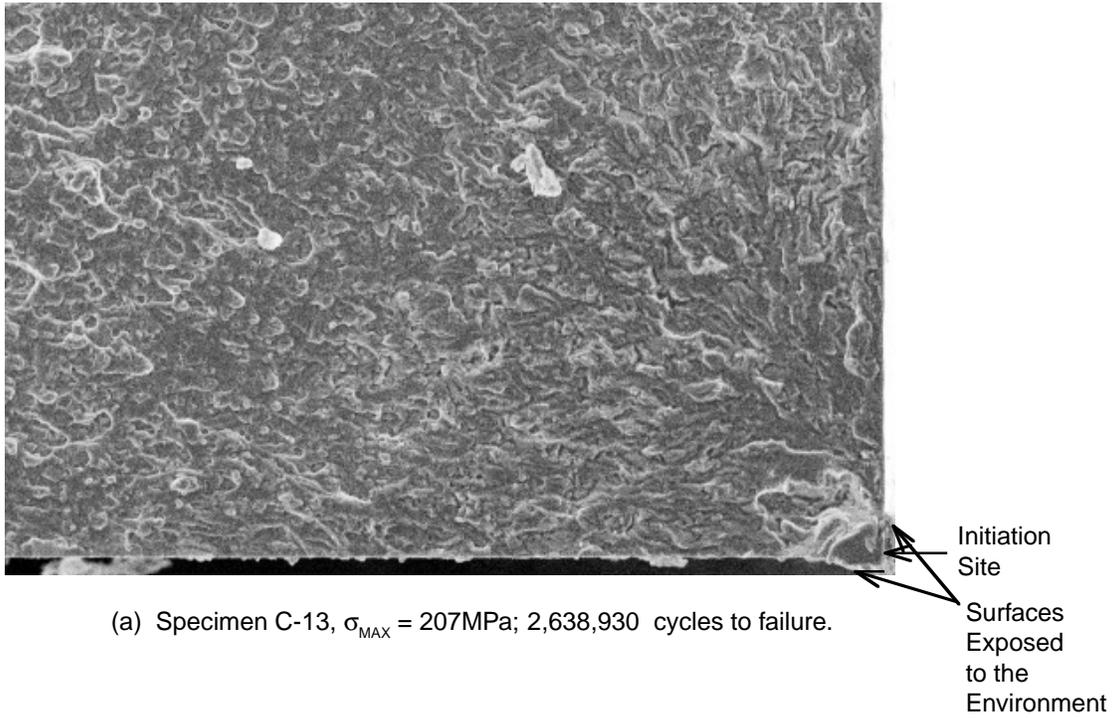
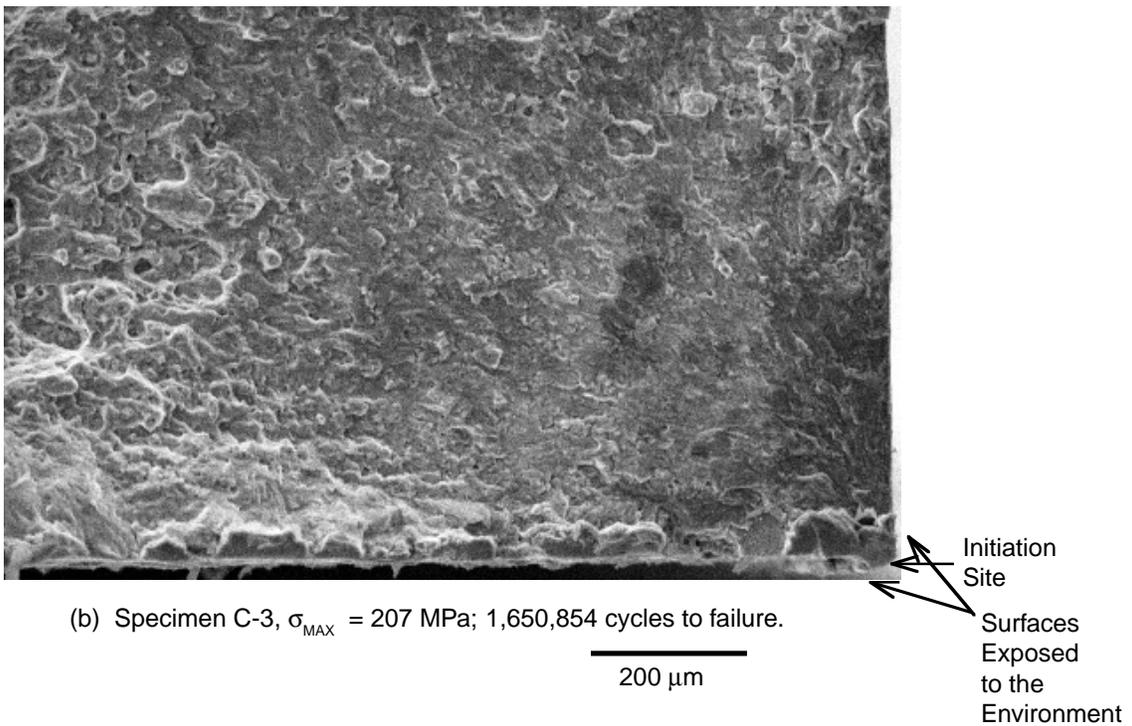
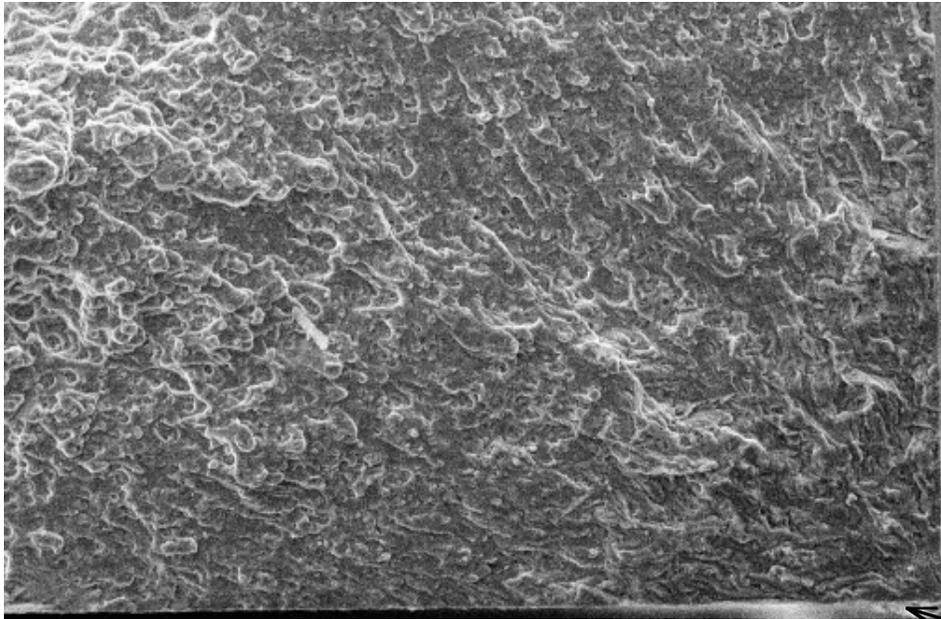
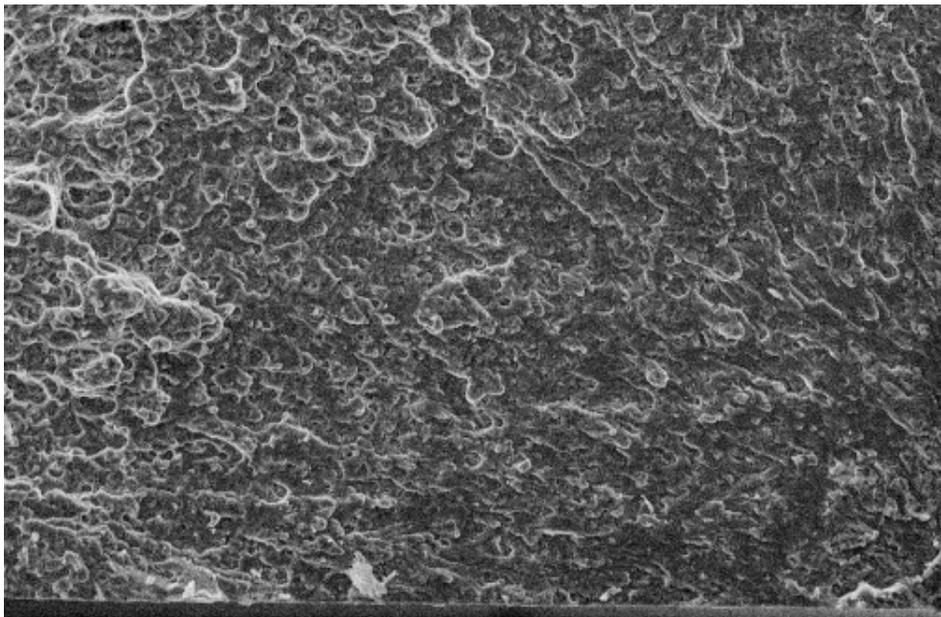
FIGURE 33. FRACTURE SURFACE APPEARANCE OF BARE 2024-T3 FATIGUE SPECIMENS TESTED IN VACUUM.

(c) Specimen C-14, $\sigma_{MAX} = 255$ MPa; 499,773 cycles to failure.

(d) Specimen C-4, $\sigma_{MAX} = 255$ MPa; 645,519 cycles to failure.

Figures 33 through 35 show the results of tests on bare material.

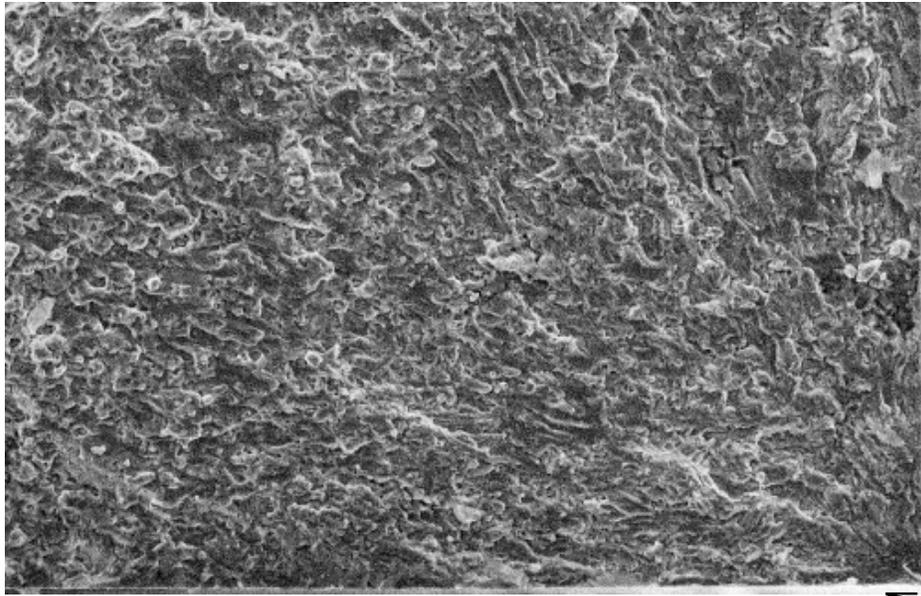
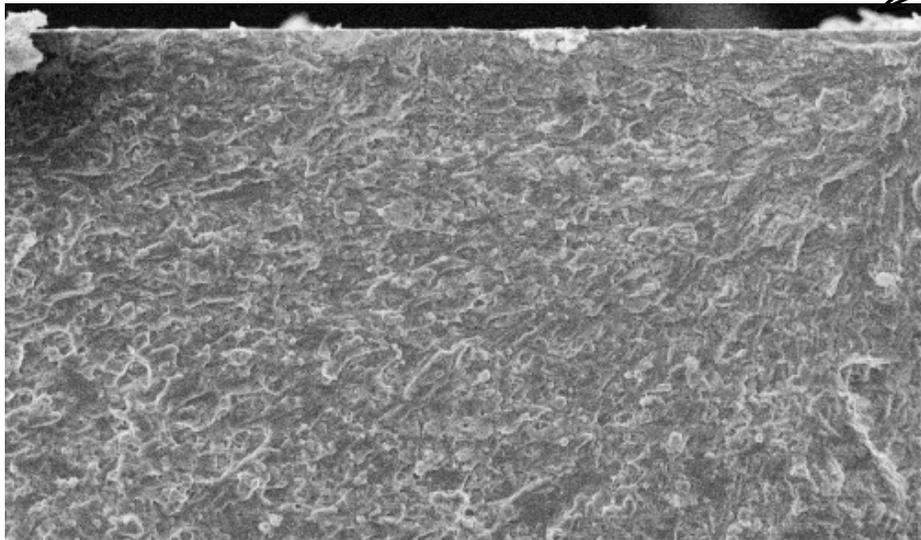
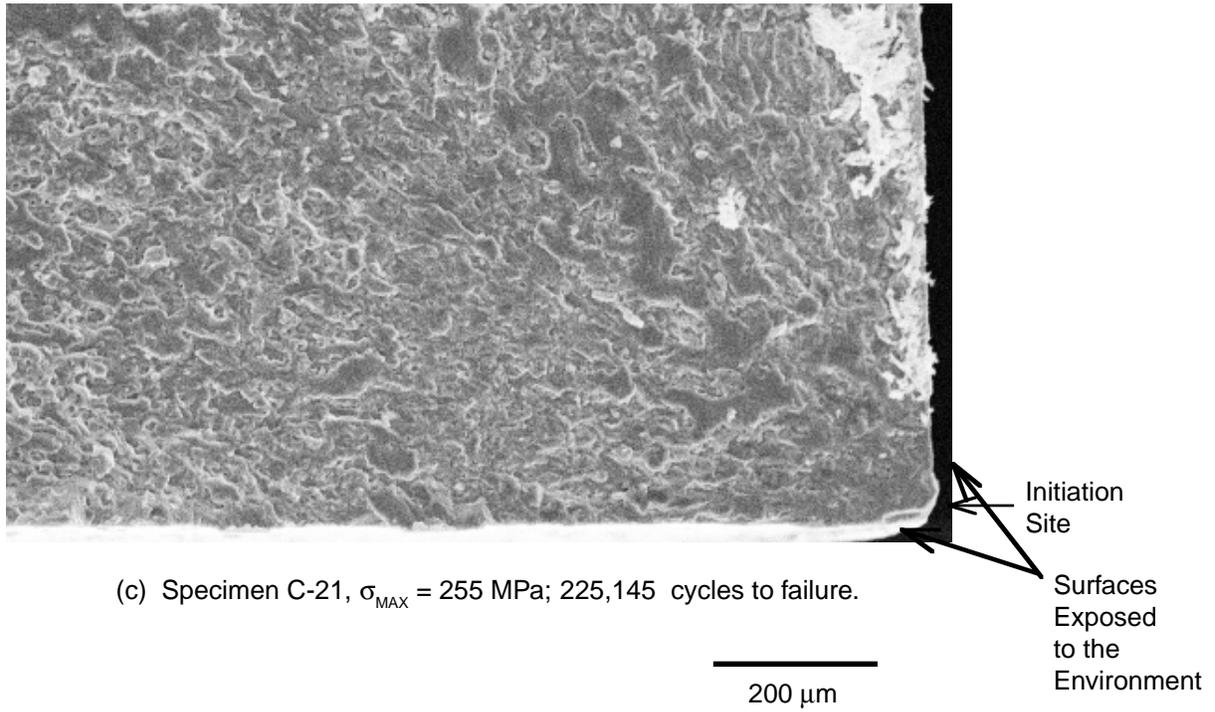
(a) Specimen C-6, $\sigma_{MAX} = 255$ MPa; 163,866 cycles to failure.

(b) Specimen C-15, $\sigma_{MAX} = 255$ MPa; 464,894 cycles to failure.

FIGURE 34. FRACTURE SURFACE APPEARANCE OF BARE 2024-T3 FATIGUE SPECIMENS TESTED IN AIR.
