DOT/FAA/AR-99/34

Characterization of Early Stages of Corrosion Fatigue in Aircraft Skin

Phase II: Interpretation of Corrosion-Fatigue Fracture Surfaces in Alclad 2024-T3 Aluminum Alloy Sheet

Phase II Report

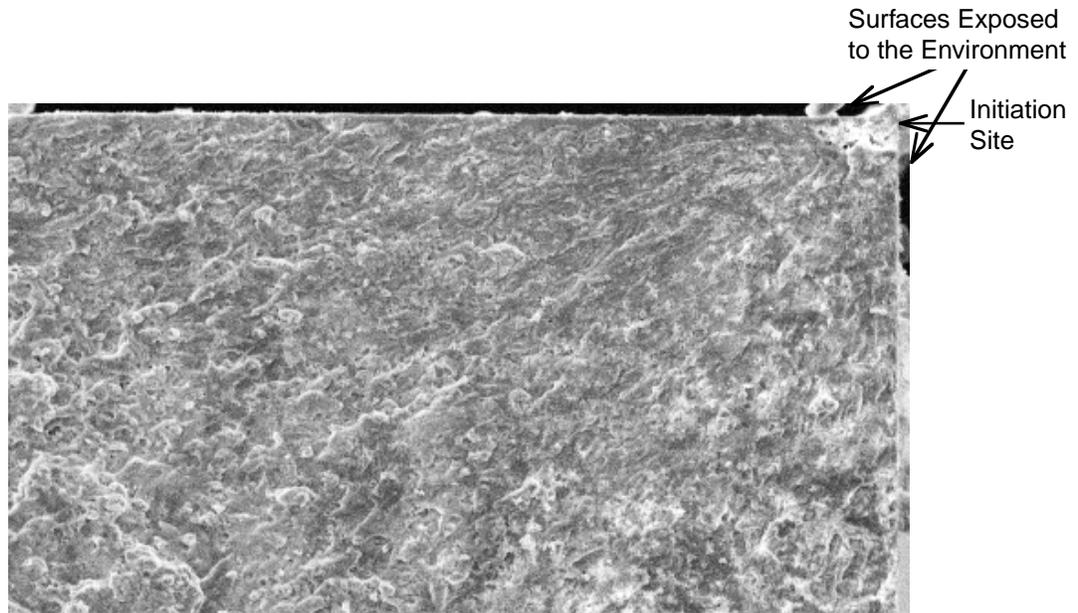
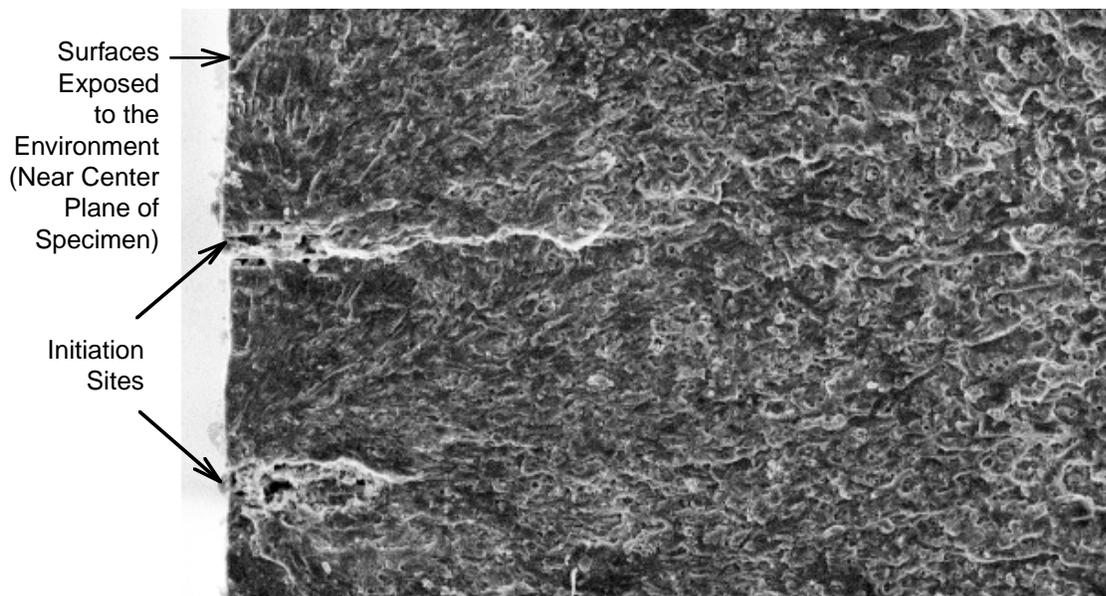
(a) Specimen C-8, $\sigma_{MAX} = 255$ MPa; 31,098 cycles to failure.

(b) Specimen C-19, $\sigma_{MAX} = 207$ MPa; 33,975 cycles to failure.

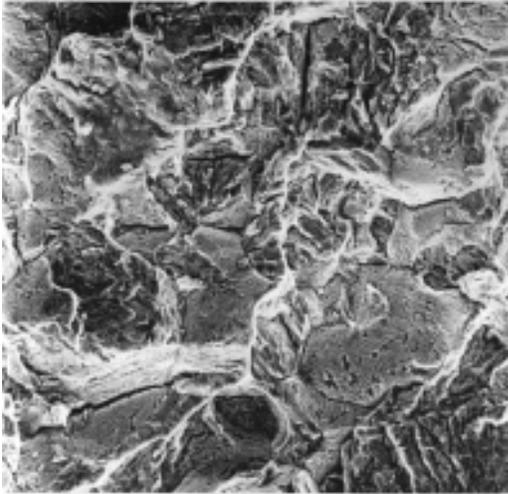
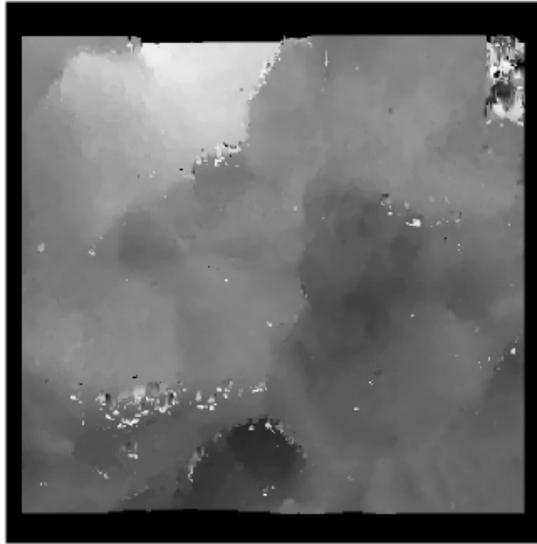
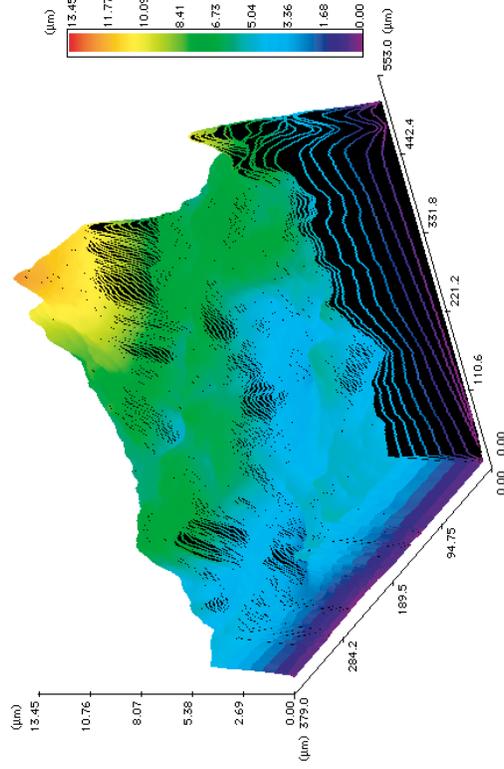
In summary, an SEM-based stereoanalysis program has been developed that can be used to study details of fracture surface topography at higher magnifications than is possible with a confocal optics scanning laser microscope. Further improvements are necessary to shorten computational time and to reduce the local noise in the elevation data.

(a) Left SEM Photograph

(b) Right SEM Photograph

(c) Grayscale Topography Image

(d) Perspective View of Fracture Surface
