DOT/FAA/AR-01/118

Aircraft Age-Related Degradation Study on Single- and Three-Phase Circuit Breakers

November 2002

Final Report

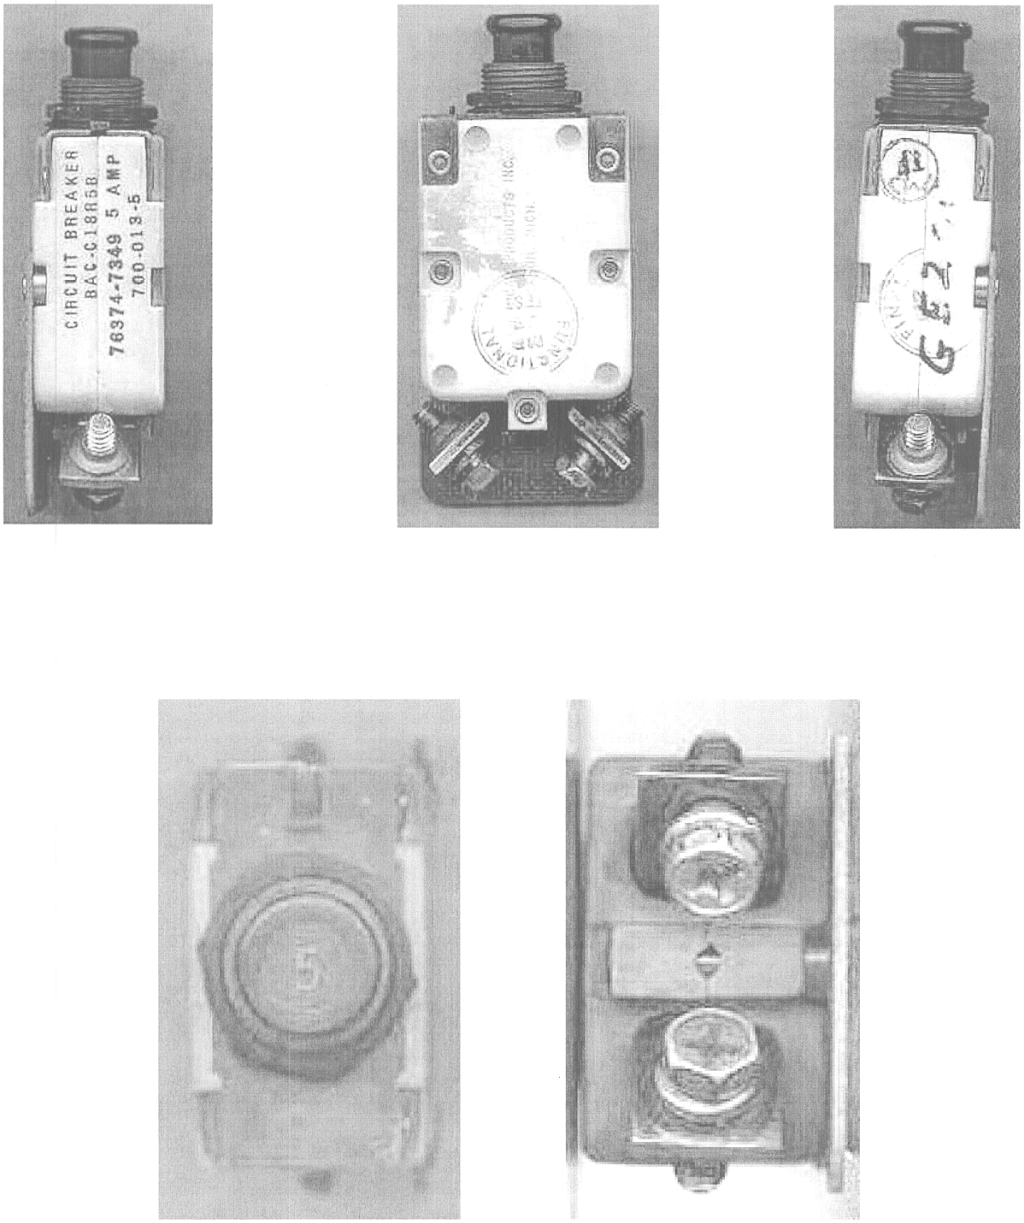
Figure 1.
Exterior of circuit breaker "GE200".

CORRECTIVE ACTION

None requested or required.

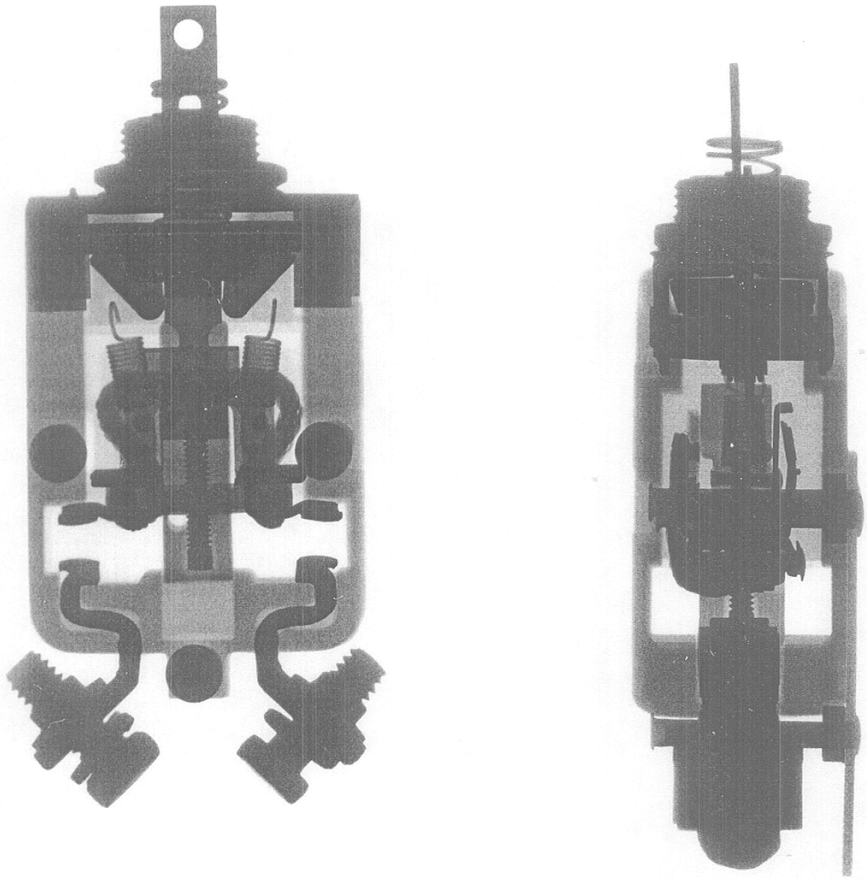
Radiographs were taken in the "open" condition as received (Figure 2). No anomalies were noted.

Figure 2.
Radiograph of breaker "GE200" in the open (unlatched) position as received.

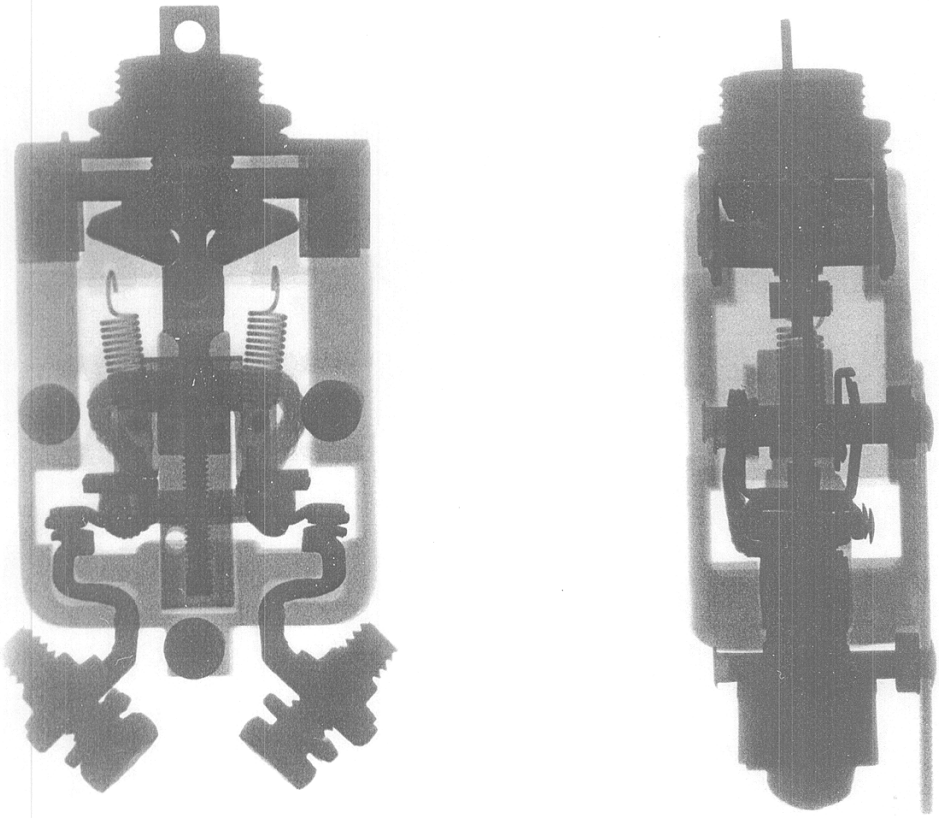
The breaker was then tested according to the requirements of "Block 8 - Failure Analysis (200% Overload Calibration)" of the FAA's "Research Plan for ... Circuit Breakers". During the first on/off cycle radiographs were taken of the breaker in the "closed" condition (Figure 3). The low voltage contact resistance measurements were as follows:

Figure 3.
Radiograph of breaker "GE200" in the closed (latched) position.

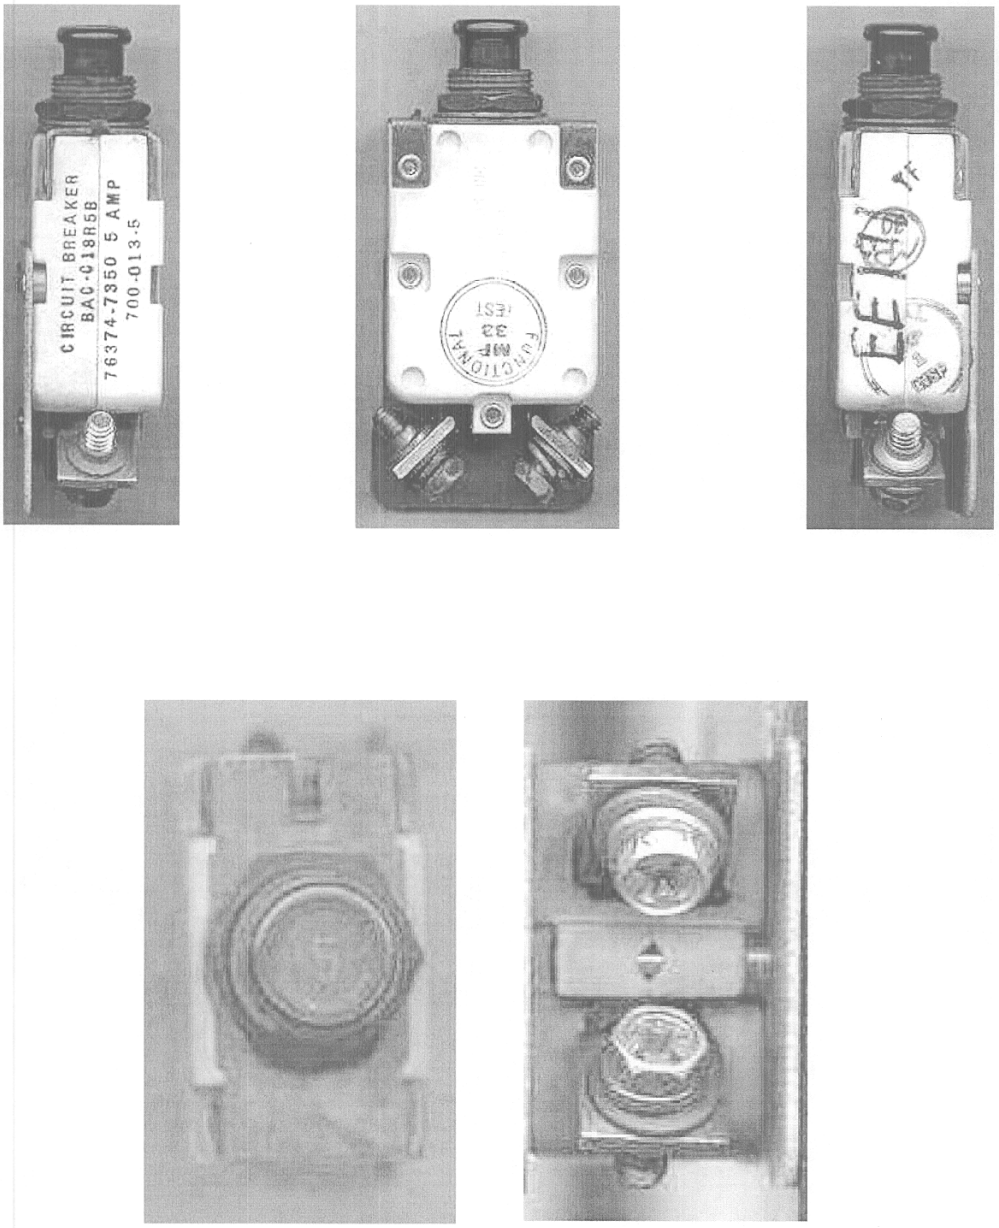
Figure 1.
Exterior of circuit breaker "EE191".

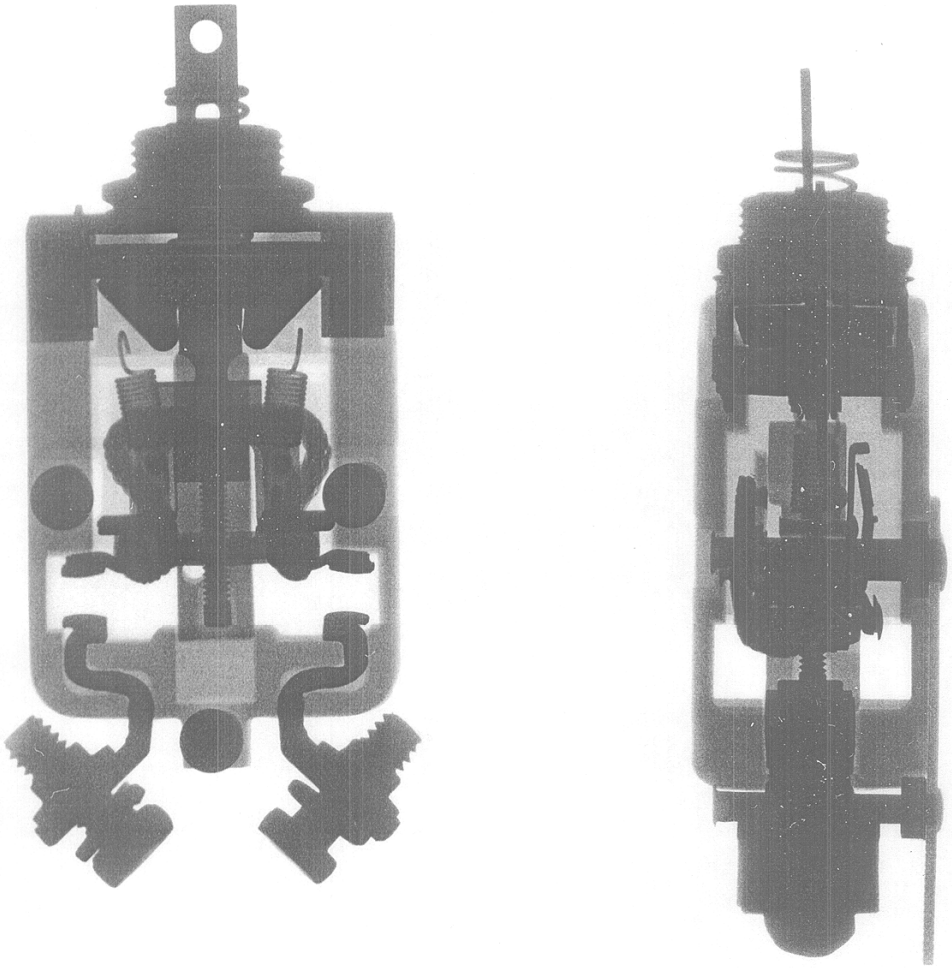
Figure 2.
Radiograph of breaker "EE191" in the open (unlatched) position as received.

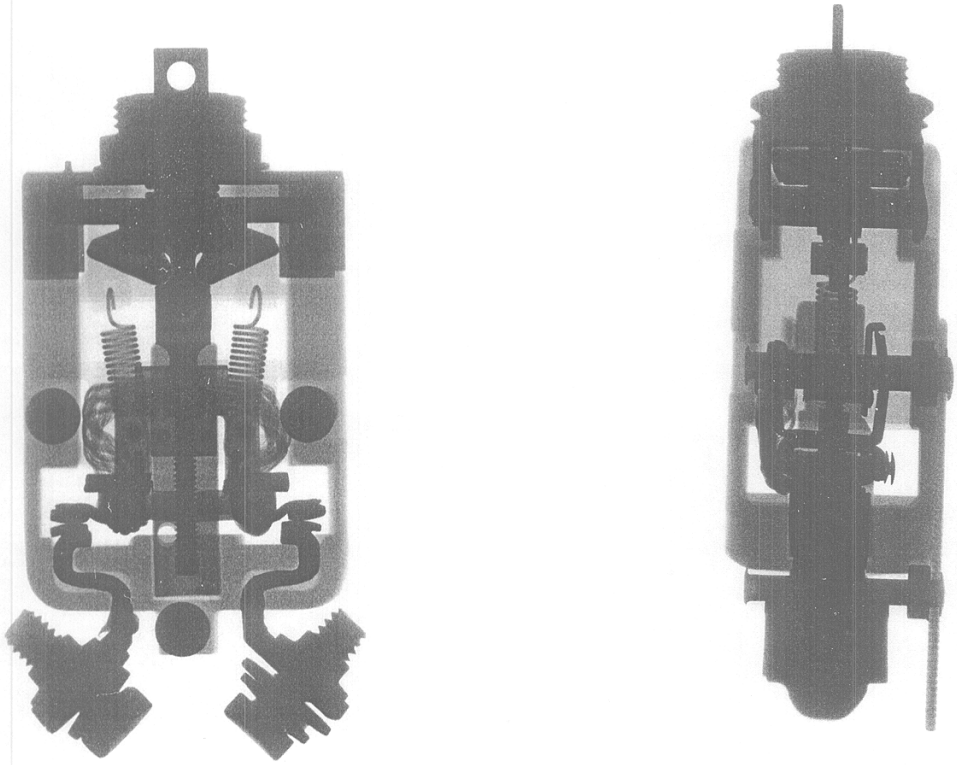
Figure 3.
Radiograph of breaker "EE191" in the closed (latched) position.

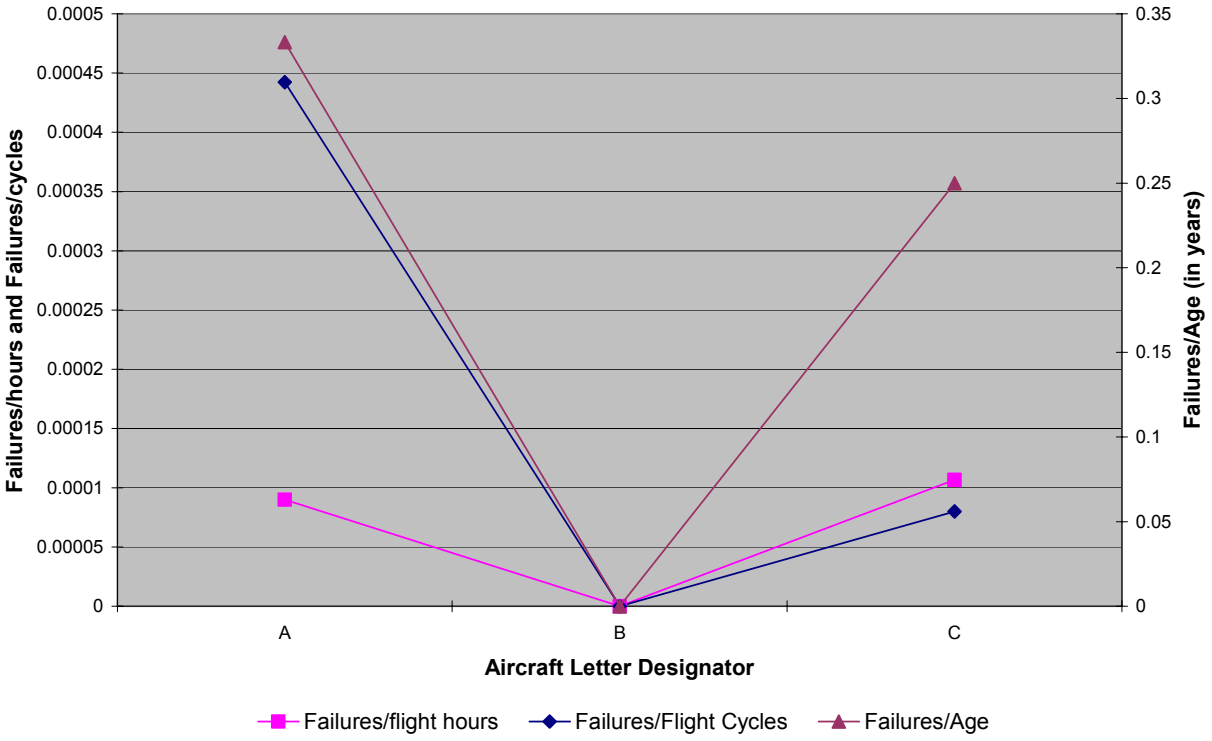
FIGURE J-7. FAA AANC CIRCUIT BREAKER FAILURES PER AIRCRAFT HOURS, CYCLES, AND AGE

g. Figure J-7 compares the circuit breaker failures per flight hours, failures per flight cycle, and failures per service life (years) of the aging aircraft.
