DOT/FAA/AR-98/53

Residual Strength Test on Stiffened Panels With Multiple-Site Damage

February 1999

Final Report

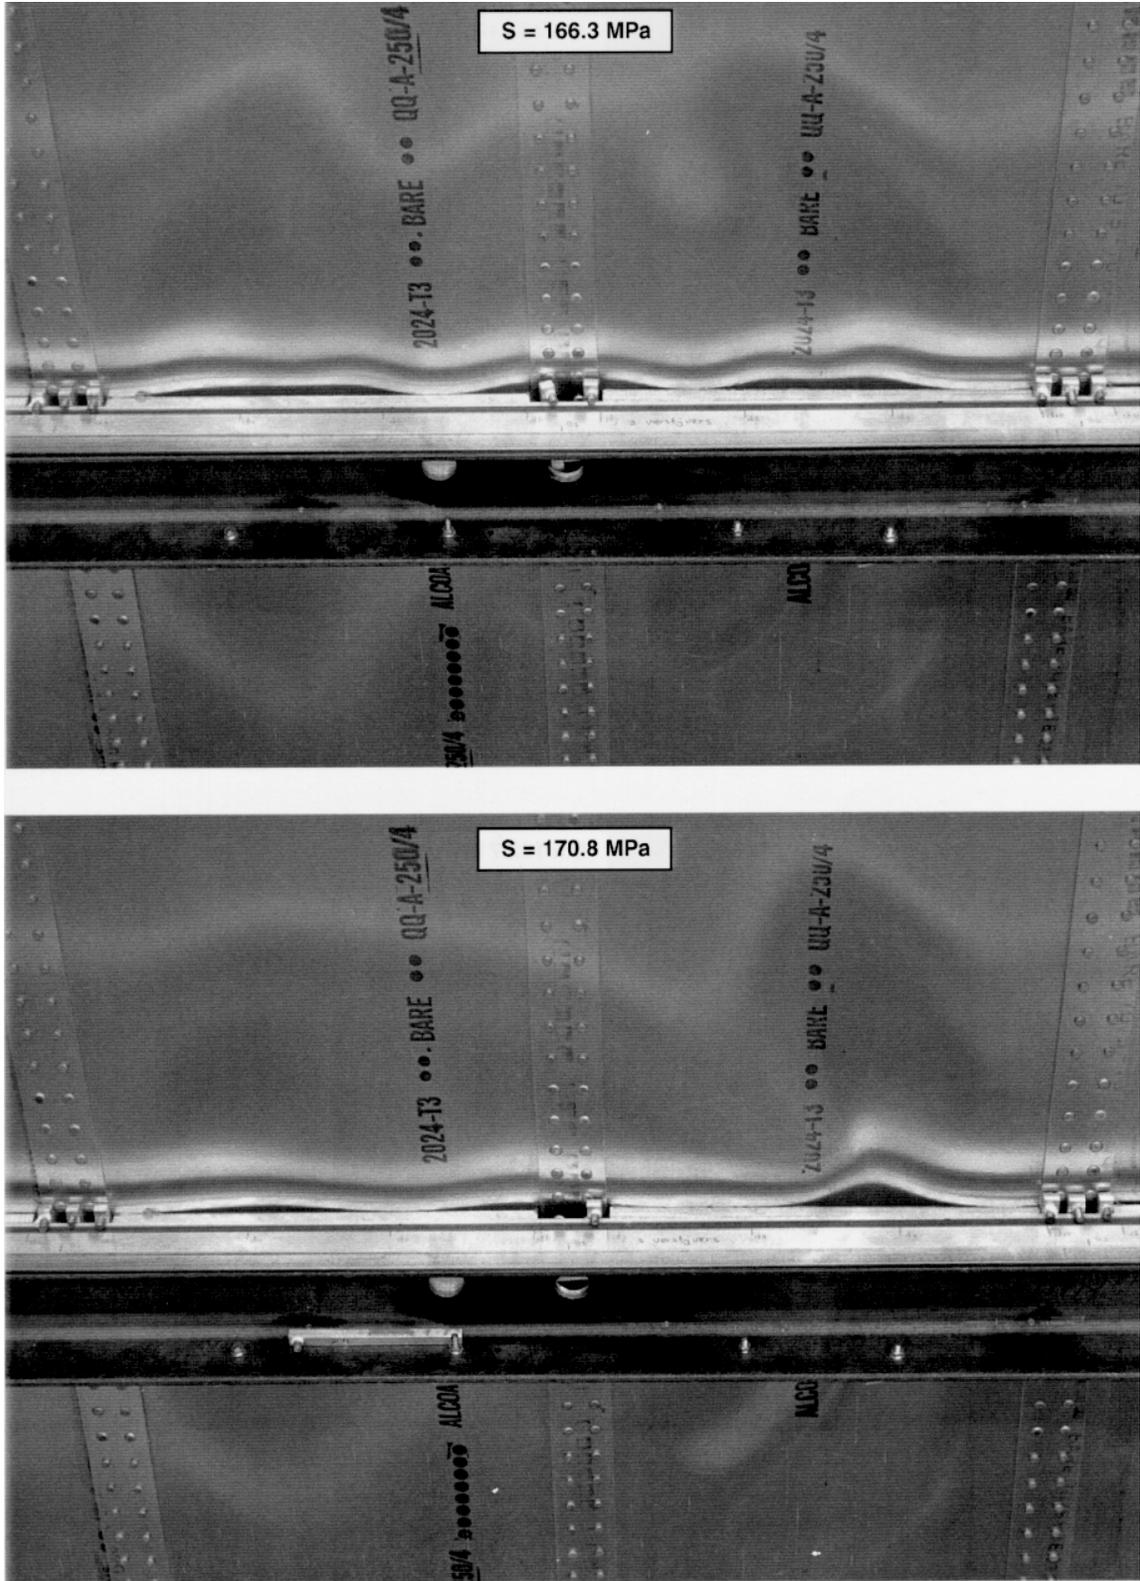
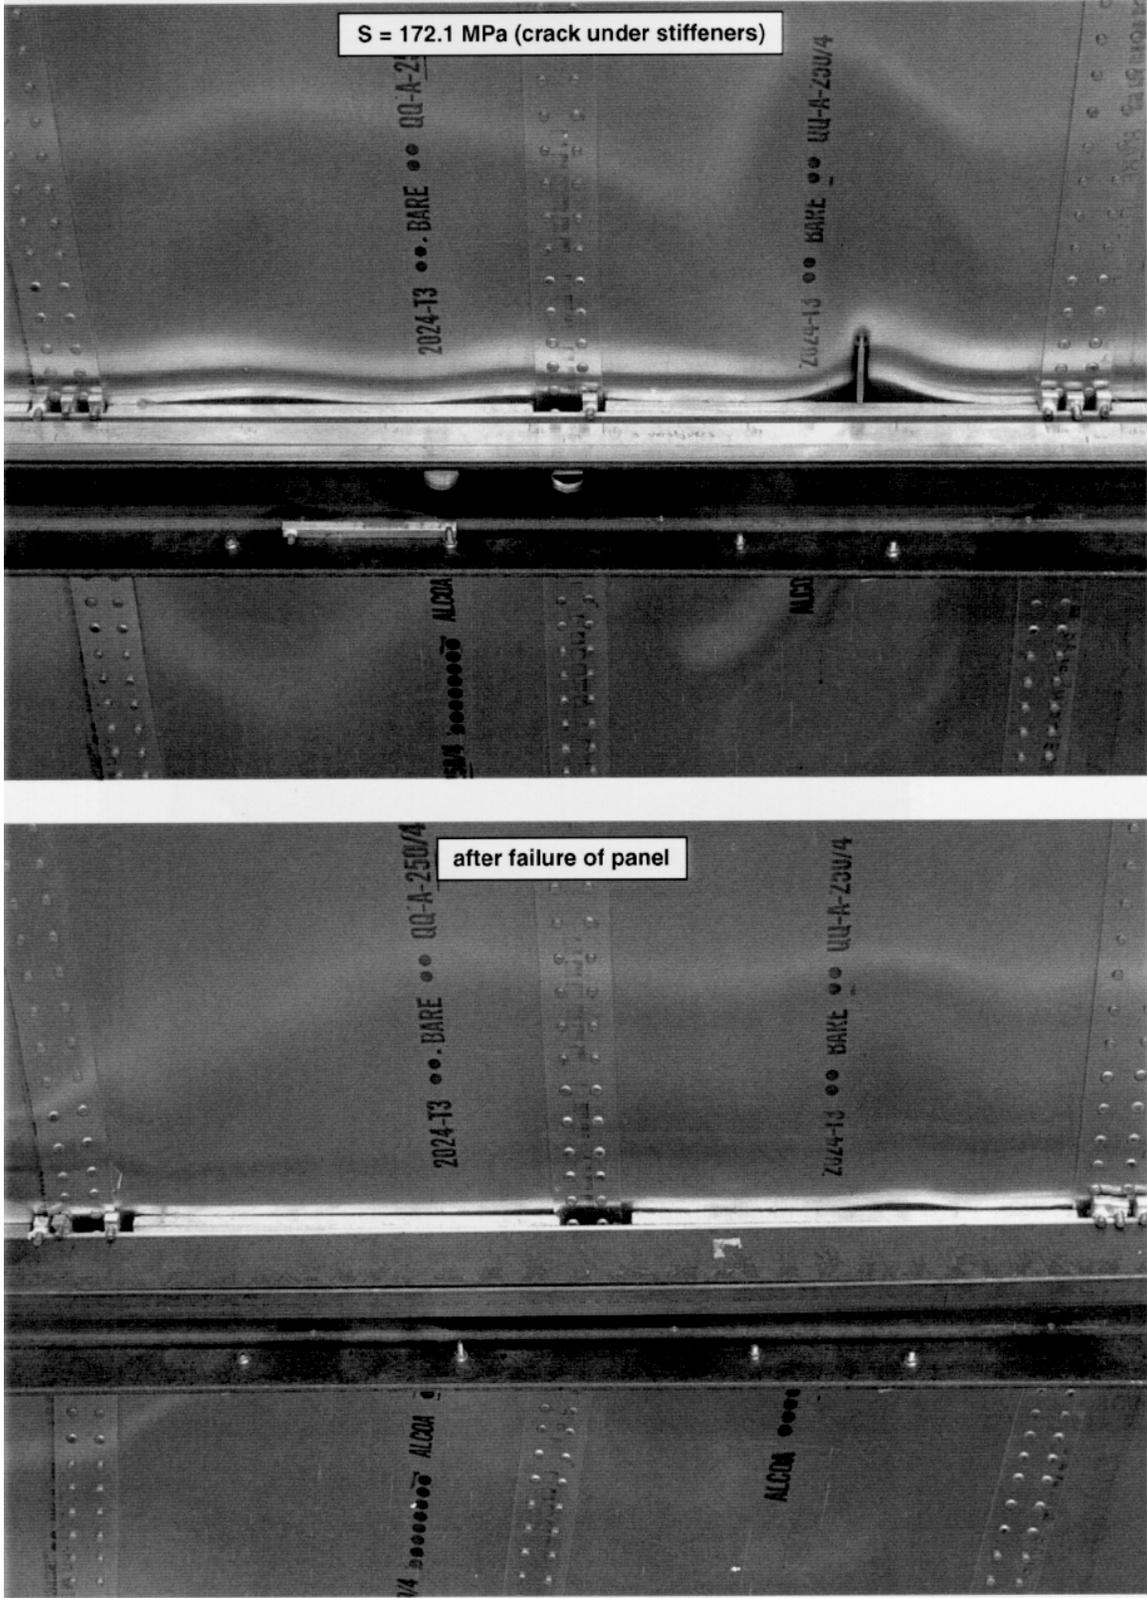
FIGURE 18. BUCKLING OF PANEL IIIb IN DIFFERENT PHASES OF THE RESIDUAL STRENGTH TEST (VIEW AT REAR SIDE OF PANEL)
