Activation of Oxygen Generators in Proximity to Combustible Materials

May 1999

DOT/FAA/AR-TN99/9

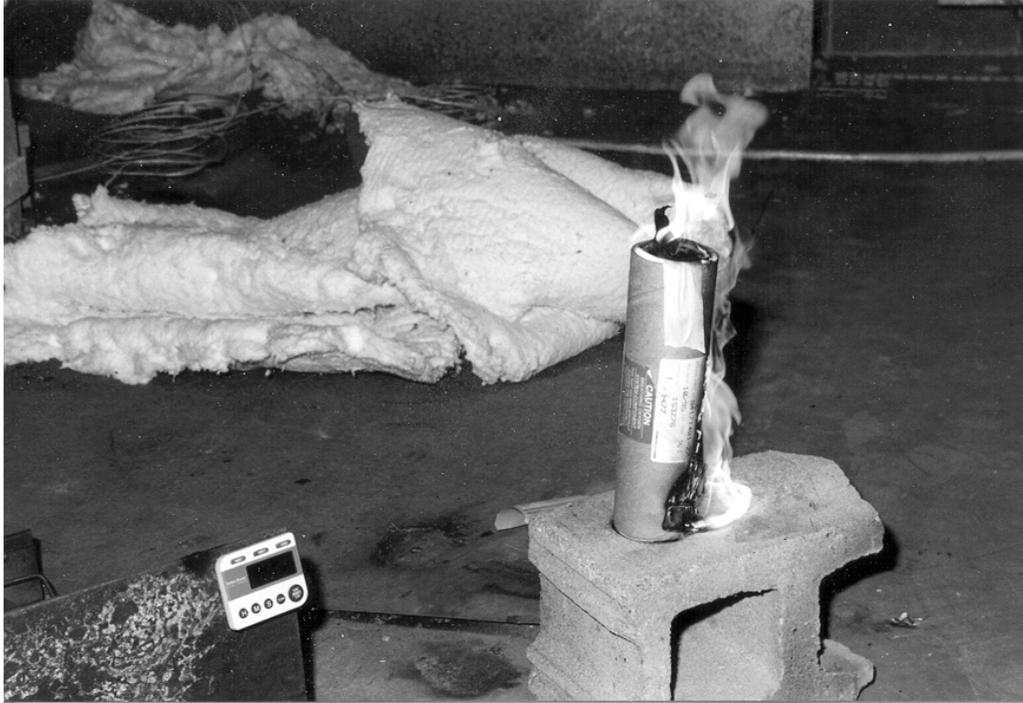
FIGURE 2. GENERATOR PACKAGING IGNITED AFTER THE GENERATOR WAS ACTIVATED

TEST 3. A generator packaged in polyurethane foam and a cardboard tube was activated by pulling the firing pin. This is a standard method for shipping individual generators. The generator gave off oxygen almost immediately. After 7 to 8 minutes, smoke started coming out of the top of the package. One to 2 minutes later the package ignited and completely burned in about 5 minutes. See figures 1 and 2.

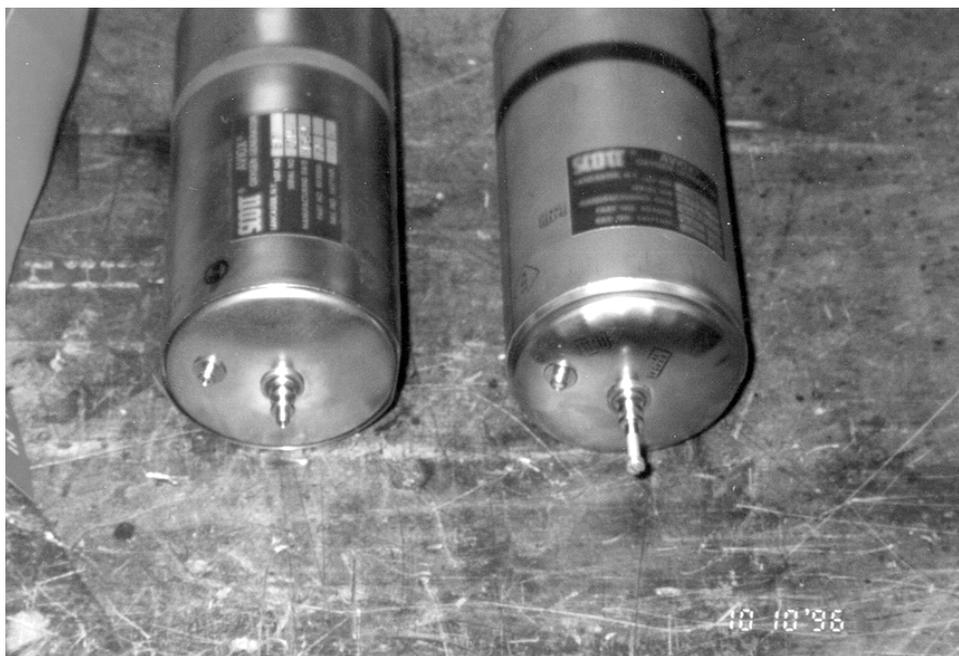
FIGURE 5. GENERATORS OVERPRESSURIZED AFTER PLUGGING THE OUTLETS AND ACTIVATED

TEST 10. The oxygen outlet on a Scott 803000-03 generator was tapped with screw threads and a screw inserted, plugging the outlet. The pressure relief valve was plugged with a Swagelock fitting. The generator was set off with the firing pin. Within 1 minute both ends of the generator popped out but did not appear to separate. After sitting approximately eighteen hours, there was no pressure in the cylinder. Upon closer examination, the metal had separated around the firing pin. It does not appear that plugging the outlet and pressure relieve valve will cause the generator to burst. See figure 5.

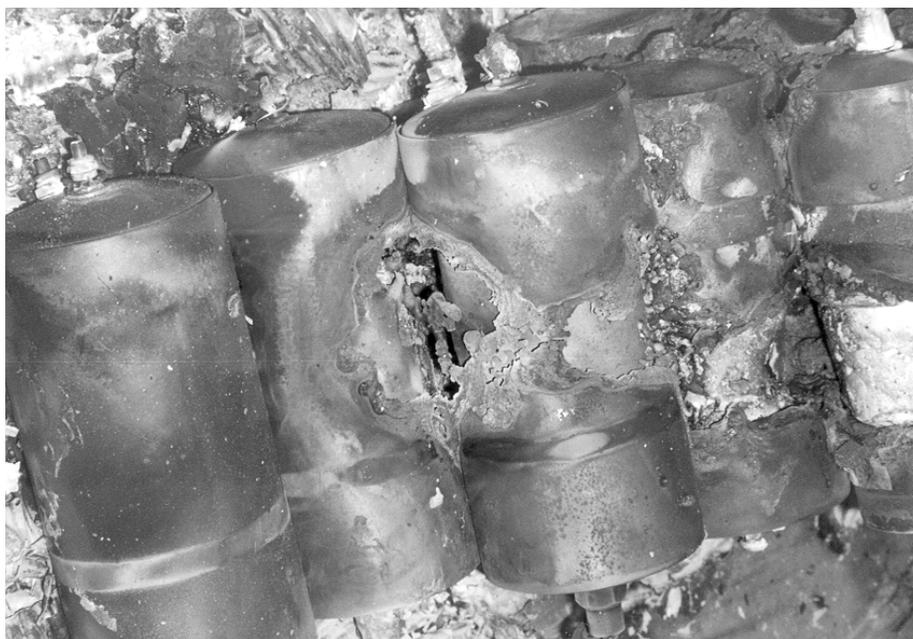
FIGURE 6. MELTED GENERATORS

TEST 14. Eleven generators were packed in a box identical to test 11. A wire was attached to the firing pin on a generator at the top of the box, next to the bubble pack. The box was placed on its side and the firing pin pulled. The box ignited and all 11 generators were activated. Most of the generators' stainless steel shells were melted through. See figure 6.

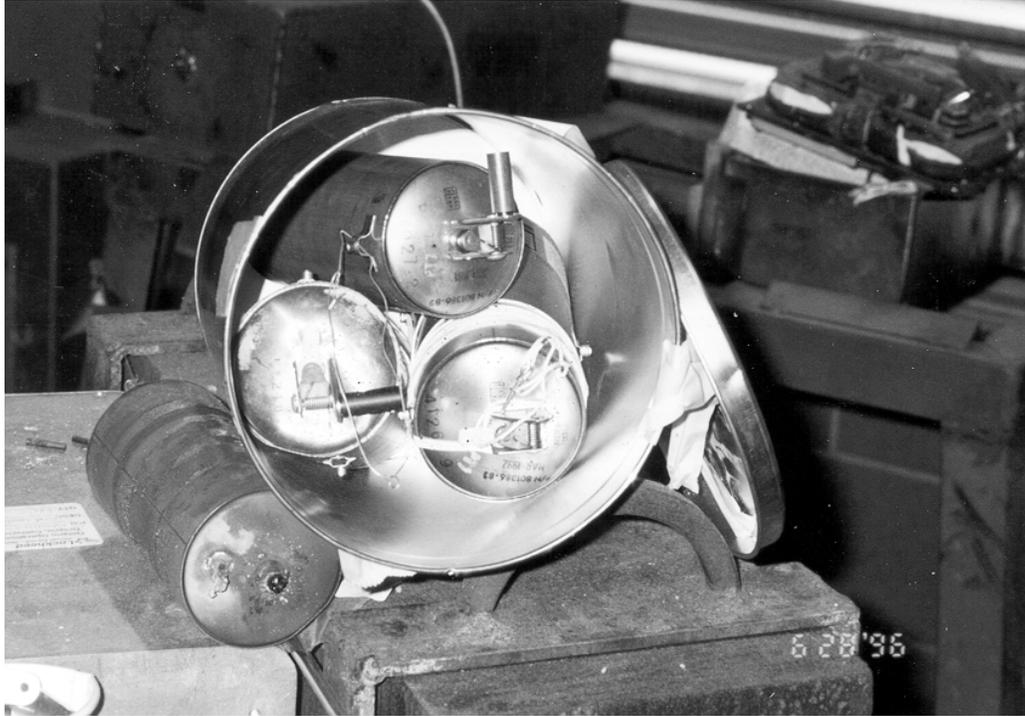
FIGURE 11. THREE GENERATORS PLACED IN A TIN CAN

TEST 22. Three generators were placed in a tin can used for shipment of hazardous or dangerous chemicals. Normally the can is packed with vermiculite, a noncombustible material, used to cushion shipping material. However, for this test no vermiculite was used. Only one of the three generators was activated. The lid was placed on the can and taped in place. A thermocouple was placed inside the container to indicate a successful ignition and record the temperature inside the can. There was no sign of smoke or fire; this demonstrates that without combustible material the generators would be relatively safe for shipment. See figure 11.

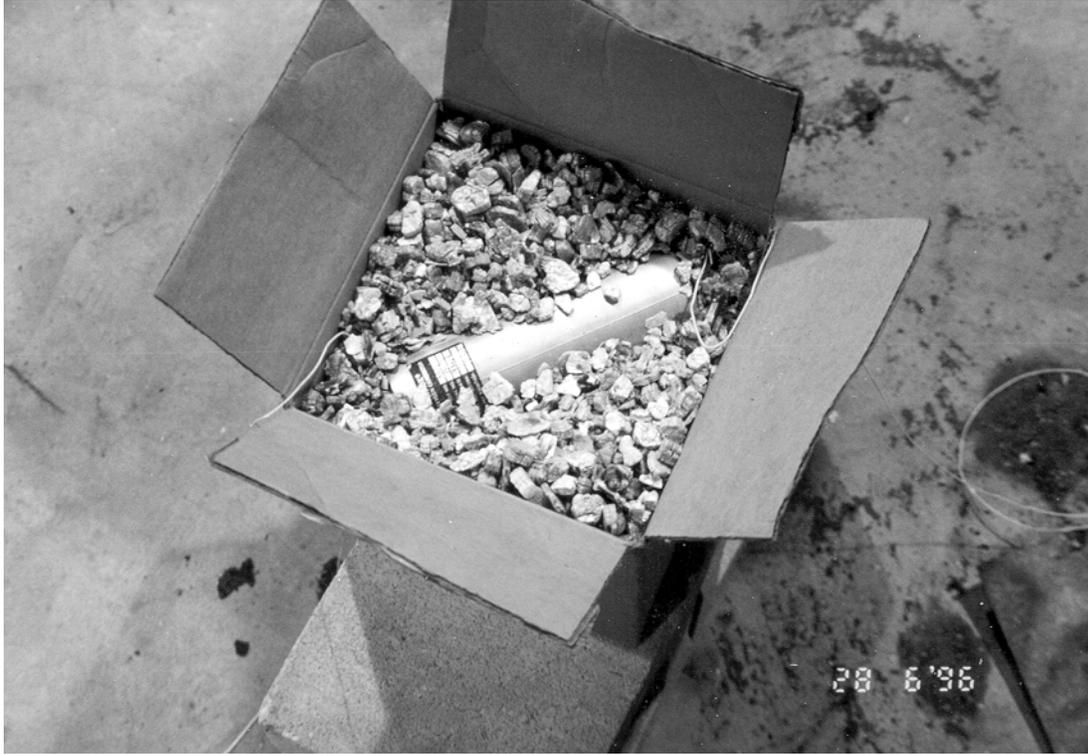
FIGURE 13. GENERATOR PACKED IN NONCOMBUSTIBLE MATERIAL

TEST 24. Two generators, the Puritan-Bennett 117003-13 and the Scott 801386-83, were completely surrounded with vermiculite and packed in a cardboard box. The Puritan-Bennett generator was placed on the bottom and activated. The Scott generator was not activated. The box was closed after activation, and the test ran for 20 minutes. Although the box got warm, no flames or smoke were observed. After unpacking and inspecting the box, generators, and vermiculite, no heat damage was found other than the color change of the activation band on the Puritan-Bennett generator. See figures 13 and 14.

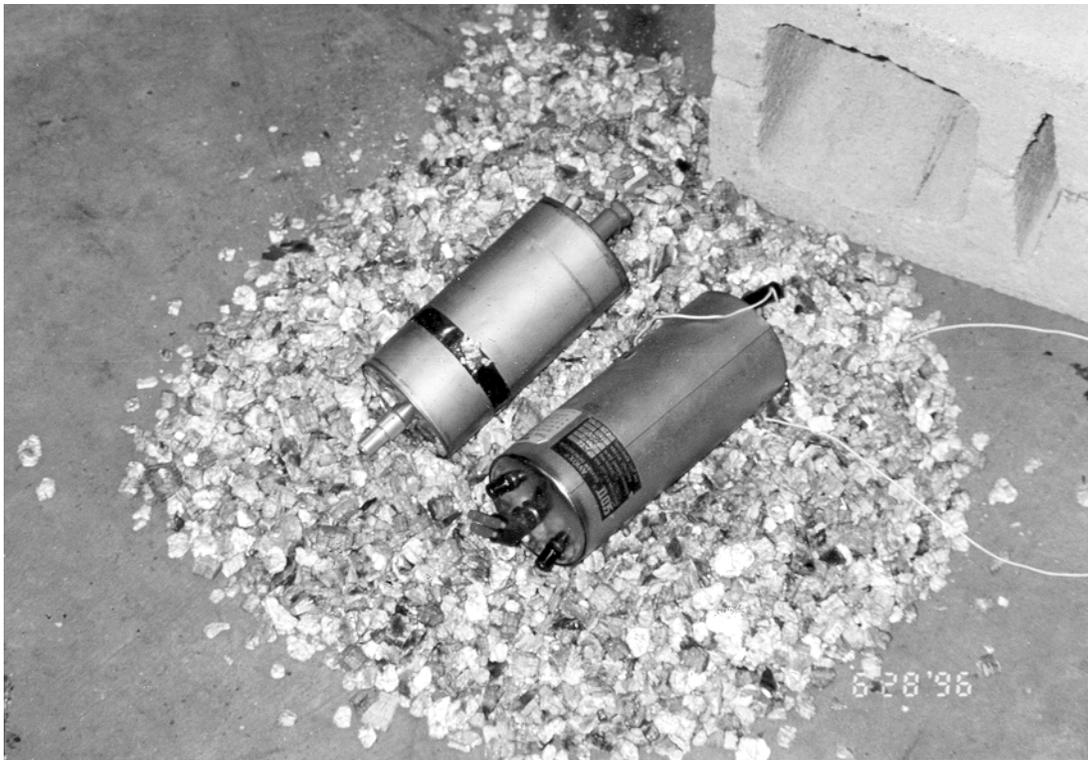
FIGURE 14. GENERATORS AFTER ACTIVATION AND REMOVED FROM BOX

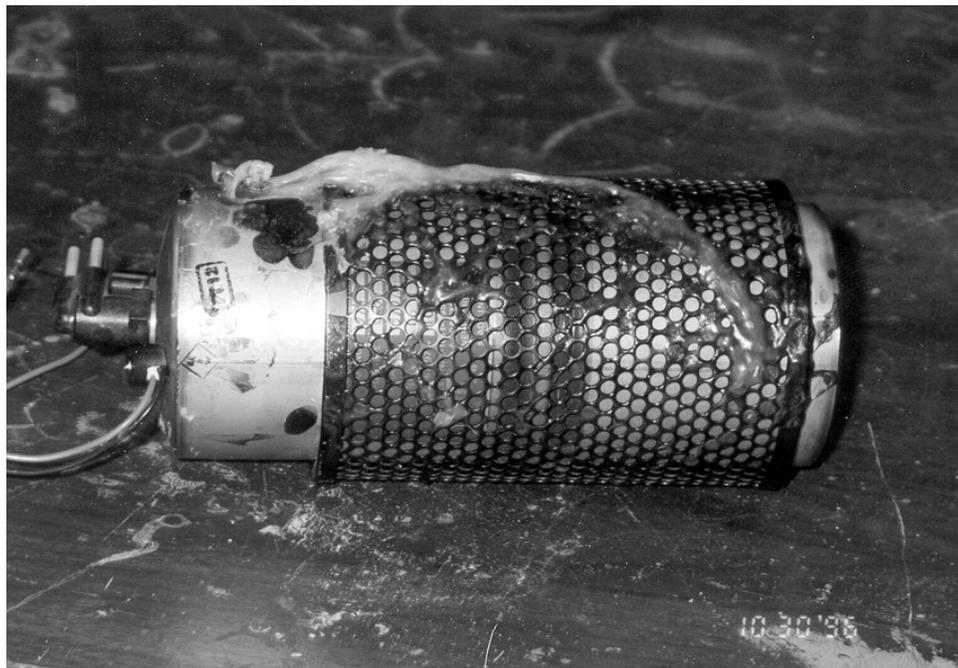
FIGURE 15. ELECTRICALLY ACTIVATED GENERATOR WITH HEAT SHIELD AND MELTED BUBBLE PLASTIC

Test 25. Eight Scott 801462-06 electrically activated generators were placed in a cardboard box with bubble plastic on top. The generator on top, next to the bubble plastic, was activated with a battery. The temperature inside the box peaked at 275°F. These generators, from an L-1011, come with a metal mesh heat shield that prevents combustible material from coming into direct contact with the hottest part of the generator. Heat from the generator melted the bubble plastic and a small amount of smoke was seen. The melted bubble plastic did not drip past the heat shield mesh. See figure 15.
